# INTERPRETING GRAPHITIZATION

A Report for Power Plant Engineers

*Helmut Thielsch, Metallurgical Engineer  
Industrial Piping Division*

TECHNICAL REPORT NO. 1  
APRIL 2, 1954

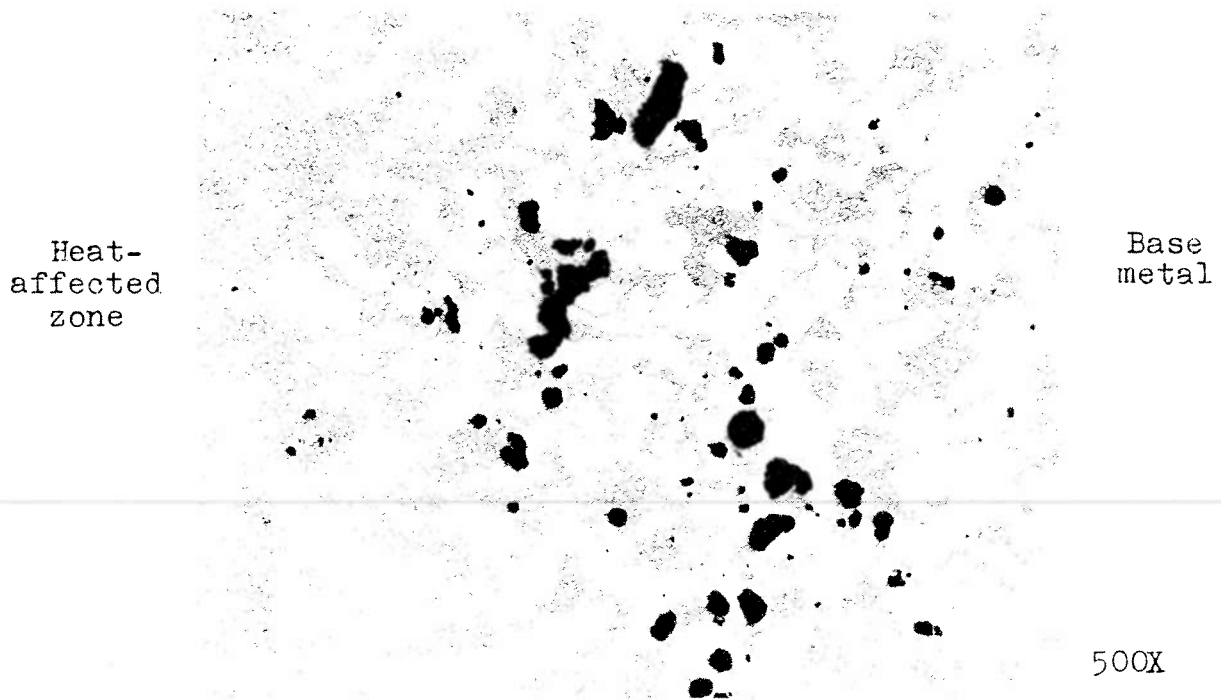
Fig. 2. Photomicrograph of the graphitized zone in the cracked valve material shown in Fig. 1.

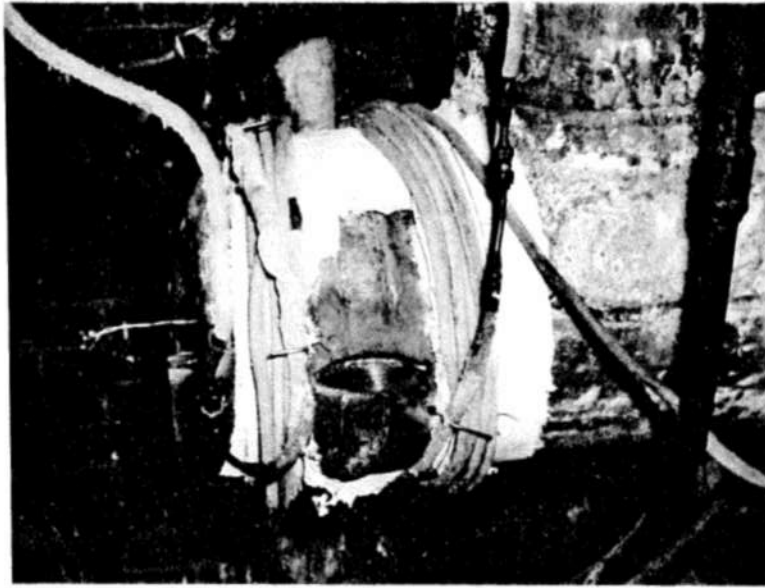
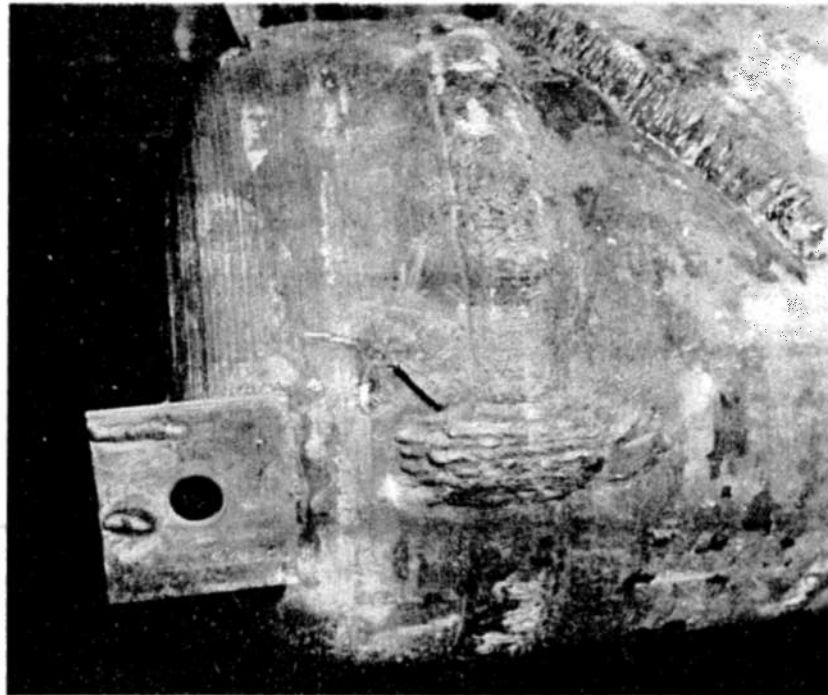
Fig. 6. Rewelded area of sampled cap-to-header joint in steam header  
(a) with preheating coils and deposit of initial root pass,  
(b) completed weld (which has been stress relieved).

Upon removal of the slice from the pipe, the cavity is filled by arc welding, Fig. 6. This is followed by a stress relieving operation. Where rehabilitation of the piping system is contemplated, the stress

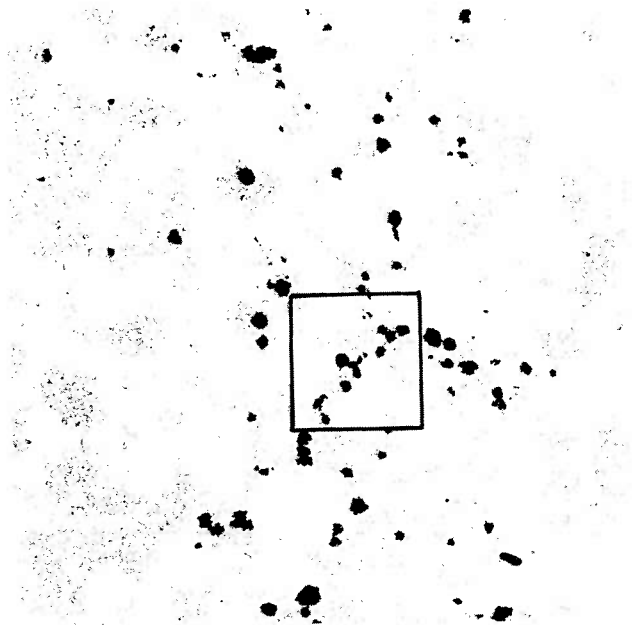
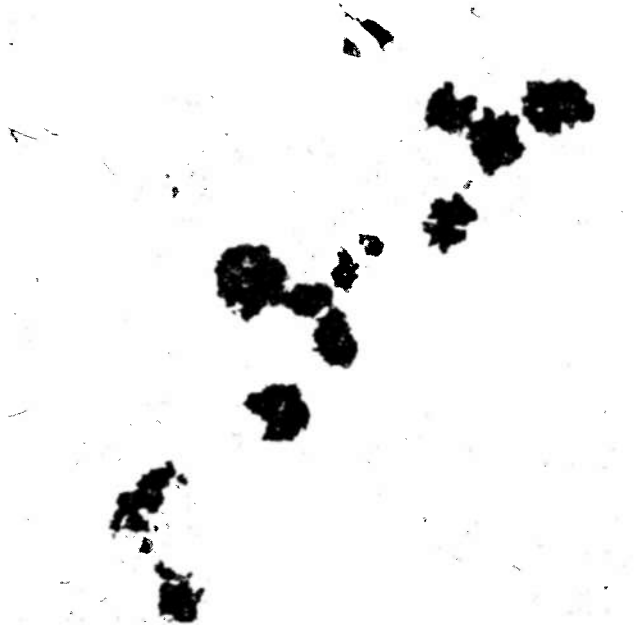
(c) "Moderate" graphitization

<u>Graphite observed in microstructure</u>	<u>Bend angle</u>
mild	over 90°
moderate	45-90°
heavy	30-45°
severe	15-30°
extremely severe (dangerous)	below 15°

<u>Degree of graphitization</u>	<u>Recommended rehabilitation</u>
none	take another weld-probe specimen after 20,000 - 30,000 hrs. of service.
mild	take another weld-probe specimen after 8,000 - 10,000 hrs. of service.
moderate	gouge out (partially) heat-affected zone and reweld.
heavy	cut out (completely) heat-affected zone and reweld.
severe	replace respective piping or valve materials at next scheduled shutdown. Check affected materials for cracks.
extremely severe	present condition of material extremely hazardous. Check for cracks, make immediate repairs and replace materials as soon as replacement sections can be obtained.

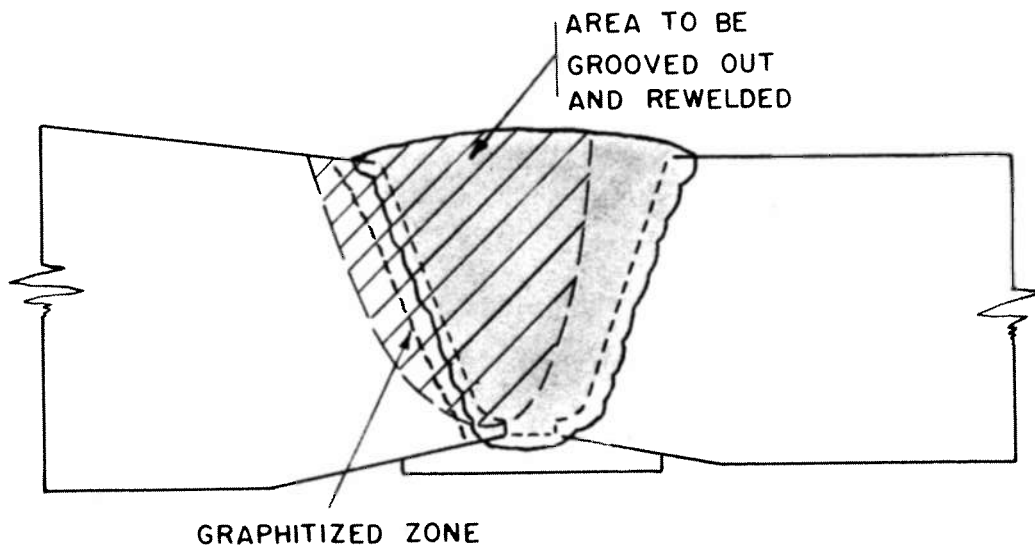
Fig. 8. Sketch illustrating procedure for partial grooving out and rewelding of joint with graphitization on one side of the weld.

In the case of moderate graphitization, partial removal of the graphitized area may be adequate. The groove is cut to about 1/16 in. from the backing ring on the inside diameter of the pipe or valve. Where graphitization has occurred only on one side of the weld, as may be the case in the valve side of pipe-to-valve joints, the procedure illustrated in Fig. 8 should be followed. Where graphitization has occurred on both sides of the weld, the recommended procedure is illustrated in Fig. 9. The new groove is approximately 1/3 to 1/2 wider than the original groove.

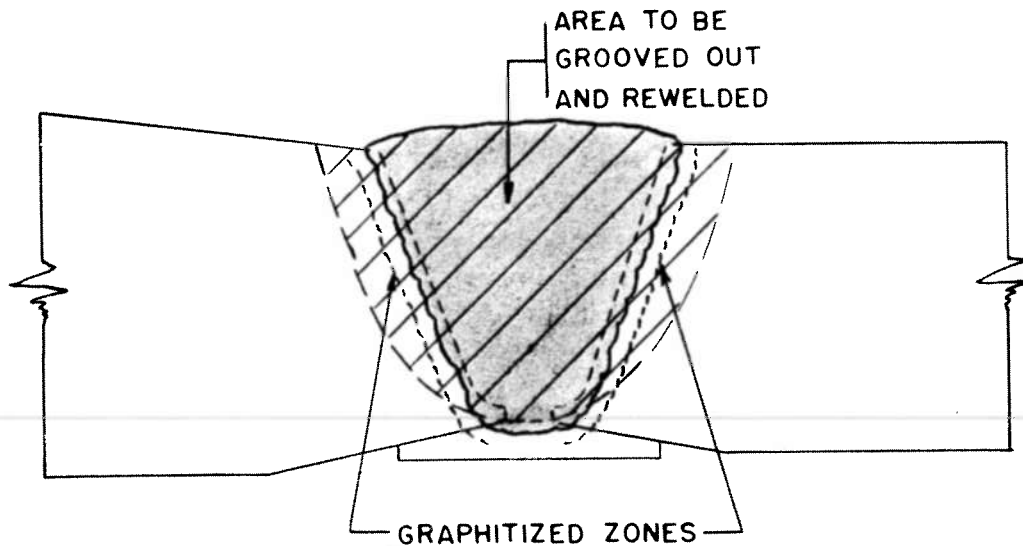
Fig. 9. Sketch illustrating procedure for partial grooving out and rewelding of joint with graphitization on both sides of the weld.

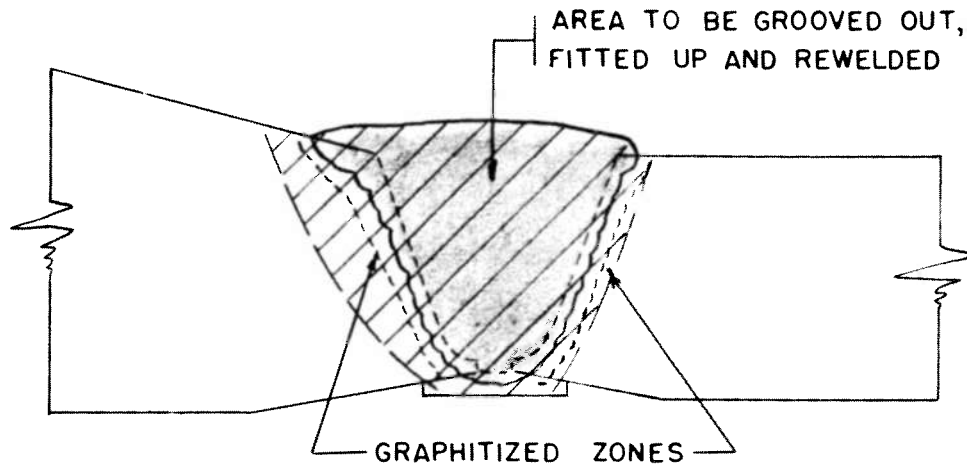
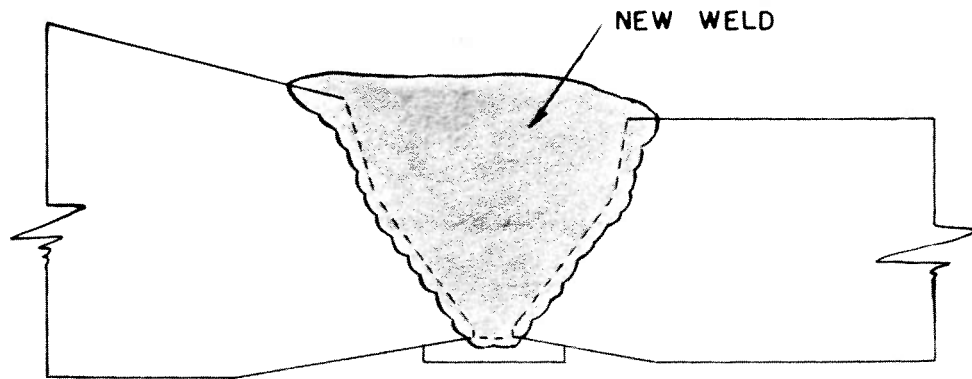
Fig. 10. Sketch illustrating procedure for complete (a) grooving out and (b) rewelding of joint with graphitization on both sides of the weld.

Where the degree of graphitization has been sufficiently heavy to reduce seriously the ductility and toughness in the graphitized area causing cracking to occur in bend specimens at an angle of less than 45°, it may be advisable to remove completely the heat-affected and weld areas. The cut ends should then be pulled together, fitted-up and rewelded as illustrated in Fig. 10. In rigid systems it may be desirable to build up the groove faces with weld metal and grind to obtain a standard edge preparation prior to the final welding operation of the two ends.

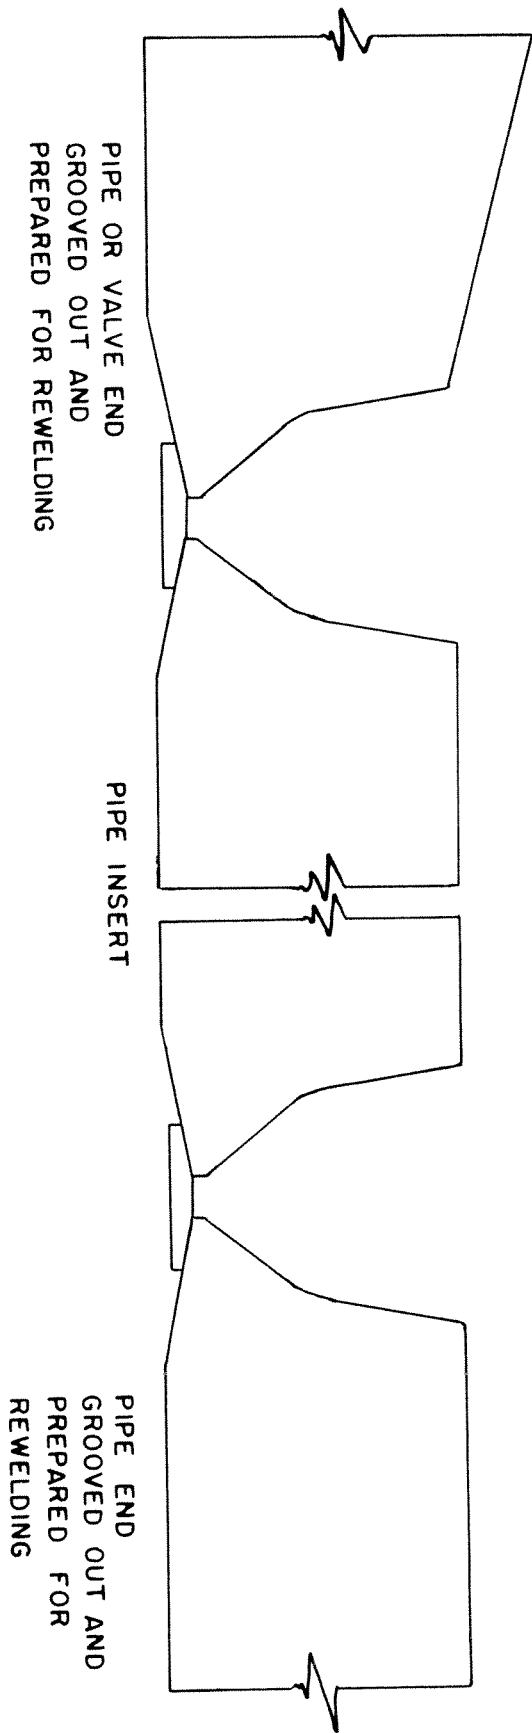
Fig. 11. Sketch illustrating inserting of pipe section to compensate for several weld joints completely grooved out, pulled together, fitted-up and rewelded.

Where necessary, suitable pipe sections should be inserted, preferably of 1/2 Cr - 1/2 Mo, 1 Cr - 1/2 Mo or 1 1/4 Cr - 1/2 Mo steel to replace one or several removed sections, as illustrated in Fig. 11. Generally, the 1 1/4 Cr - 1/2 Mo grades are most readily available.
