COPE CRACKING IN STRUCTURAL STEEL AFTER GALVANIZING

There have been isolated reports of cracks in the flame cut radius of copes of galvanized steel

By Thomas J. Langill, Ph. D.
and Tom Schlafly

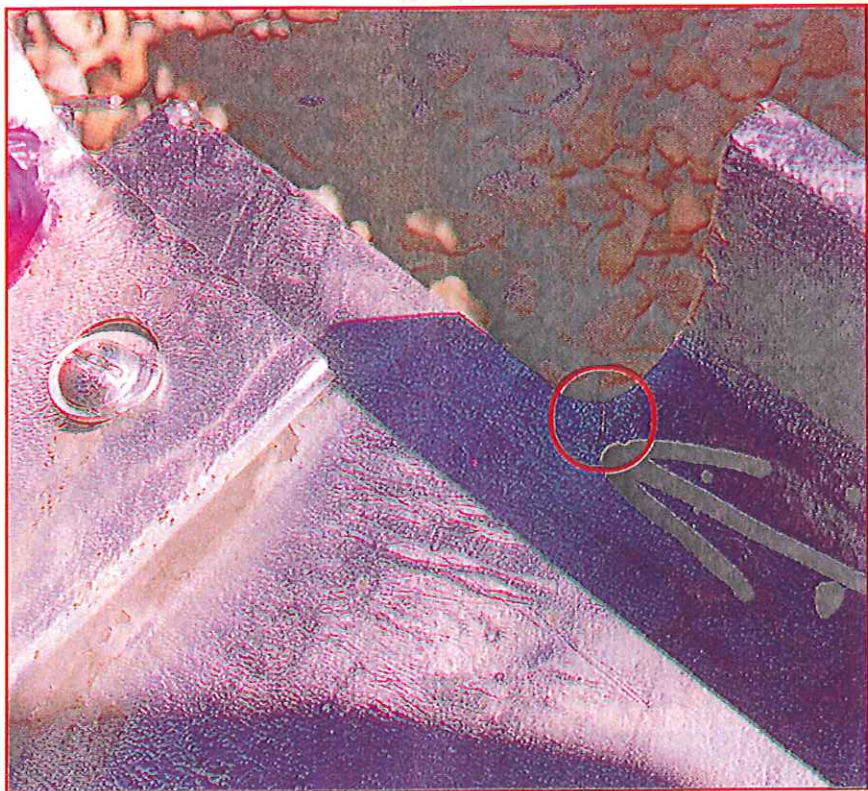
Pictured above is an example of cracking in an oxygen cut cope in a structural steel beam.

monly found in the flame cut radius of copes and extend radially away from the copes at 45 degrees. They are visible on both sides of the web indicating they extend through the material. The cracks have appeared in A36, A572 and probably in A588. Cracks have been found in some material from a given heat and not in other material from the same heat. There have been reports of cracking in material
