SUPPLEMENT TO THE WELDING JOURNAL, DECEMBER 1971

Cracking in Welded Steam Pipe

Cracking tends to occur in a new grade of austenitic stainless (Fe-Ni-Cr-Mn-No-V-N-B) when the carbon content exceeds 0.030% and when noncircular inclusions are present

BY J. A. ISASI, R. C. BATES, AND J. HEUSCHKEL

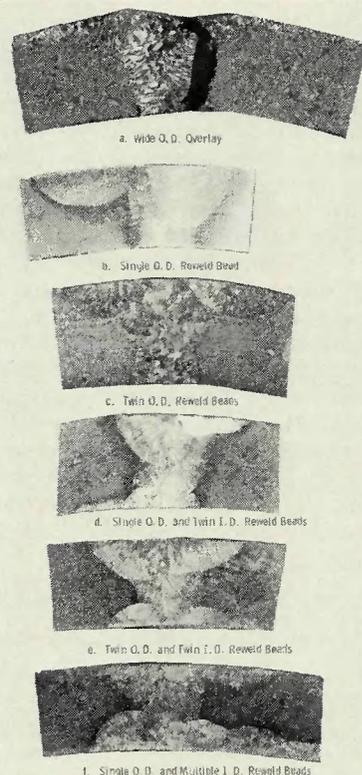
Some of the observed variations in final weld cross-sections are shown in Fig. 2

Fig. 2—Range of elbow weld anomalies. Mag: 5X

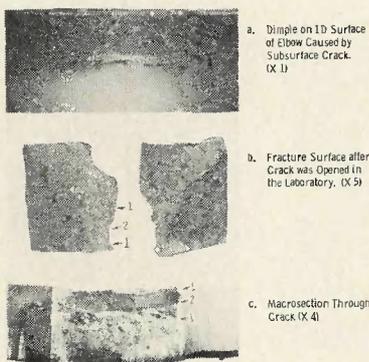
An extrados crack in the elbow made from Heat 2696 was significantly different from those examined in other elbows. This crack appeared to be completely internal and did not penetrate to either surface, although a dimple was formed on the I.D. surface from necking of the material between the internal crack and the surface, see Fig. 4a. Verification that the crack did not penetrate to the surface was obtained from fluorescent penetrant testing.

Fig. 4—Crack and associated surface dimple in Elbow No. 10, Installation No. 5 (heat 2696) (Portions marked 1 broken in lab and that marked 2 is original crack)

The crack was opened and examined visually (see Fig. 4b) and found to be approximately $3/4$ -in. long and 0.080 -in. deep. Its nearest approach to the I.D. surface was about 0.050 in. Even though this crack was completely subsurface, it appeared heavily oxidized. The oxide was uniform in appearance, even near the boundaries, indicating that crack propagation had not occurred in service and that it had formed during welding.

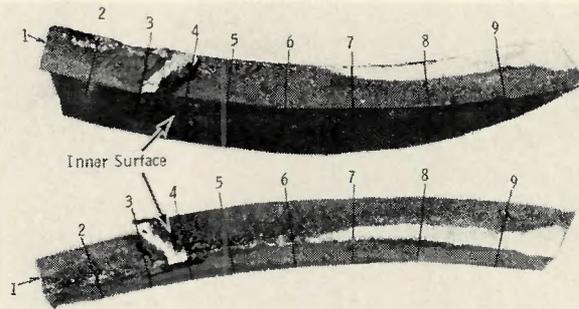
Fig. 5—Photographs of fracture surfaces in elbow no. 12, installation no. 1, showing locations of metallographic sections and fracture replicas. Mag: 2X

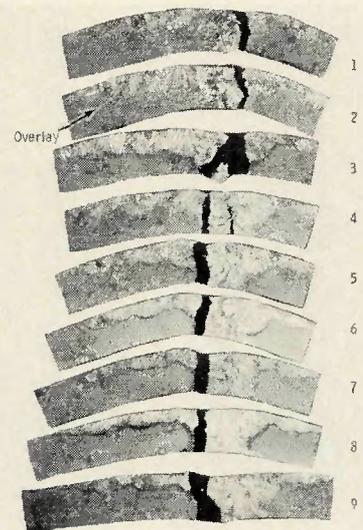
Fig. 6—Macrographic sections through fractures in elbow no. 12, installation no. 1. Numbers indicate location as shown in Fig. 5. Mag: 2X

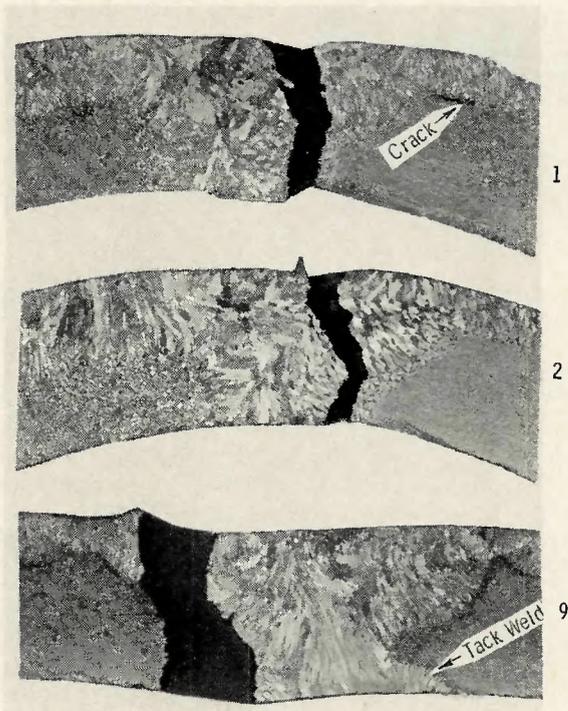
Elbow No. 12, Installation No. 1

Fig. 7—Selected macrographs of cracked welds. Mag: 3.25

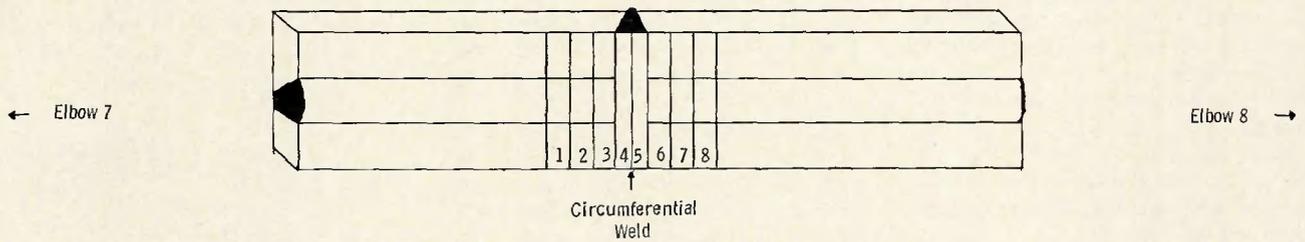
Fig. 8—Macrosections through cracked intrados welds in installation no. 4. Mag: 5X

bows 7 and 8 (see Fig. 8). The effect of the circumferential weld on the already existing intrados weld may well have been similar to the effect of a weld repair.

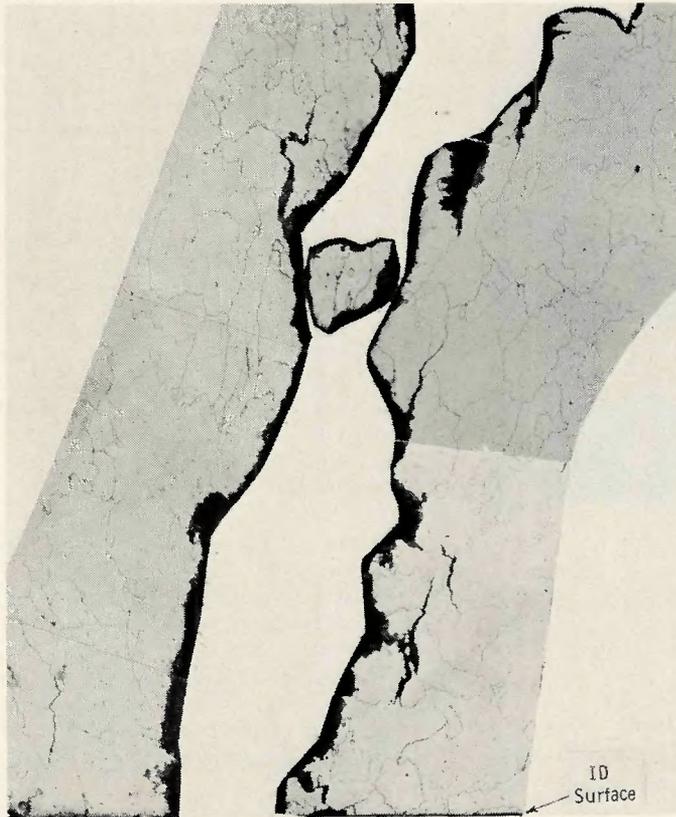
a. Section Near ID Surface of Pipe

For all cracked components except Elbow No. 12, Installation No. 2, the crack was restricted to the heat-affected zone either at the interface between the HAZ and the weld or one or two grains away from it. For Elbow No. 12, Installation No. 2, most of the crack path was confined to the weld region with the exception of small portions of the crack. In those small portions, the cracking was in the HAZ and it resembled the HAZ cracks in the other components.

Fig. 12—Microstructure of area containing crack in elbow no. 12, installation no. 2. Mag: 100X

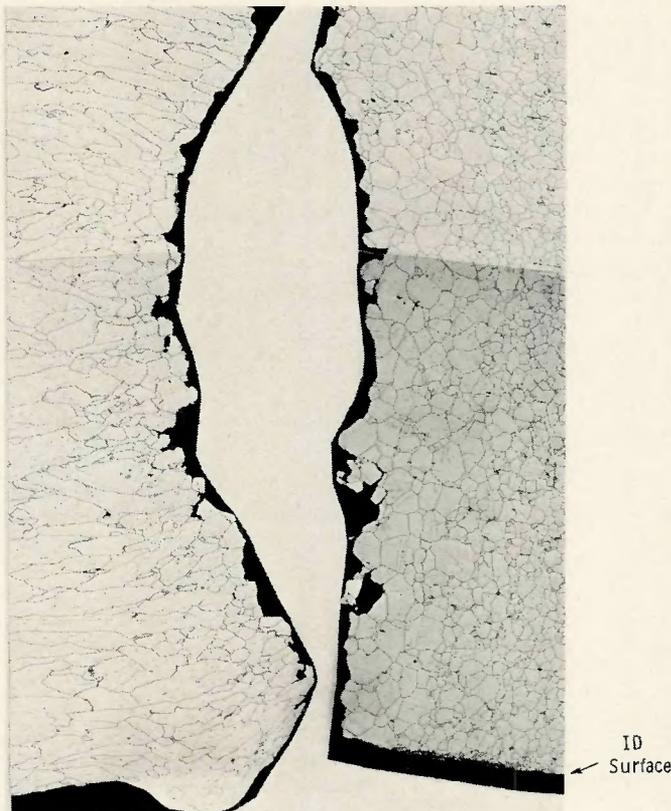
a. Section Near ID Surface of Pipe.

Fig. 13—Microstructure of area containing crack in elbow no. 1, installation no. 3. Mag: 100X

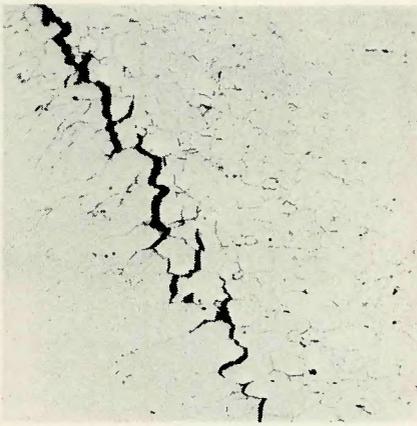
Fig. 14—Typical microstructure at mid-depth of straight pipe, installation no. 3, showing crack. Mag: 100X

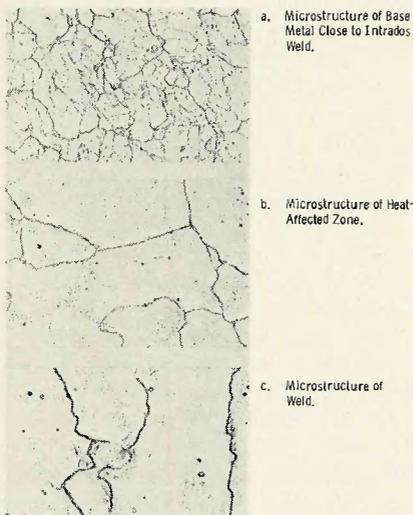
The microstructures of all investigated components except Elbow No. 2, Installation No. 3, were found to contain large amounts of precipitates as illustrated in Figs. 15 and 16. The relative distribution of particles in these components was determined to be about the same. In the base metal, the particles were located primarily at the grain boundaries, twin boundaries, and prior boundaries, with small amounts situated randomly within the grains. In the HAZ and weld regions, the particles were found mainly at the grain boundaries; although small amounts of fine intragranular precipitates were present in the weld which appear to be associated with the dendritic structure. In general, the size of the particles in the HAZ and weld areas were much larger than in the base metal and form essentially a continuous network at the boundaries.

Fig. 15—Typical microstructure of three areas in elbow no. 12, installation no. 2. Elbow made from heat no. 806286. Mag: 1000X

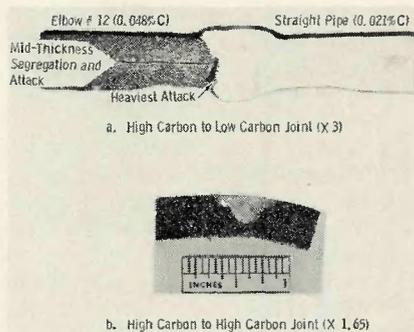
The results obtained from the Strauss test agree well with the microscopic observation showing that all areas with large amounts of precipitate (elbows from high carbon heats) were attacked. In all cases in which attack occurs, the maximum attack was at the HAZ. Figure 19 illustrates the appearance of two such specimens

Fig. 19—Transweld specimens after 24 hr Strauss test (acidified copper sulfate solution)

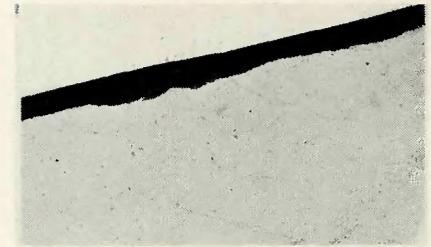
a. Micrograph Showing Transgranular Nature of the Crack

Fig. 20—Micrographs of a section containing crack from elbow 10, installation no. 5. Mag: 500X

(b) Elbow No. 10, Installation No. 5. For this component, the cracking was determined to be mostly transgranular and no evidence of secondary cracking nor branch cracks were found, Fig. 20a. In addition, a thin layer of oxides could be seen in the unetched condition, Fig. 20b. No evidence of cracking in the HAZ was observed. The portion of the crack formed in the laboratory while opening the defect for observation was principally transgranular.

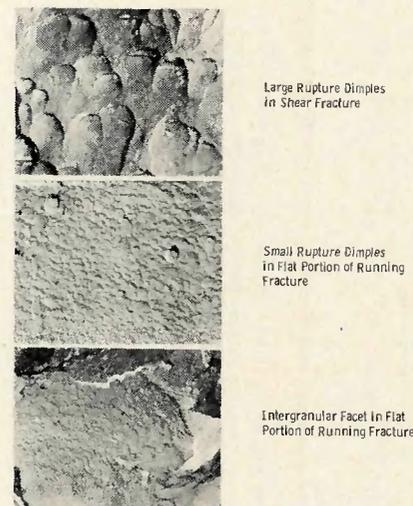
equiaxed (tensile) types, and a wide range of sizes was evident. Some typical cases are shown in Fig. 23. Some intergranular separation had occurred, an example of which is also shown in Fig. 23, indicating that an extensive creep damage occurred throughout this area. Many small particles are present on the grain boundary surface shown in Fig. 23, and many impressions are present where particles appear to have pulled out (the particles are probably attached to the mating surface). This appearance suggests that decohesion of the boundaries of the precipitate (at the grain boundaries) and the matrix has occurred.

Fig. 23—Selected portions of surfaces in fast crack in elbow no. 1, installation no. 3. Mag: 2700X
