Effect of Low Frequency Thermal Cycling on the Crack Susceptibility of Soldered Joints

Mechanism of cracking in four solder alloys used on PCB joints is studied during and after cycling from -65 to +150 C

BY E. R. BANGS AND R. E. BEAL

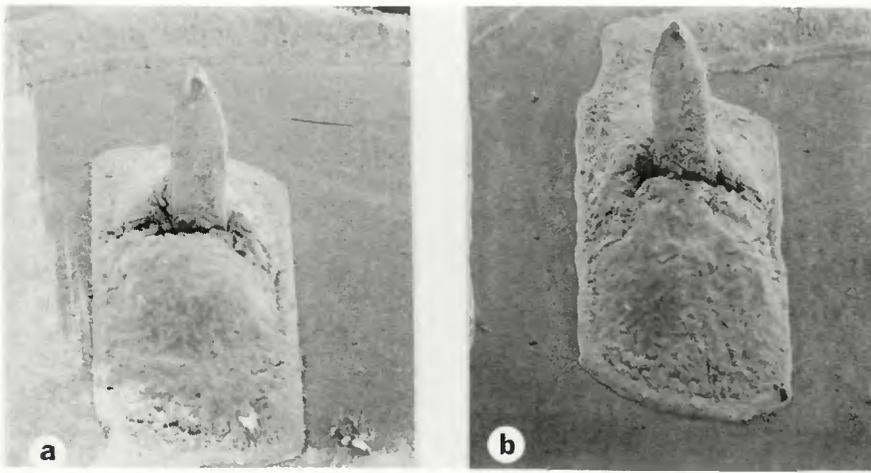
Fig. 2 — SEM view of PCB solder joints containing 63Sn alloy after environmental testing. (a) Integrated circuit pin on reflow soldered PCB; (b) same on nonreflow soldered PCB X25, reduced 39%

The first test run with 63Sn and 50Sn alloys was concluded at 800 cycles. The reflowed printed circuit board soldered with the 63Sn alloy contained the highest incidence of solder joint cracking. Examination of the soldered joints revealed failures comprised of large open cracks in the solder fillets and areas in which particles of the solder alloy actually broke away, as shown in Figs. 2 and 3.

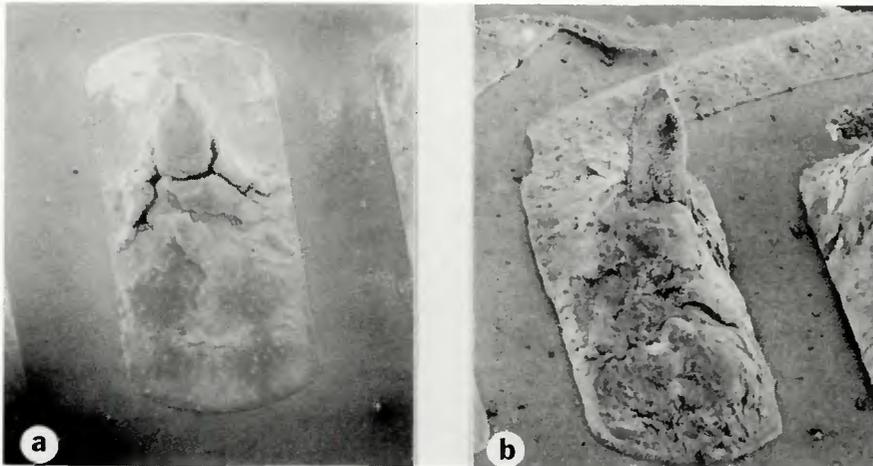
Fig. 3 — SEM view of PCB solder joints with 50Sn alloy after environmental testing. (a) Integrated circuit pin on reflow soldered PCB; (b) same on plated soldered PCB. X25, reduced 38%

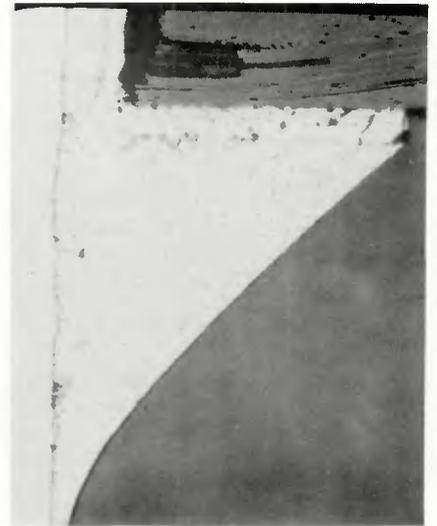
Fig. 4 — As-soldered plated integrated circuit joint soldered with 63Sn alloy. X170, reduced 37%

Figure 4 shows a section of the 63Sn alloy plated integrated circuit soldered joint in the as-soldered condition containing the fine eutectic microstructure. Figure 5 shows a fillet after exposure to 800 cycles without failure of LEDs. Cracking is evident near the pin lead and the upper tapered region; the cracking follows the pin in a very linear manner. Fractured regions of the solder alloy fillet toe at the pin interface showed evidence of solder alloy loss and deformation during thermal cycling. The solder alloy microstructure adjacent to the pin in the fillet throat region and near the copper-plated board has coarsened. The type of cracking that will be defined here as thermal fatigue cracks shows characteristics of both a

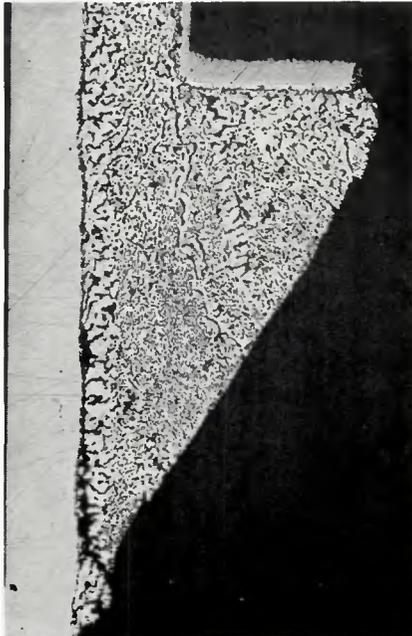
failure due to stress rupture and fatigue, as revealed in the copper-clad region of the PCB in which a linear fracture follows the surface of the solder plated zone.

Fig. 5 — Stress-rupture and thermal fatigue failures in pin region of 63Sn solder alloy on plated soldered PCB. X170, reduced 50%

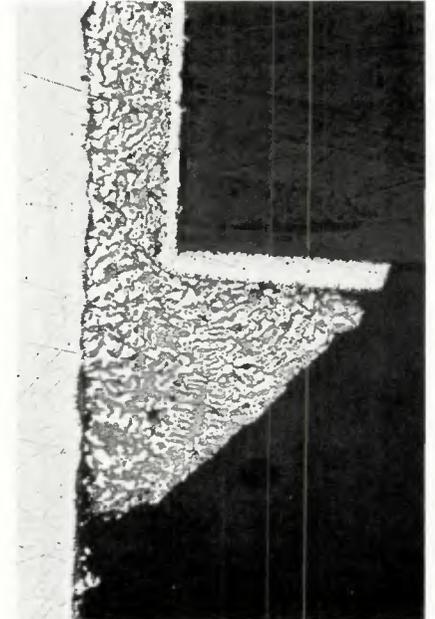
Figures 7 and 8 are representative of the 50Sn-50Pb joints on plated and reflowed solder alloy PCBs. The characteristics of the cracks of the reflowed and plated joints were similar. Cracks were evident propagating from the solder fillet toe at the pin region. There was no extinguishing of light-emitting diodes upon completion of cycling at 800 cycles. The cracks follow the pin interface with the presence of grain coarsening adjacent to the crack opening. Areas in the toe region of the fillet contained fragmented solder material.

Fig. 7 — Integrated circuit joint (pin side) containing 50Sn-50Pb solder alloy on plated soldered PCB. x170, reduced 50%

The fracture and deformation characteristics of the reflowed PCB were similar to the plated PCB. Figure 7 shows intergranular disintegration on the solder alloy fillet face. Figure 8 shows the intersecting area of the crack that proceeds to open and surround the pin. Crack propagation is occurring in an intergranular manner.

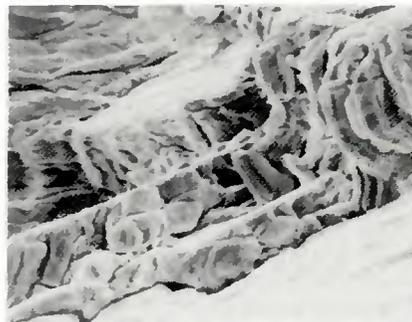
An examination of the fractured surfaces using the SEM revealed further data relating to the fracture mechanism of the joints with 63-37 solder alloys. Figure 6 is representative of the fractured 63-37 solder alloy interface on the pin side of the soldered joint. The fracture had a nonductile fracture appearance in areas of coarsened eutectic distribution combined with interphase separation. Plastic deformation has oc-

curred during crack propagation. Fracture due to slip is occurring combined with evidence of twinning lamellae in the tin-lead matrix.

Fig. 6 — SEM view of 63Sn-37Pb solder alloy fractured interface between pin and fillet face of reflowed board. X3000, reduced 48%

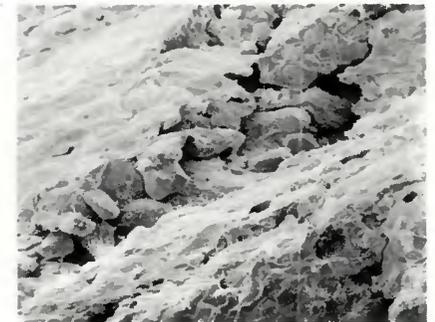
Fig. 8 — SEM view of 50Sn-50Pb solder alloy on reflowed PCB, intersection of crack on solder fillet face. X750, reduced 47%

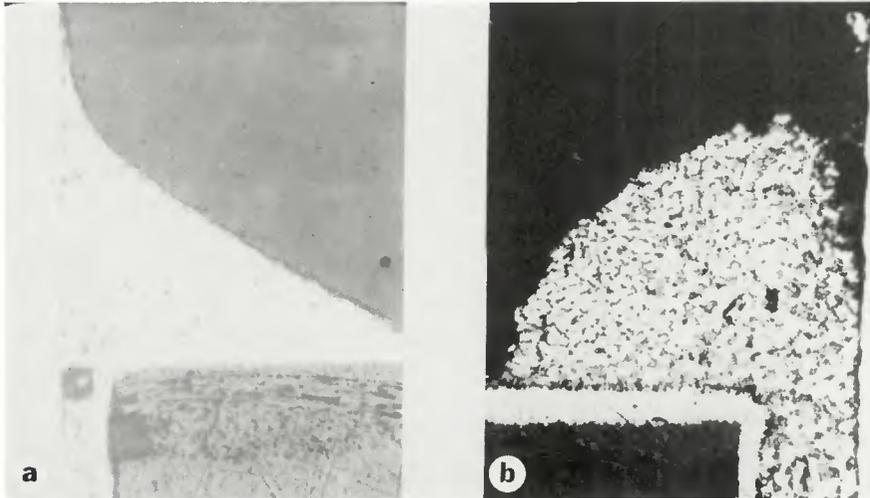
Figure 9(a) shows the 40Sn plated soldered joint prior to thermal cycling. The microstructure contains the lead-rich matrix with sharply defined eutectic and dendritic branches. Figure 9(b) shows the soldered fillet after exposure to 800 cycles of thermal testing with a drastically transformed microstructure after being subjected to thermal and mechanical stressing.

After exposure to 800 thermal cycles, crack initiation occurred at the solder fillet toe adjacent to the lead pin. Extensive grain coarsening was produced, with excessive amounts of lead-rich phase present in the crack

Fig. 9 -- Thermally cycled 40Sn-60Pb soldered plated joint (a) in the as-soldered condition and (b) after exposure to 800 cycles of environmental testing. X170, reduced 40%

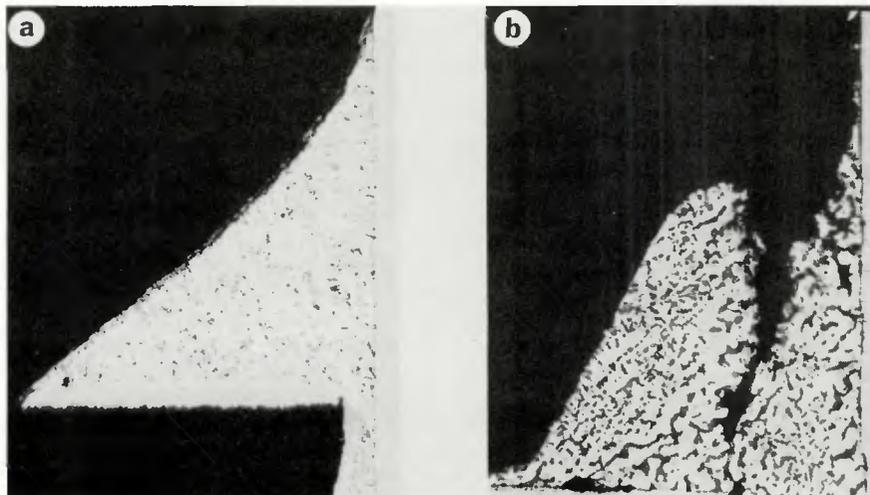
Figure 10(a) shows the tin-rich microstructure of the 70Sn soldered joint of the reflowed PCB prior to testing. Figure 10(b) shows the fillet after 800 cycles of thermal testing. As can be observed, the microstructure has undergone a drastic transformation to a coarsened eutectic distribution in which cracking has occurred through areas of excessive coarsening.

Fig. 10 -- Thermally cycled 70Sn alloy soldered joint (a) in the as-soldered condition and (b) after exposure to 800 cycles. X170, reduced 40%

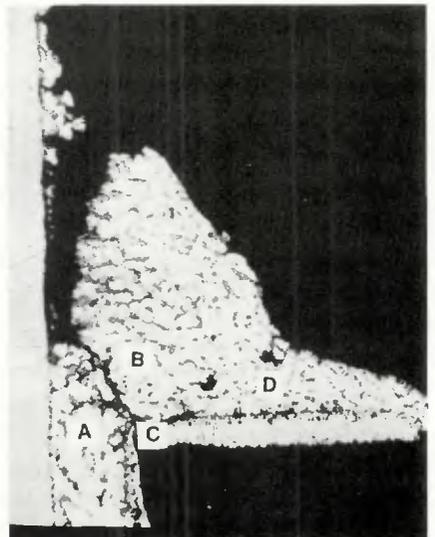
Figure 11 shows the gross cracking condition which exists at the pin fillet leg region and multi-directional cracking existing in the throat region of the fillet. The cracking condition describes clearly the "hinge" effect created through the throat region of the fillet. As shown at A the crack path has propagated transverse to the throat direction of the fillet. Hairline cracking can be detected through the lead-rich layers extending perpendicular to the pin/fillet crack interface. As shown in B, hairline crack

Fig. 11 -- Plated soldered joint with 70Sn-30Pb alloy after exposure to 800 cycles of thermal cycling containing multidirectional microstructural cracking and fragmentation of solder alloy. X170, reduced 37%

growth is occurring through the tin-rich grains. Crack formation is starting between points C and D which is an early stage of fillet fragmentation.

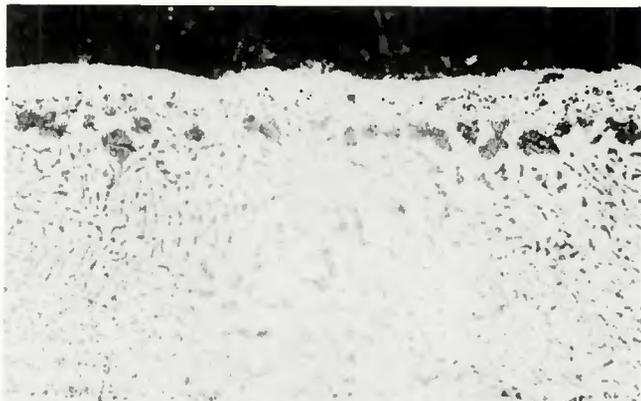
Fig. 12 — Growth of lead-rich phase in 63Sn reflowed PCB at solder/copper clad interface. X480, reduced 49%

A major difference in the microstructure of the reflowed joint compared to the plated joint is the spheroidal phase evident in the reflow region of the PCB, Fig. 12. A similar spheroidal phase is shown in some regions at the solder alloy/pin interface. The reflowed layer is thicker than the plated layer. The solder in this area, because of added soldering temperature exposure, has dif-

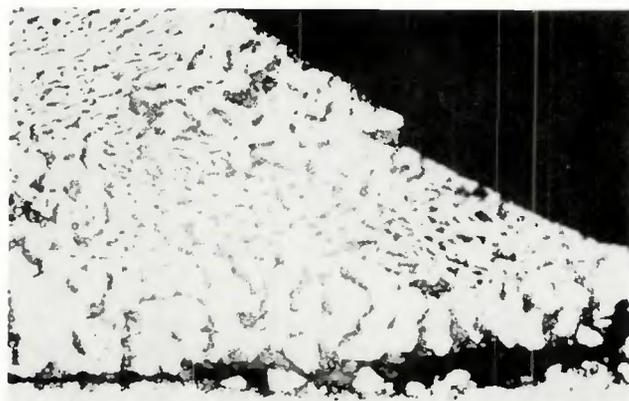
Fig. 13 — Crack along pin interface, mainly intergranular in form; 63Sn alloy. X480, reduced 49%

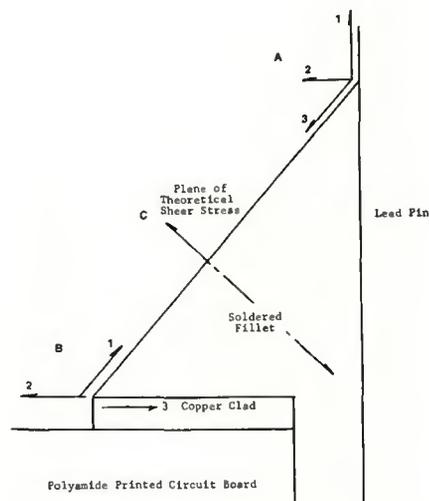
Fig. 14 — Model of stresses applied to the soldered printed circuit board joint during thermal cycling

The model in Fig. 14 diagrammatically shows the stresses applied to the fillet when the joint is subjected to 150 C. The stress concentration regions are the fillet toes at the pin A and the copper cladding B. During

thermal cycling, a load is applied to the root area of the fillet and thus a twisting load is applied about plane C. As a result of the twisting load, fracture is starting to occur at the fillet toe and through the throat region of the fillet. Upon heatup of the joint, differences in expansion between the solder and the pin at A result in a stress which applies a shear load to the solder fillet leg. The pin expansion also applies loads to the fillet. At the same time a shear load is applied through the fillet throat at C. Due to the expansion differences between the solder and copper-polyimide board, a shear load is applied at B. These stresses produce progressive deformation as shown in Fig. 15.

The primary area of cracking is the toe region of the solder-pin interface. As depicted in the Fig. 14 model, it is in this region that multiaxial stress systems are applying shear and compressive loading to the solder/pin interface. A "hinged" twisting moment

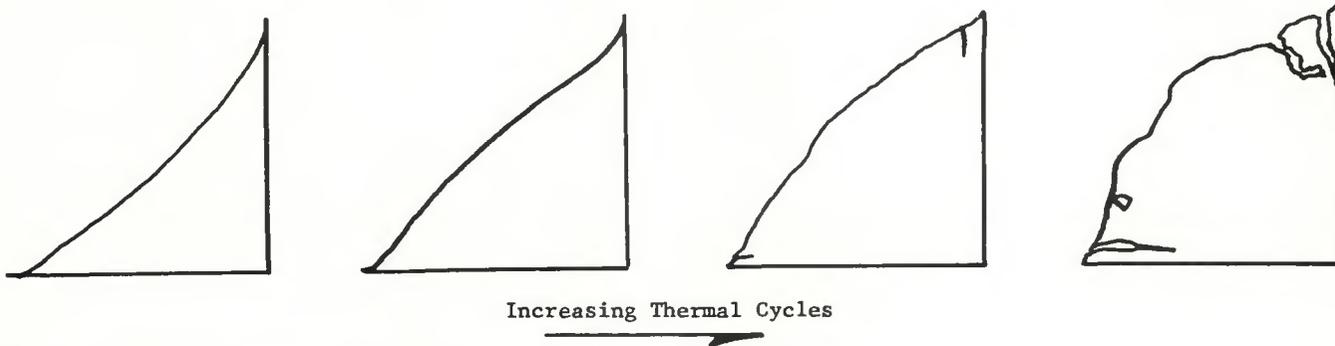
As-Soldered
Fillet Geometry
(diode lead to
PCB cladding)

Initiation of Internal
Grain Coarsening, Throat
Dimension Beginning to
Increase

Fillet Face Becoming
Convex, Grain Coarsen-
ing Increasing at
Stress Concentration
Zone, Cracking Begin-
ning to Occur

Excessive Fillet Face
Convexity, Cracking
and Fragmentating
Excessive

Fig. 15 — Solder fillet geometric change during thermal cycle stress failure mode
