Austenitic Stainless Steel-Ferritic Steel Weld Joint Failures

BY R. L. KLUEH AND J. F. KING

ABSTRACT. The cause of failures of dissimilar-alloy (austenitic or ferritic) joints in superheater and reheater tubes of fossil-fired steam plants was investigated. In the failures of interest, cracks form and propagate in the ferritic steel (usually 2½ Cr-1 Mo steel) about 5 to 15 µm from the fusion line. The complex microstructure developed at the interface between weld metal and 2½ Cr-1 Mo steel during welding and elevated-temperature service was examined in (1) the as-welded and as-welded-and-tempered conditions and (2) failed and unfailed joints having more than 100,000 h of service in a fossil-fired boiler.

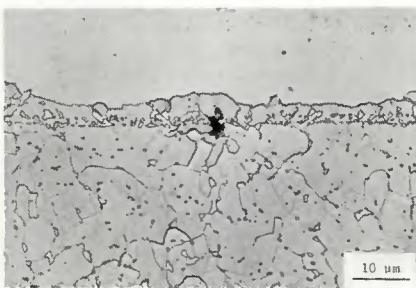
After prolonged service in a fossil-fired boiler, the microstructure changes, but vestiges of the as-welded microstructure remain; this is shown in Fig. 6 for a Type 321 stainless steel—2½ Cr-1 Mo steel joint welded with ENiCrFe-1. This joint was in service at about 560°C (1040°F) for more than 100,000 h. Interestingly, the dark-etching phase has disappeared. The grain boundaries parallel to the fusion line are still present, and they very definitely contain another phase.

Fig. 6—Microstructure of transition weld joint between 2 1/4 Cr-1 Mo steel and Type 321 stainless steel welded with ENiCrFe-1. Joint was in service in a fossil-fired plant for more than 100,000 h at about 560°C (1040°F)

The phase in the grain boundaries parallel to the fusion line (Fig. 6) is of special interest because transition joint failures usually occur by cracks that propagate along this boundary or in a region adjacent to it (Ref. 6, 11).^{*} High-chromium δ -ferrite regions are believed to form in these grain boundaries during welding. Apblett et al. (Ref. 18) showed that δ -ferrite can occur in 2 1/4 Cr-1 Mo steel heated to welding temperatures. They stated, "Apparently when the carbide phase (in the annealed 2 1/4 Cr-1 Mo steel being heated during welding) dissociates, there exist regions of sufficiently high-alloy content to close the gamma loop." They concluded that the high-alloy content at the site of the original carbide resulted in alloy diffusion, which caused the size of the δ -ferrite regions to increase. They found these regions to occur only at grain boundaries.

We also examined the precipitates in the grain boundaries parallel to the fusion line of the specimens shown in Fig. 6. This was the same ENiCrFe-1 weld that had been in service more than 100,000 h at

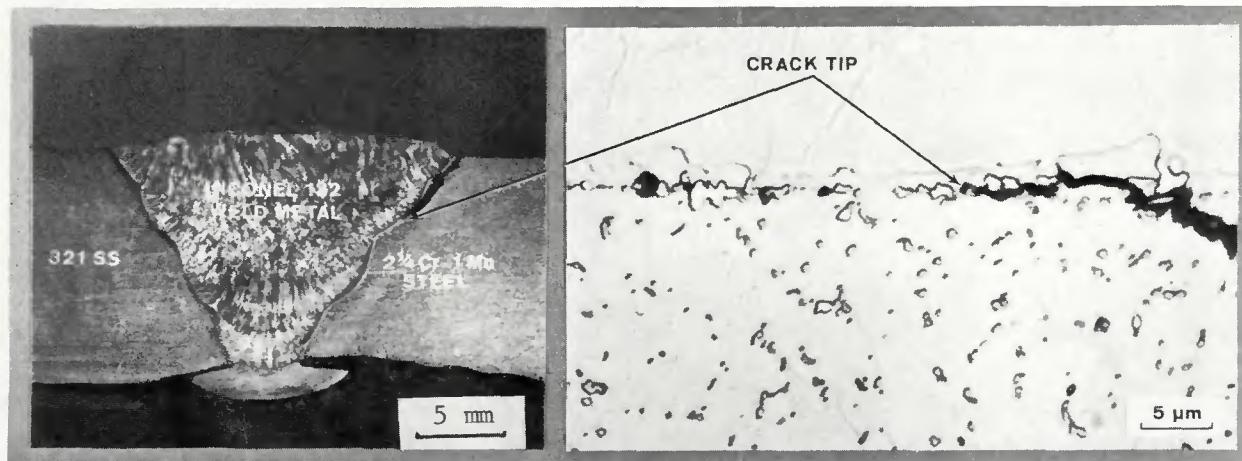
Fig. 7—Cross section of failed transition joint that was in service for about 150,000 h (17 years) at about 560°C (1040°F). The photomicrograph shows that the crack propagates in grain boundaries of 2 1/4 Cr-1 Mo steel. Source: Gray, R. J., King, J. F., Leitnaker, J. M., and Slaughter, G. M., *Examination of a Failed Transition Weld Joint and the Associated Base Metals*. ORNL-5223, 1977, Oak Ridge National Laboratory, Oak Ridge, TN

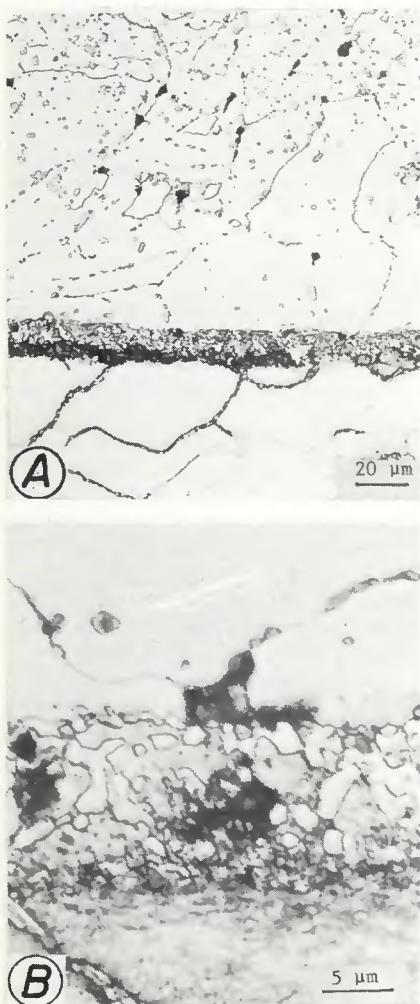
The microstructure in this case was somewhat different from that observed for fusion welds—Fig. 11. The decarburized grain-growth region was readily apparent. In addition to the decarburized region, what appeared to be a two-phase zone occurred adjacent to the bond line. At high magnification the second phase appears to be similar to the phase in the grain boundaries parallel to the fusion line in the fusion welds.

Fig. 11—Microstructure of an induction-pressure weld between $2\frac{1}{4}$ Cr-1 Mo steel and Type 321 stainless steel. The joint was taken from service after about 137,000 h at about 560°C (1040°F). Etched with 2% nital

The photomicrographs (Fig. 11) also show indications of precipitate particles in the grain boundaries of the Type 321 stainless steel. This finding is attributed to carbon diffusion from the $2\frac{1}{4}$ Cr-1 Mo steel. The grain boundary microstructure of the $2\frac{1}{4}$ Cr-1 Mo steel near the interface of the pressure welds is also different from that of the fusion weld (no parallel grain boundaries)—Fig. 6.

In induction-pressure welds, chromium is removed from the 2 1/4 Cr-1 Mo steel matrix adjacent to the two-phase zone described—Fig. 11. On close examination, an almost continuous layer of this phase appears to exist at the interface of the two-phase region and 2 1/4 Cr-1 Mo steel. During service, this phase could grow by the same method as the particles in the grain boundaries of the fusion weld. An oxide notch is always observed to form in this chromium-depleted region.

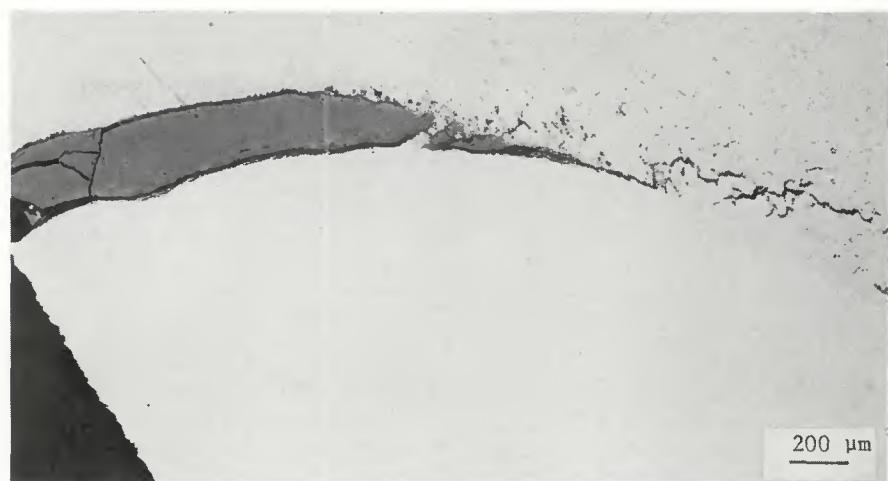
Fig. 12—Photomicrograph of an oxide-filled crack in failed weld joint

Once a crack is nucleated, crack growth will proceed from the influence of the external stress, from the cyclic thermal stresses, and possibly from the stresses generated by the oxide that forms within the crack. Because the region adjacent to the grain boundaries parallel to the fusion line has low oxidation resistance, a tendency for oxidation to continue along this boundary will exist. Once a crack forms ahead of the oxide notch, oxide should quickly fill the crack—Fig. 12.

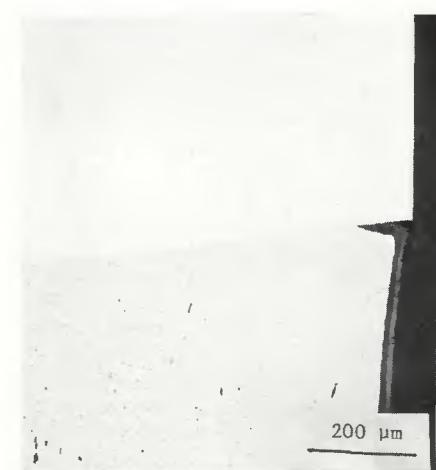
Reduced oxidation resistance leads to an oxide notch at the external surface—Fig. 13. Such a notch is present on all tubes that have been in elevated-temperature service. Without the loss of chromium from the matrix, however, no pronounced notch should form slightly away from the fusion line, and the oxide thickness at that point should be the same as it is on $2\frac{1}{4}$ Cr-1 Mo steel away from the interface, which is not the case—Fig. 13.

Fig. 13—Example of oxide notch formed on outer surface of a dissimilar-alloy weld joint

Finally, if the formation of an oxide notch could be prevented, the life of transition joints should be extended. The most obvious way to do this would be an oxidation-resistant cover over the weld on the inner and outer surfaces of the tube. This obvious solution was proposed by Tucker and Eberle (Ref. 4). Indeed, they tested coatings applied by calorizing and chrome plating. However, when these joints were tested under cyclic conditions, the thermal expansion differences between the coatings and the other materials caused the coatings to crack, after which failure occurred by the usual manner. They did find that, "The weld overlay deposited with 80Ni20Cr withstood over 5000 h at 1100°F (2012°F), involving 308 temperature-stress cycles without notch or crack for

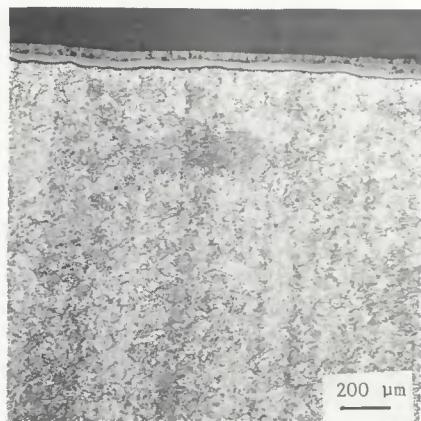
Fig. 14—The 2 1/4 Cr-1 Mo steel fracture surface. Oxide forms on surface after fracture. Photomicrograph is near the inner surface. Etched with 2% nital

Metallographic examination of two sections from the failed tube indicated that most of the separation occurred at or near the prior weld interface—Fig. 14. The separation at the weld interface occurred from the tube inner surface through about 85 to 90% of the wall thickness. For the remainder of the wall thickness, separation occurred along 2 1/4 Cr-1 Mo steel grain boundaries about one grain width into the 2 1/4 Cr-1 Mo steel. This separation resulted in grains of 2 1/4 Cr-1 Mo steel adhering to the Type 347 stainless steel (Fig. 15) and grains pulling from the 2 1/4 Cr-1 Mo steel (Fig. 16). Interspersed within the grain-boundary separation, further regions occurred in which separation again occurred along the weld interface.

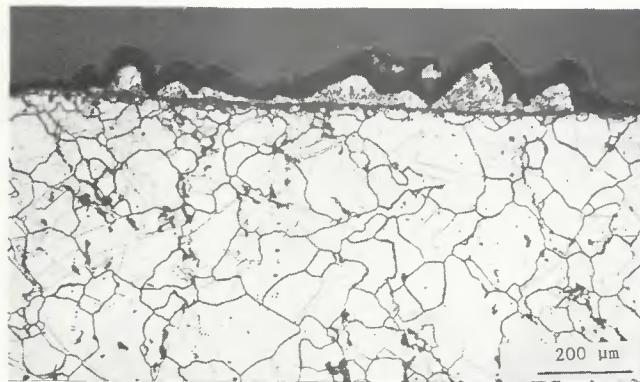
Fig. 15—Fracture surface showing grains of 2 1/4 Cr-1 Mo steel adhering to Type 347 stainless steel. Photomicrograph is near the outer surface. Etched with aqua regia

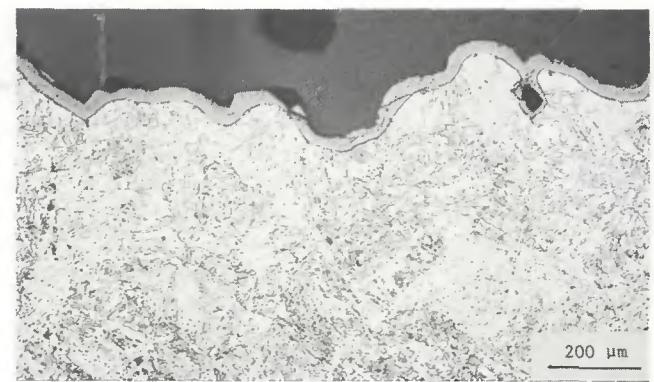
Fig. 16—Fracture near outer surface showing that 2 1/4 Cr-1 Mo steel grains were removed during fracture. Etched with 2% nital

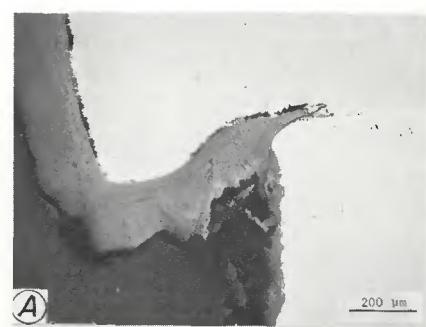
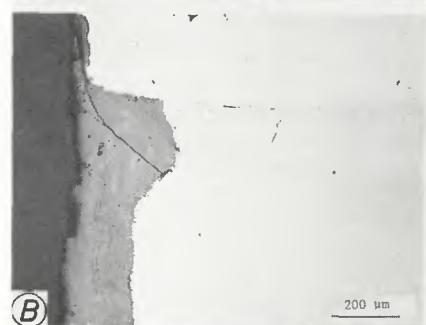
The first metallographic examination of the cross section of the unfailed joint revealed no indication of cracks forming parallel to the weld interface. Features of interest in the unfailed joint were the oxide notches that appeared on the external surfaces at the weld interface. Two types were observed: a wedge-shaped notch at the inner surface (Fig. 17A) and a blocky notch at the outer surface (Fig. 17B). Similarly shaped notches were observed on both pieces of the joint that were examined.

Fig. 17—Photomicrographs of oxide notches at the weld interface: A—wedge-shaped notch at the tube inner surface; B—blocky notch at tube outer surface

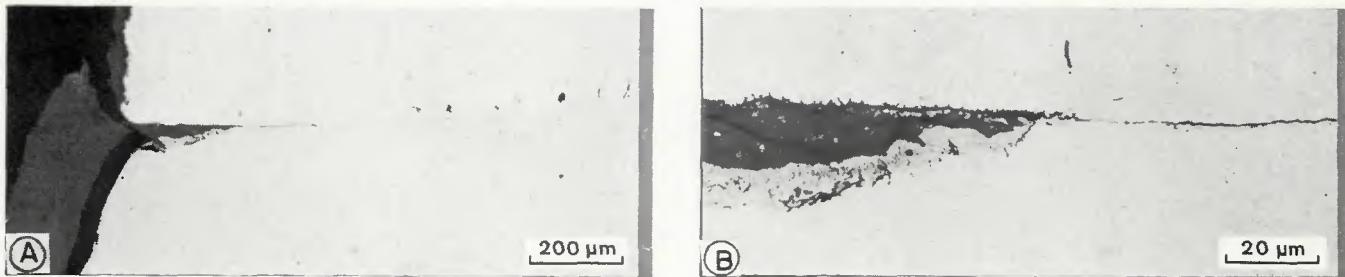
After grinding and repolishing the unfailed specimen, we found evidence of crack formation. On the tube inner surface of both metallography specimens (the same two pieces of sample were studied), we found evidence that a crack was present—Fig. 18. Figure 18 shows the oxide wedge and a very fine "crack" ahead of the massive wedge. As expected, the cracks run along the weld interface adjacent to the two-phase zone. It is not possible to determine whether or not the crack contains oxide, although it appears to.

Fig. 18—After repolishing there was evidence of a crack below the wedge-shaped oxide notch of the unfailed joint

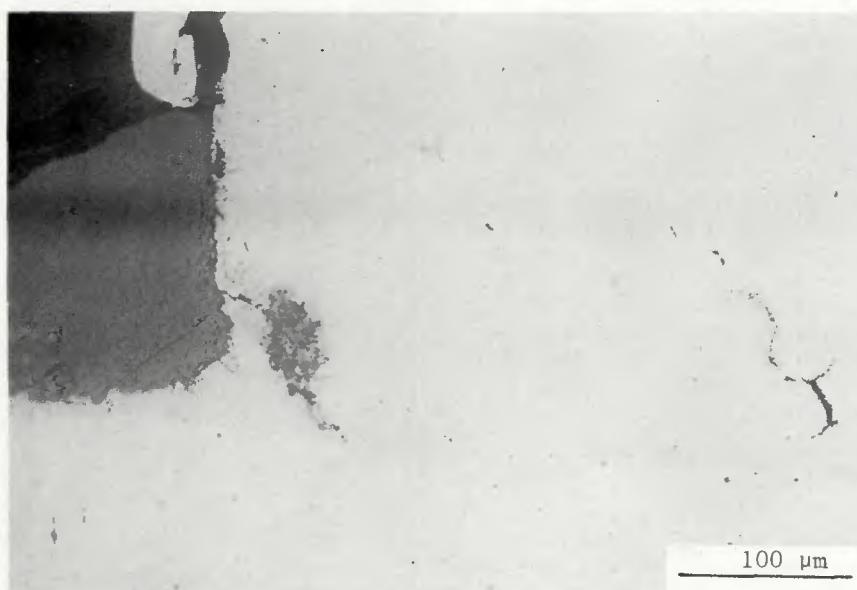
Examination of the blocky outer surface oxide notch also provided additional evidence of the failure mode (Fig. 19). Two cracks are evident within 2 1/4 Cr-1 Mo steel grain boundaries. The crack adjacent to the oxide layer contains oxide, but we are less certain that the other does. These cracks come through 2 1/4 Cr-1 Mo steel and move toward the weld interface.

Fig. 19—Blocky-shaped oxide notch at the outer surface showing grain boundary cracks in 2 1/4 Cr-1 Mo steel
