Failure Investigation of Eddystone Main Steam Piping

Cause of through wall cracks in 316 stainless steel is established

ABSTRACT. In March 1983, personnel at Philadelphia Electric's Eddystone No. 1 power plant discovered a through wall leak in the main steam outlet piping. This pipe was designed to carry steam at a pressure of 5300 psi (36,538 kPa) and a temperature of 1210°F (654°C). The pipe was made of 316 stainless steel and had been operated approximately 130,000 hours at the time that failure was discovered. Subsequent inspection revealed

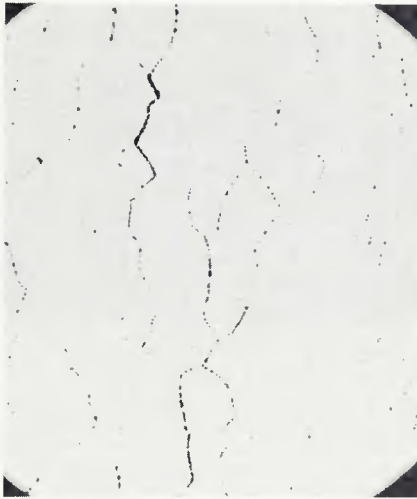
Fig. 5—Damage adjacent to main crack consisting of cavities and single grain facet (sgf) cracks (Unetched)

was similar. At low magnification, intergranular oxide-filled cracks perpendicular to the hoop stress direction (Fig. 4) were found near the OD. Figure 5 shows single grain facet (sgf) cracks and grain boundary cavities in the region adjacent to the main crack. Use of a multiple etch polishing procedure (Ref. 8) facilitated detection of the cavities which occurred at grain boundaries oriented either normal or nearly normal to the hoop stress direction. This oriented cavitation is observed on the OD and midwall positions, but the inside diameter (ID) region is free of damage. The density variation of these cavities through the wall thickness is remarkably consistent from one circumferential location to another. Figure 6 shows this through wall variation at a circumferential position 90° from the major crack.

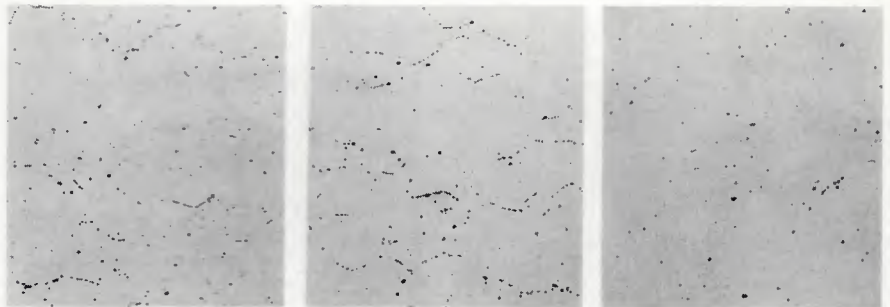
Fig. 6—Oriented cavitation in OD and midwall position while ID region is undamaged

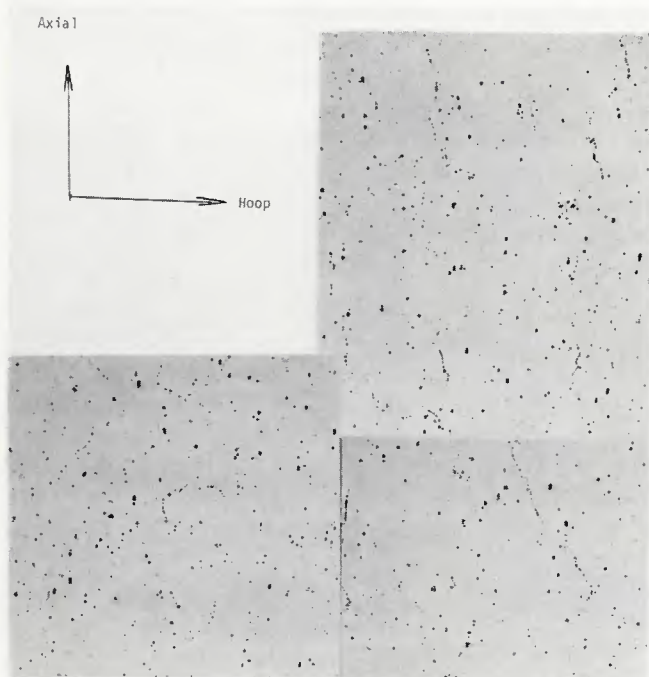
up and form the sgf cracks, which precede the major cracks and subsequent failure. Figure 7 shows the oriented cavities detected on the outside using a tangential section rather than the more common transverse sections. The combination of OD crack initiation and detection of oriented cavitation on tangential sections led to the use of plastic replica techniques for field inspection of the main steam line at the plant.

Fig. 7—Oriented cavities on outside surface of pipe (50X)

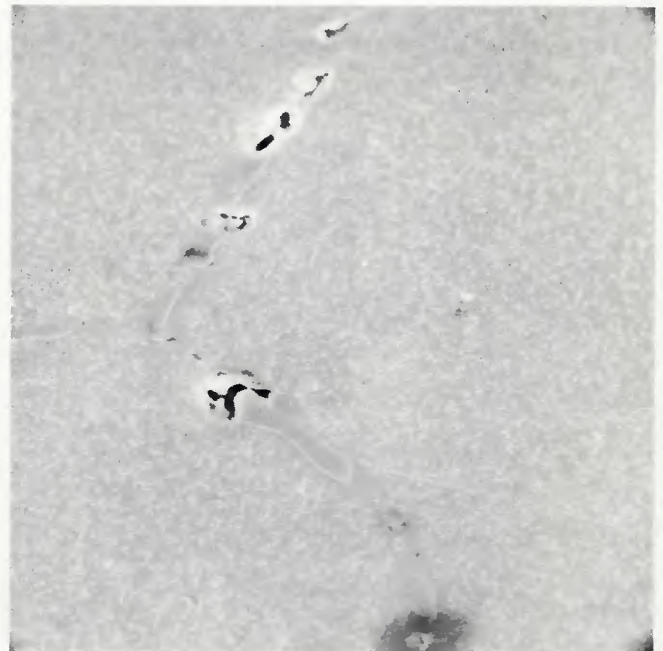
Examination at higher magnification revealed that the microstructure of the failed pipe consists of matrix precipitates (probably $M_{23}C_6$) and large sigma phase particles in the grain boundaries. Although decohesion at the sigma-austenite interface is cited as a potential failure mode for this sigma phase morphology, the cavitation found during this investigation occurs primarily in the ligament region between the sigma phase particles, as shown in Fig. 8.

Fig. 8—SEM photomicrograph showing grain boundary cavities in ligament between sigma phase particles

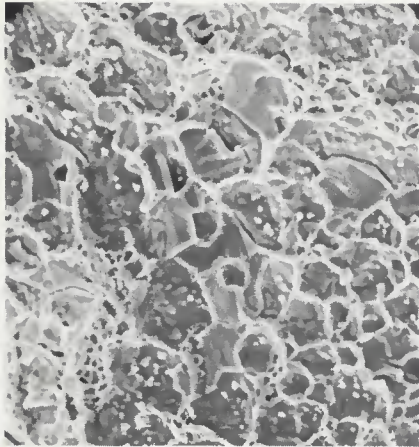
Fig. 13—Room temperature fracture face of 2B steam line material removed in 1980 at position near OD of pipe

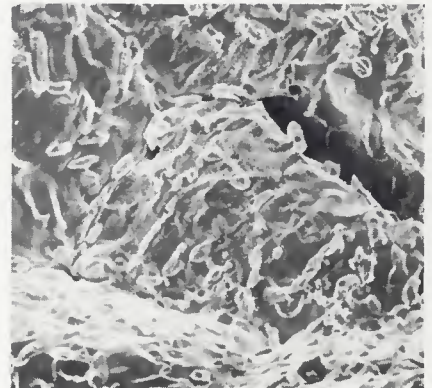
Fig. 15—Grain boundary facet, sigma phase particles and sgf cracks on fracture surface for specimen shown in Fig. 14. Specimen was fractured at LN₂ temperature

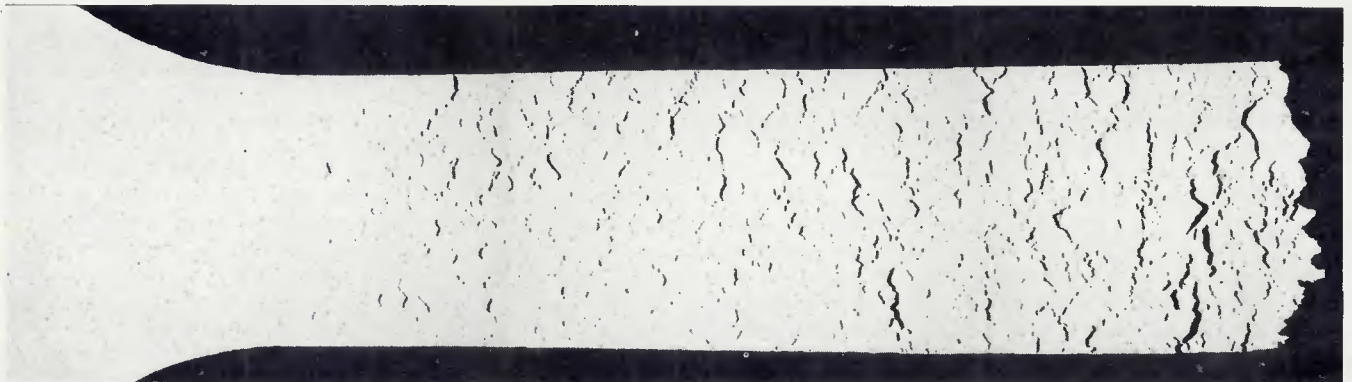
Fig. 14—Collage of creep specimen from 2B steam line. Specimen fractured at 750°C (1382°F) and 47 MPa (6.8 ksi)

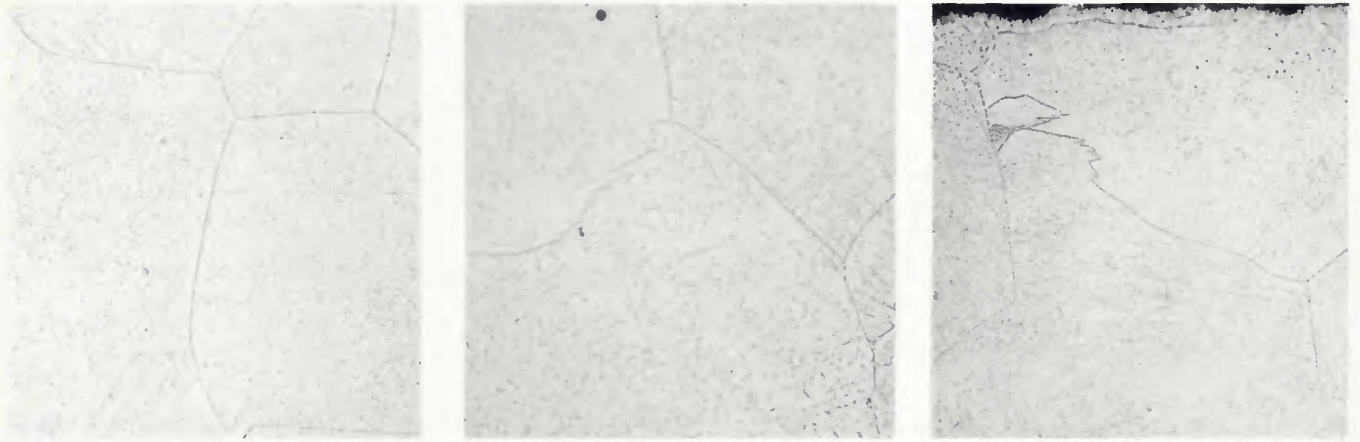
Fig. 16 - Comparison of microstructure revealed by OD plastic replication and metallographic mount of boat sample for the superheater outlet header. Left - replicating technique; center - direct viewing; right - transverse view

strated in Fig. 16 for one location. The other locations from which the boat samples were taken exhibited the same similarity.

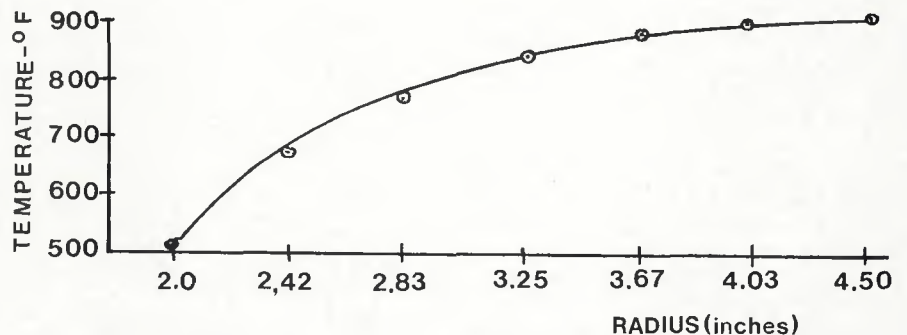
A transient heat transfer and thermal stress analysis was performed for a forced cooldown of 500°F (278°C) in 5 minutes using the computer program, CREPLACYL. CREPLACYL is a CE program which calculates the plastic and creep strains induced in thick wall cylinders due to transient thermal and pressure load-

Fig. 17 - Thermal gradient main steam pipe - 500°F in 5 minutes down-shock transient
