Liquid-Copper/Zinc Embrittlement in Alloy 718

A cause of intergranular cracks in the HAZ is demonstrated

BY W. SHIH, J. KING AND C. RACZKOWSKI

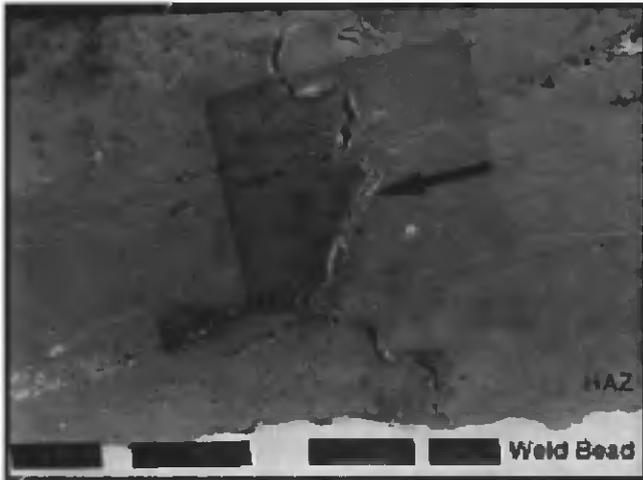
The crack was found to extend from the weld bead through the HAZ of the bellows diaphragm and into the base material. Figure 1 shows the entire length of the crack. The width of the crack was found to be about 5 microns (0.0002 in.), while the length was about 175 microns (0.007 in.). The crack length is an order of magnitude greater than the width of the HAZ. The crack penetrated the entire 0.008-in. (0.2-mm) wall thickness. EDS spectra were collected of visible debris (noted by the arrow in Fig. 1) trapped in the crack.

Fig. 1 — Heat-affected zone crack. 400X.

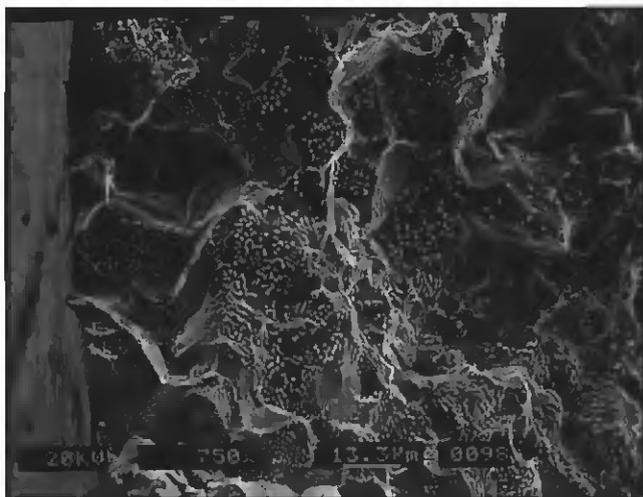
The sample was carefully sectioned and opened along the length of the crack to study characteristics of the fracture surface. Figure 2 shows the intergranular nature of the fracture surface. Note the globules that appear on the grain boundaries. Energy dispersive spectroscopy spectra were collected of various areas of the fracture surface to determine chemical composition of the various phases. To test for the presence of Cu/Zn on the fracture surface, a line profile analysis was also performed.

Fig. 2 — Fracture surface. 750X.

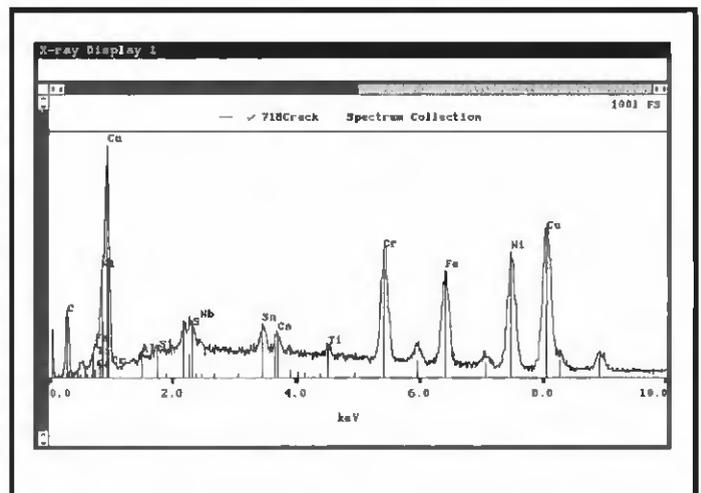
Figure 3 shows the EDS spectrum of debris in the HAZ crack shown in Fig. 1. Clearly, the level of Cu in the debris exceeds the concentration of Cu (0.01 wt%) normally found in Alloy 718. This suggests that the contamination in the crack must be from an external source. During the GTA welding process, it is likely that high heat input melted the debris on the surface near the weld area, which resulted in wetting of the metal surface at the HAZ. Molten contaminant is a prerequisite for LME.

Fig. 3 — EDS spectrum of debris marked by arrow in Fig. 1.
