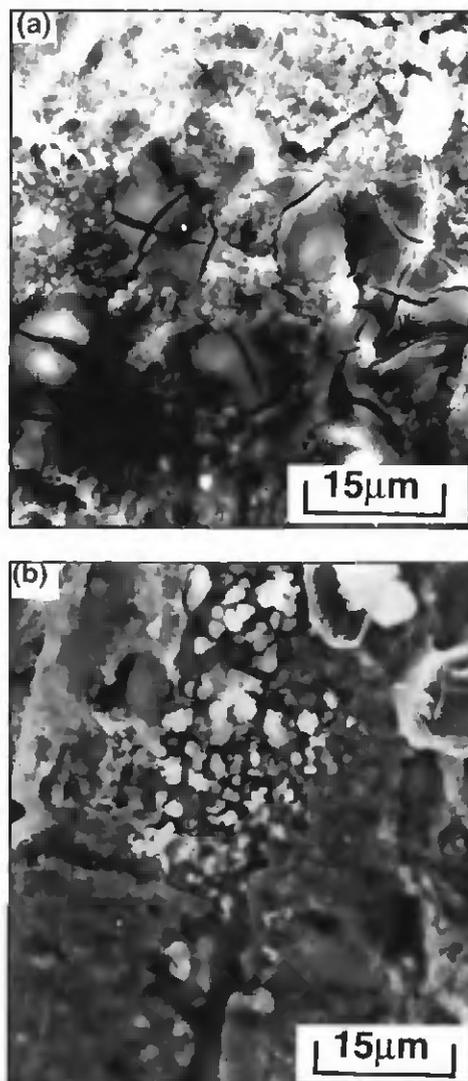
Spiral arm regions are fluid-flow-induced discontinuities where material, agglomerations of magnesium-rich precipitates and reinforcing particles, is collected during the friction welding operation. With this in mind, these flow-induced defects should not have a uniform chemical composition, and the magnesium content should vary from one region to another along the defect length. In addition, Al_2O_3 particle segregation should be observed in spiral defects; this is confirmed in Fig. 8B. In this connection, it is suggested the localized hot cracking observed in some spiral defects results from liquation of Mg-rich material. The magnesium content of spiral defects ranged from 20 to 55 wt-% in MMC/MMC friction welds. A ternary eutectic alloy — having the approximate chemical composition of 35 wt-% Mg, <0.5 wt-% Si, remainder aluminum — solidifies at approximately 450°C in the $Al-Mg_2Al_3-Mg_2Si$ system (Ref. 20). The localized hot cracks observed in some spiral defects may be associated with the formation of this eutectic alloy.

Fig. 9 — A — Localized hot cracks within a spiral defect; B — segregation of Al_2O_3 particles within a spiral defect.

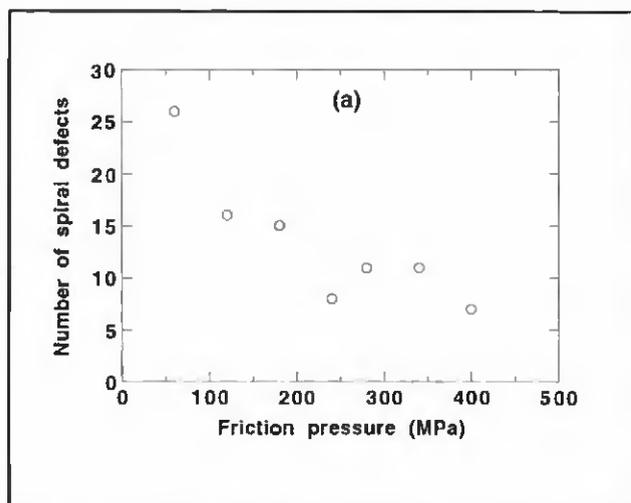
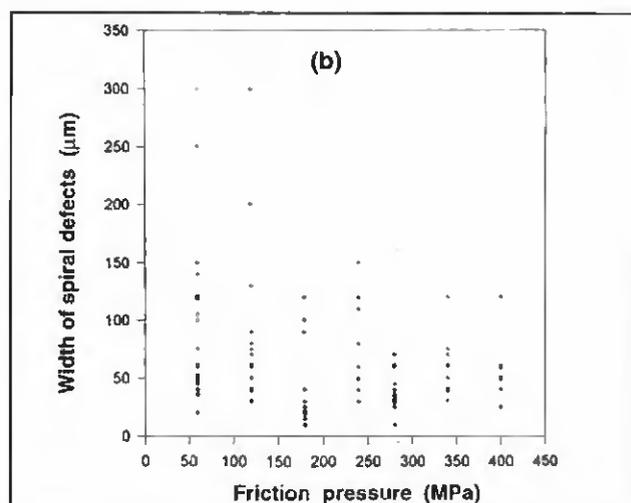
friction welded joints, spiral defects formed at the stationary boundary were located at different distances from the joint centerline. This effect is schematically illustrated in Fig. 13. Finally, the calculated spiral arm frequency markedly decreased when the friction pressure increased (Table 1). These calculated results correspond well with the actual experimental results — Fig. 10.

Fig. 10 — A — The influence of friction pressure on the spiral defect frequency in MMC/MMC friction welds; B — the influence of friction pressure on the width of spiral defects observed on the fracture surfaces of MMC/MMC friction joints (the points show the range of measured widths in joints produced using these friction pressures).
