Failure of Welded Floor Truss Connections from the Exterior Wall during Collapse of the World Trade Center Towers

Failure of connections, as a result of overloading, occurred within the heat-affected zone of the base metals

BY S.W. BANOVIC AND T. A. SIEWERT

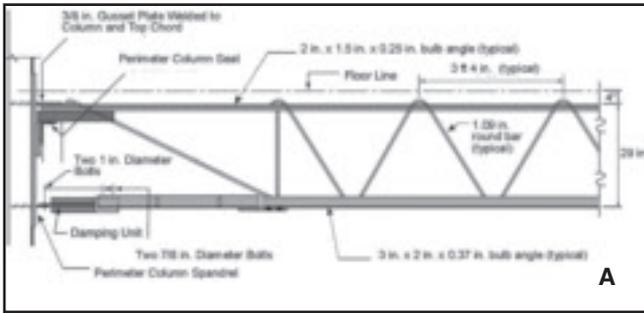
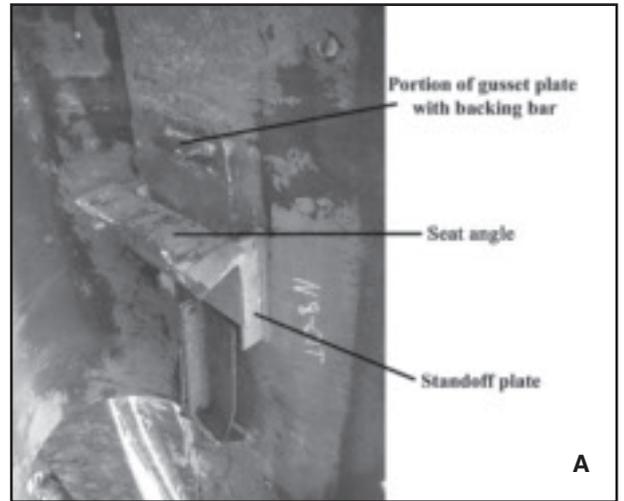
Fig. 3 —A — Schematic showing attachment of the floor truss to the exterior wall; B — undated construction photograph showing the various features of the structural subsystems and their connections.

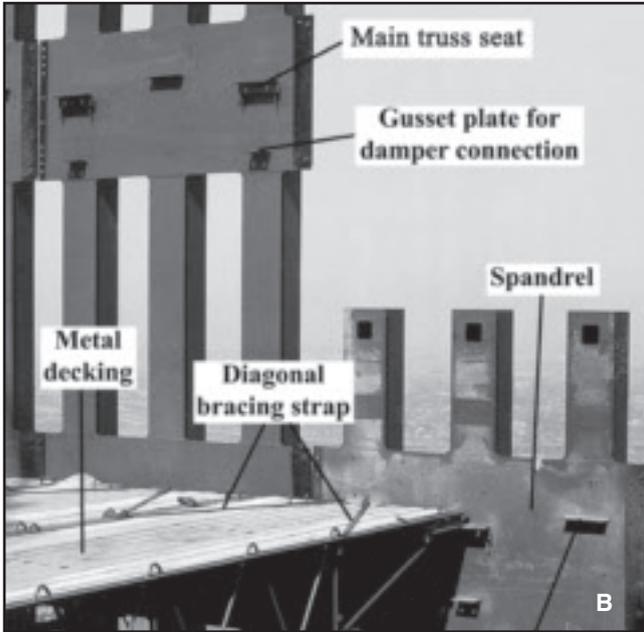
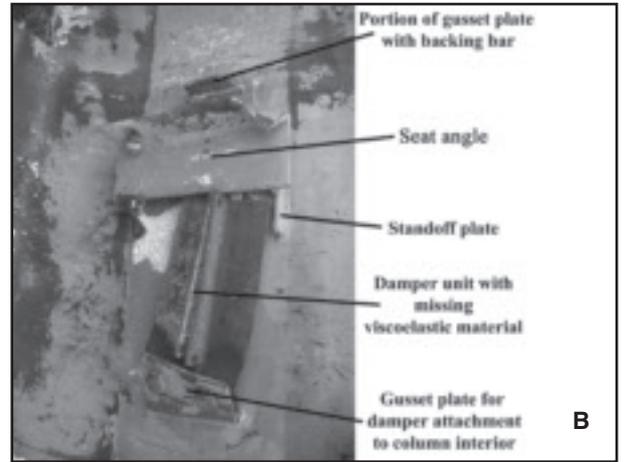
Fig. 4 — Example of a main truss seat from a recovered exterior panel (A142: 97–100). Connection shown is on column 143 at the 100th floor.

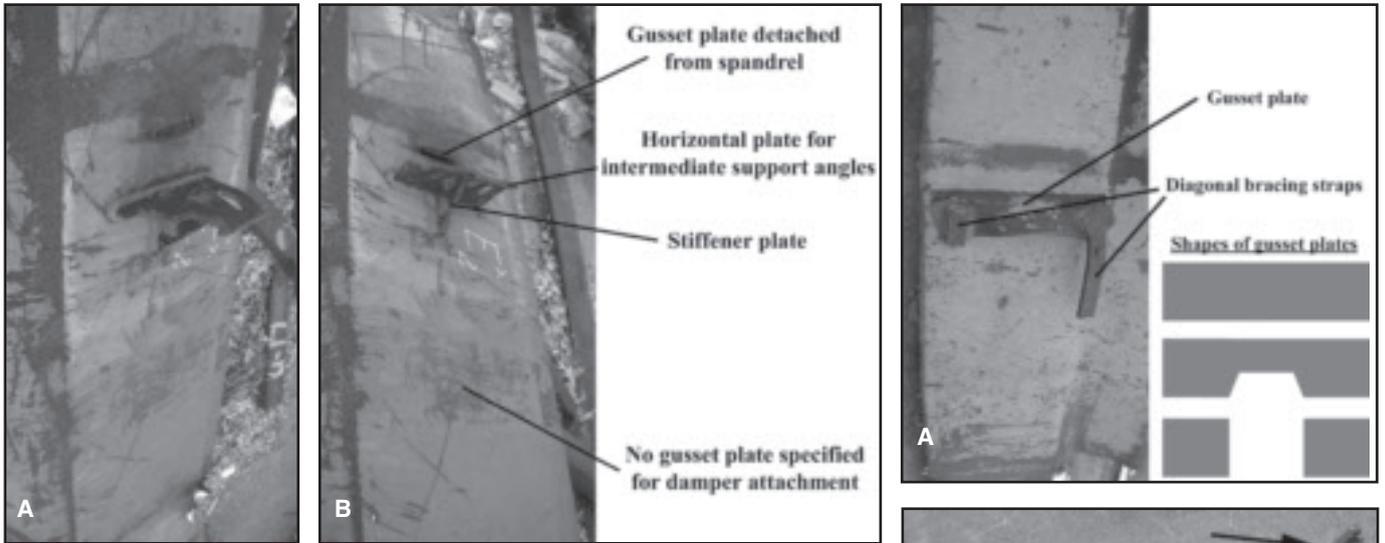
Fig. 5 — Example of an intermediate deck support angle seat from a recovered exterior panel (A451: 85–88). Connection shown is on column 452 at the 88th floor.

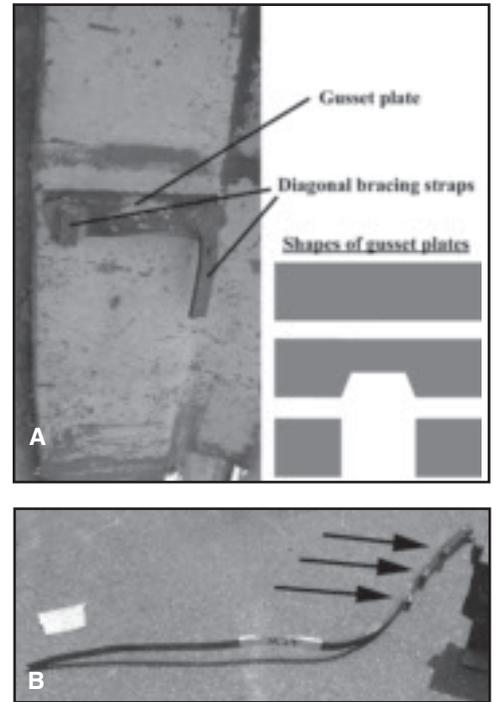
Fig. 6 — Example of a strap connection from a recovered exterior panel (A115 : 89–92). A — Recovered gusset plate, from column 116 at the 90th floor, and observed variations; B — portion of a diagonal bracing strap with shear studs (arrows).

- gusset plates intact and bent upward,
- gusset plates intact and bent downward,
- fracture in gusset plate, or
- fracture along the leg of the weld.

mon failure mode of the strap connections, regardless of location, was shear fracture along the leg of the weld at the gusset plate.

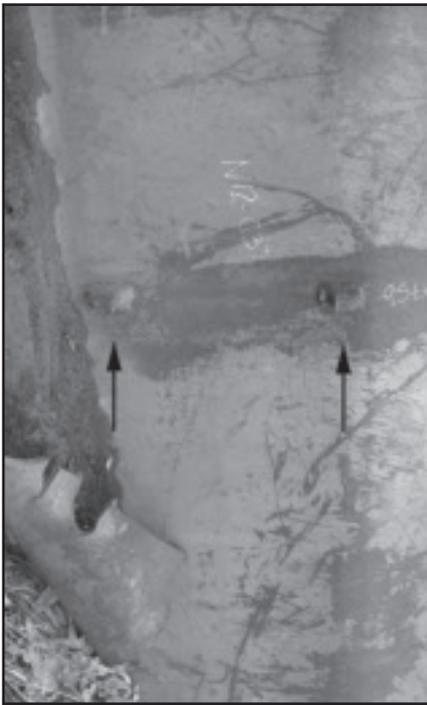
Fig. 7 — Example of strap connections without a gusset plate from a recovered exterior panel (A206: 92-95). Connection shown is on column 205 at the 95th floor. Portions of diagonal bracing strap that were directly welded to the spandrel are indicated with arrows

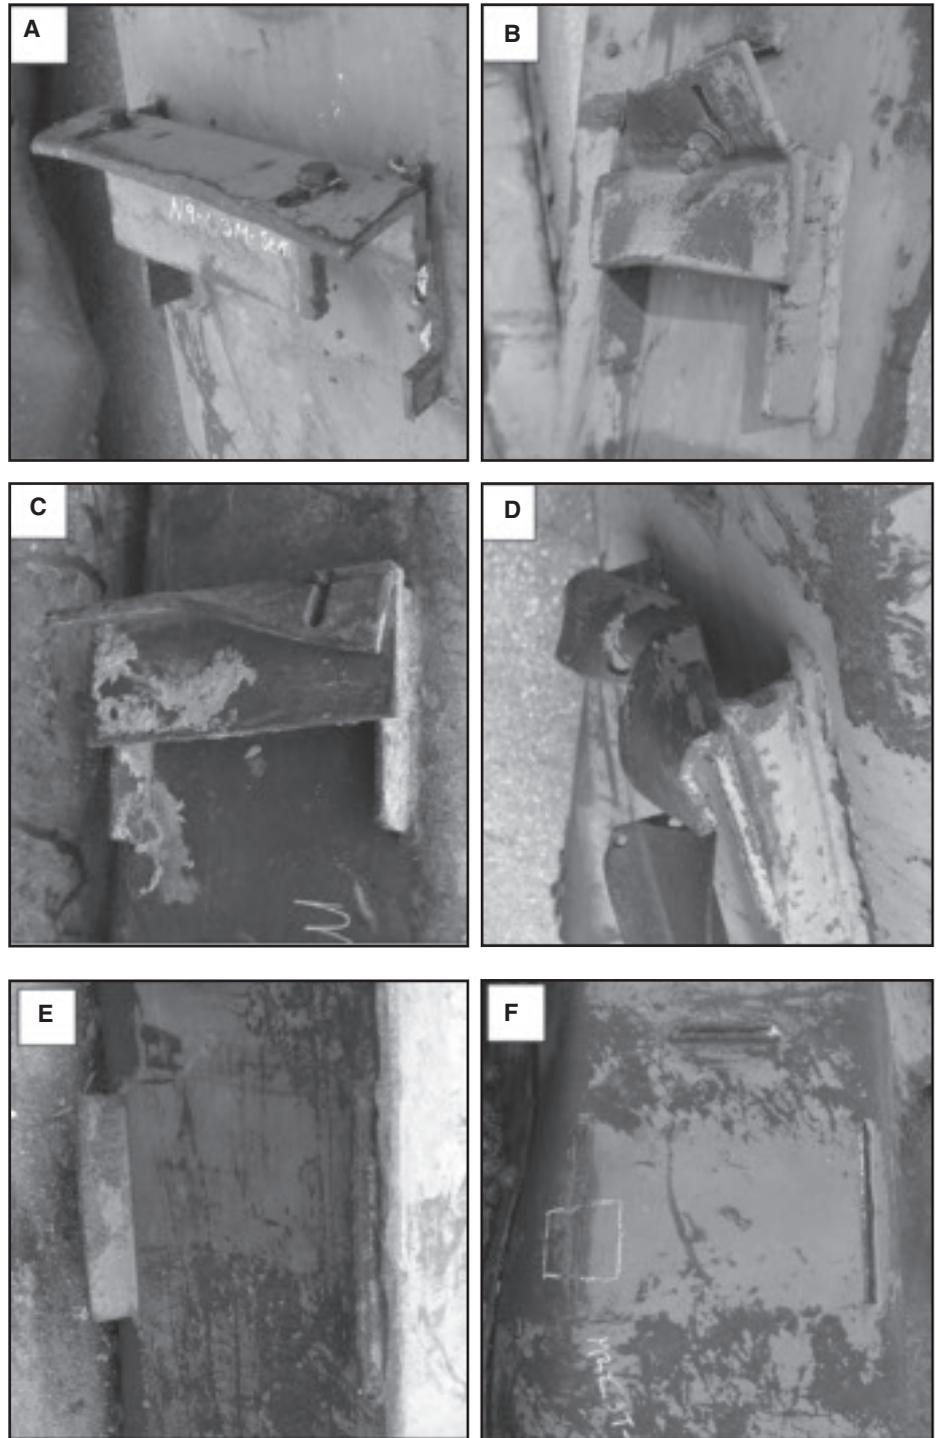
- seat angles intact and relatively undeformed — Fig. 8A,
- seat angles intact and bent up —

- seat angles intact and bent down — Fig. 8C,
- seat angles intact and bent toward the spandrel — Fig. 8D,
- seat angles missing with standoff plates remaining — Fig. 8E, or
- seat angles missing with standoff plates missing — Fig. 8F.

Fig. 8 — Description of main truss seat conditions from field observations. A — Intact and relatively undeformed from panel A154: 101-104 (connection is on column 153 at the 103rd floor); B — intact and bent up from panel A154: 101-104 (connection is on column 155 at the 102nd floor); C — intact and bent down from panel A130: 90-93 (connection is on column 131 at the 92nd floor); D — intact and bent toward the spandrel from panel B206: 83-86 (connection is on column 206 at the 84th floor). E — seat angle missing with standoff plates remaining from panel A124: 70-73 (connection is on column 123 at the 71st floor); F — seat angle missing with standoff plates missing from panel A130: 96-99 (connection is on column 129 at the 99th floor).

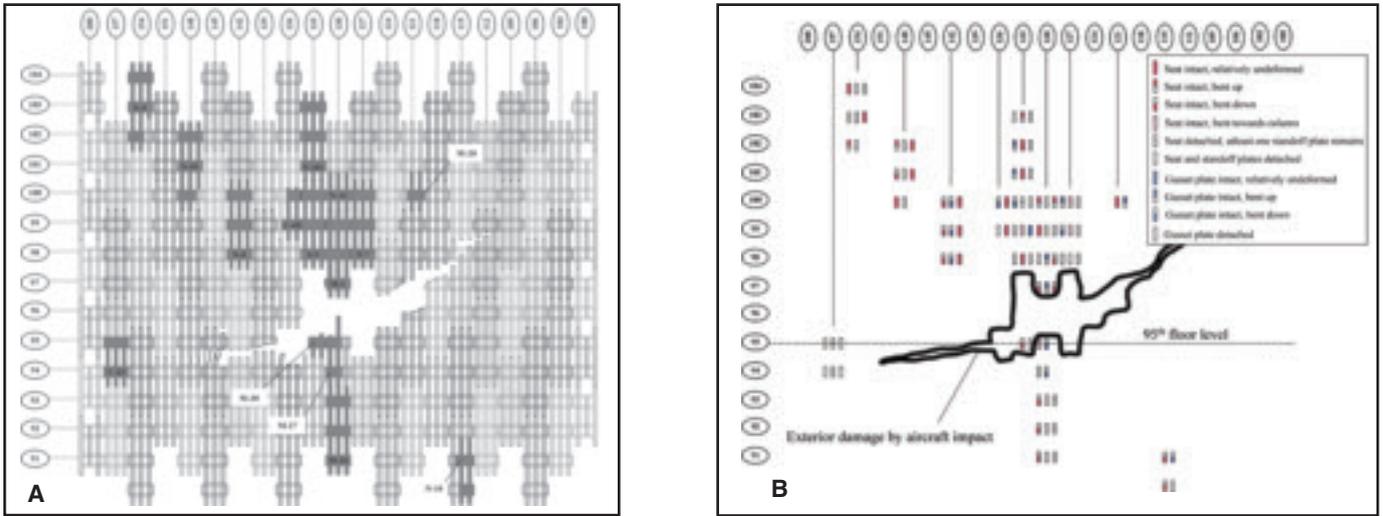
Fig. 9 — A — Damage diagram of WTC 1 north face showing the location of recovered exterior panels; B — observed condition of recovered floor truss connection; those at or below the 95th floor level are either missing or bent downward.

Failure of floor truss connections from WTC 1 were analyzed to determine whether connections above and below the impact region failed by different mechanisms. There were 51 observations at or below the 95th floor and 72 above the 95th floor. The spatial display of a fraction of this information for WTC 1 near the impact region of the north face is seen in Fig. 9. Both pictorially and statistically (Tables 2 and 3), an overwhelming majority of main truss seats and strap connections were either bent down or completely missing below the impact zone. Below the 95th floor level, 93% of the main truss seats failed by these modes compared with only 37% of the seats above

the 95th floor. For the strap connections, 96% were either bent down or torn off below the 95th floor and 74% were similarly deformed above this level.

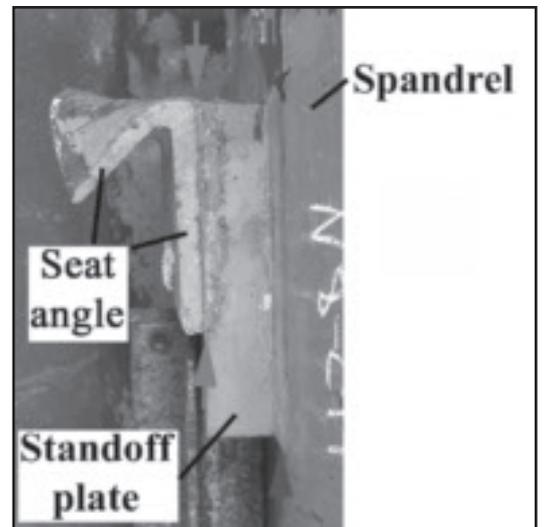
Fig. 10 — Location of the two welds analyzed from the main truss seats (A142: 97–100; column 143, 100th floor).

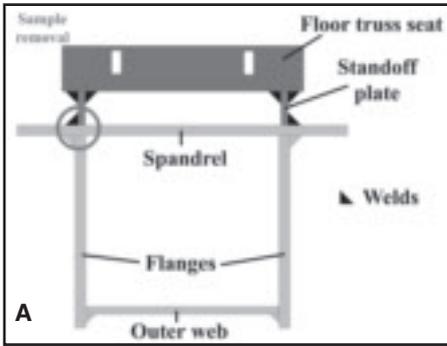
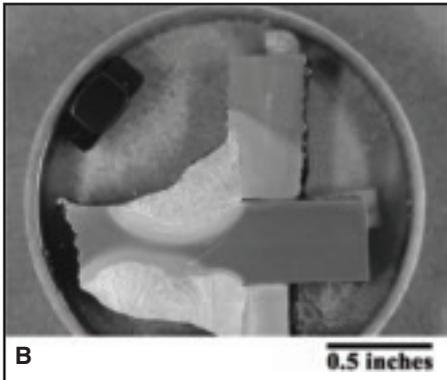
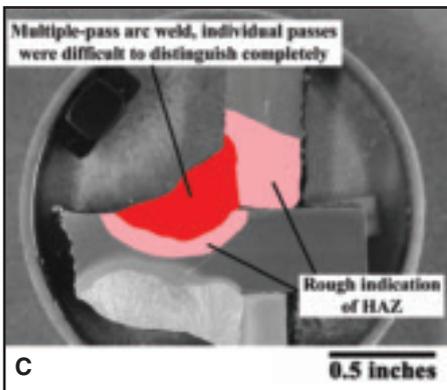
Figure 11 shows, in cross section, one of the undamaged welds between a standoff plate and a spandrel plate. Both plates are ferrite-pearlite steels with minimum yield strengths of 42 and 65 ksi, respectively (1 ksi equals 1000 lb/in.²). As stated previously, the two standoff plates were fillet welded directly to the spandrel plate. Multipass beads were observed only on the outboard face of the plates. The specific arc welding process was not found

Fig. 11 — Cross section of fillet weld between spandrel and standoff plate from an undamaged main truss seat (A157: 93–96; column 157, 94th floor). A — Schematic showing the location of sample removal; B — metallographically prepared specimen; C — HAZ and weld were determined via optical means. Two percent nital and four percent picral etch.

within the design drawings, but due to the short welding length, shielded metal arc welding (SMAW) or flux cored arc welding (FCAW) was most likely used. Typically, these joints were overwelded, meaning that a $\frac{3}{8}$ or $\frac{1}{2}$ -in. weld may have been deposited where only a $\frac{1}{8}$ -in. weld was specified. The HAZ in the standoff plate extends through the entire thickness of the plate; the HAZ in the spandrel plate is shallower. This difference is most likely related to welding procedures and angle of the electrode with respect to the two plates. Of the five welds randomly selected for examination, all were of good quality and contained no visible surface flaws (e.g., cracks, undercuts, or overlaps)

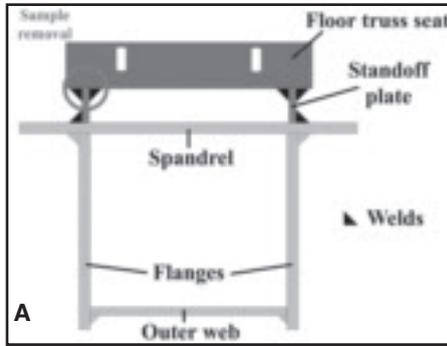
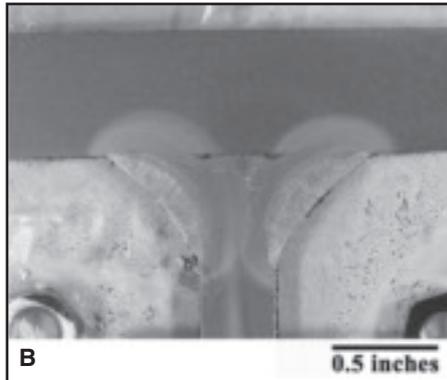
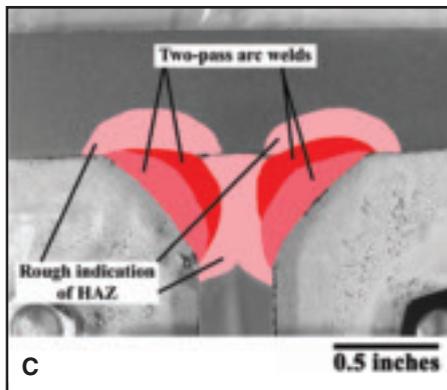
Fig. 12 — Cross section of fillet weld between standoff plate and seat angle from an undamaged main truss seat (A154: 101–104; column 153, 103rd floor). A — Schematic showing the location of sample removal; B — metallographically prepared specimen; C — HAZ and weld were determined via optical means. Two percent nital and four percent picral etch.

A two-pass fillet weld, on both faces of the standoff plate, joined the seat angles to the standoff plates — Fig. 12. This clearly indicates that the standoff plate/seat angle assemblies were prefabricated and then welded to the spandrel. Again, SMAW or FCAW was probably used for joining. The combined HAZ from both fillet welds spans the entire standoff plate. Again, the HAZ in the seat angle is shallower. All five welds

randomly chosen for examination were of good quality with no visible flaws or defects.

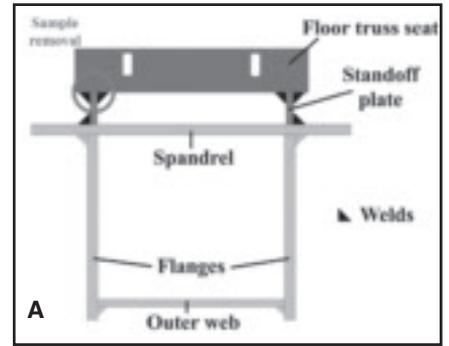
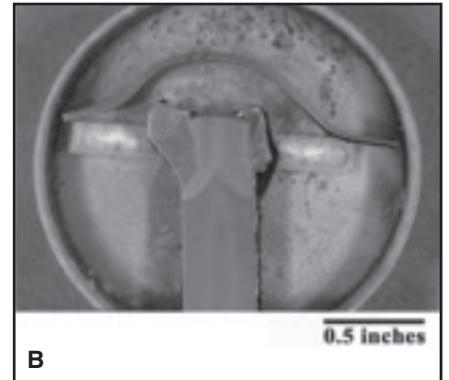
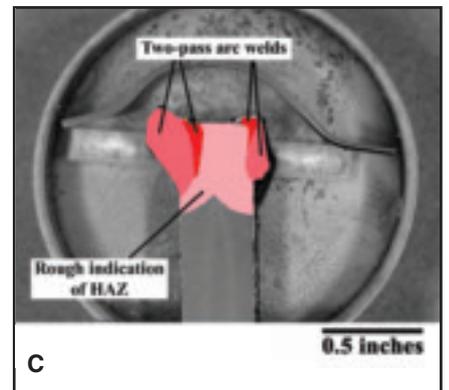
Fig. 13 — Cross section of fillet weld between standoff plate and seat angle from a damaged main truss seat (A157: 93–96; column 157, 94th floor). A — Schematic showing the location of sample removal; B — metallographically prepared specimen; C — HAZ and weld were determined via optical means. Two percent nital and four percent picral etch.

Table 1 shows that nearly 25% of the main truss seats at or below the impact regions had the seat angles detached with at least one of the standoff plates remaining. Again, the seat angles probably detached via a shear mechanism as the buildings collapsed. Figure 13 shows the failed cross section of one of these joints. Failure occurred within the weld metal at the weld-seat angle interface. Similar failure features were observed on other samples

examined that had a failed joint between the standoff plates and the seat angle. Attempts were made to microscopically view the fracture surfaces; however, a corrosion product was found on the surfaces due to environmental degradation. Even after removal of the corrosion product, the positive identification of the microscopic fracture mechanism (cleavage facets or dimpling) was not possible.

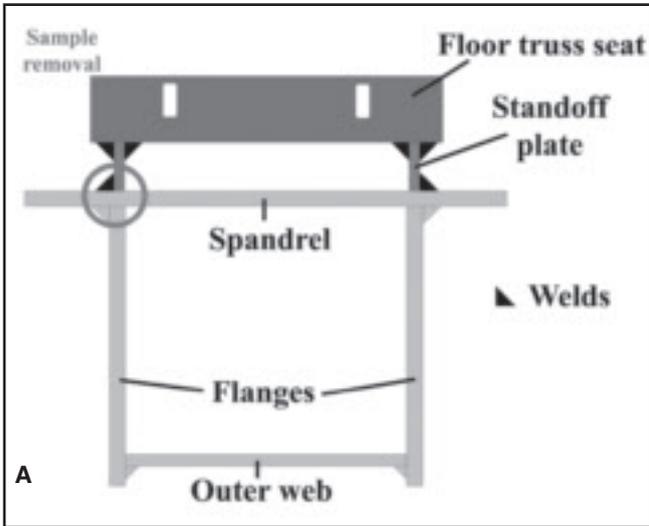
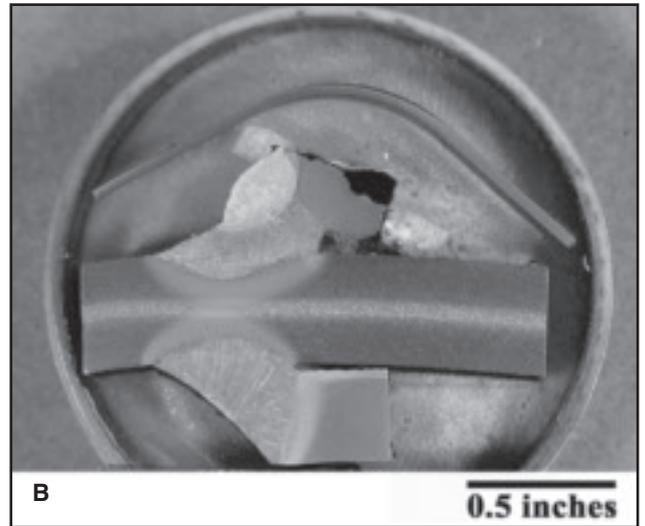
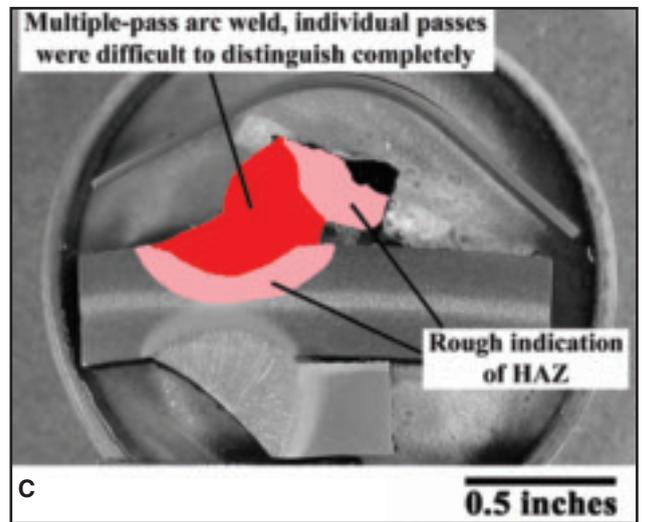
Table 1 also shows that nearly 40% of the main truss seats at or below the impact regions from both towers had at least one of the standoff plates detached from the spandrel in the process of removing the seat assembly from the column. The plates probably detached via a shear mechanism as the buildings collapsed due to the overloading of the floors. Figure 14 shows one of these failed joints in cross section. Failure occurred almost exclusively within the HAZ of the standoff plate. Similar failure features were observed on all samples metallographically analyzed that had a failed joint between the spandrel plate and standoff plates.

Detached main truss seats failed near one of two welded joints associated with the standoff plates. Inspection of the weld failures showed that fracture typically occurred in the location with the lowest cross-sectional area. The joints between the standoff plate and spandrel failed primarily in the HAZ of the standoff plate because this path is shorter than the one that traverses the stronger weld material. Additionally, the standoff plate had the lowest cross-sectional area for load transfer at this joint. Conversely, when the seat angles were detached from the standoff plates, failure occurred in the weld metal at the seat angle/standoff plate interface. Figure 12 shows that the fillet weld between the standoff plate and the seat angle did not fully penetrate the portion of the standoff plate in contact with the seat. Thus, the joint failed there because that location had the lowest cross-sectional

Fig. 14 — Cross section of fillet weld between spandrel and standoff plate from a damaged main truss seat (A130: 96–99; column 129, 99th floor). A — Schematic showing the location of sample removal, B — metallographically prepared specimen, C — HAZ and weld were determined via optical means. Two percent nital and four percent picral etch.
