# Sulfide-Induced Corrosion of Copper-Silver-Phosphorus Brazed Joints in Welding Transformers

*A source of moisture was traced to leaking brazed joints within the transformer's secondary winding*

BY D. R. SIGLER, J. G. SCHROTH, Y. WANG, AND D. RADOVIC

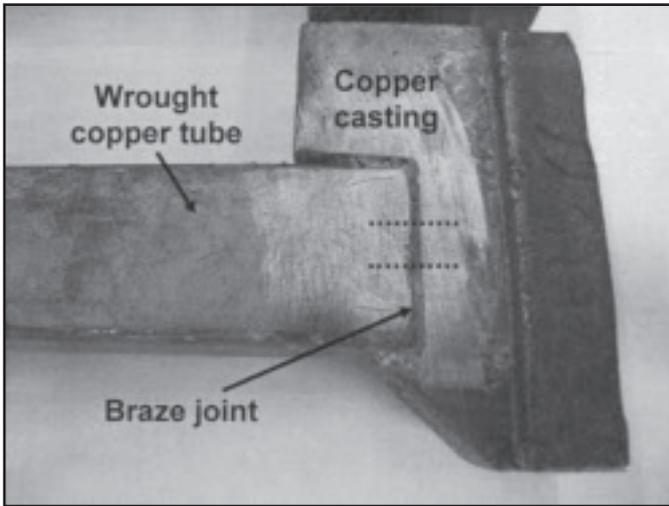
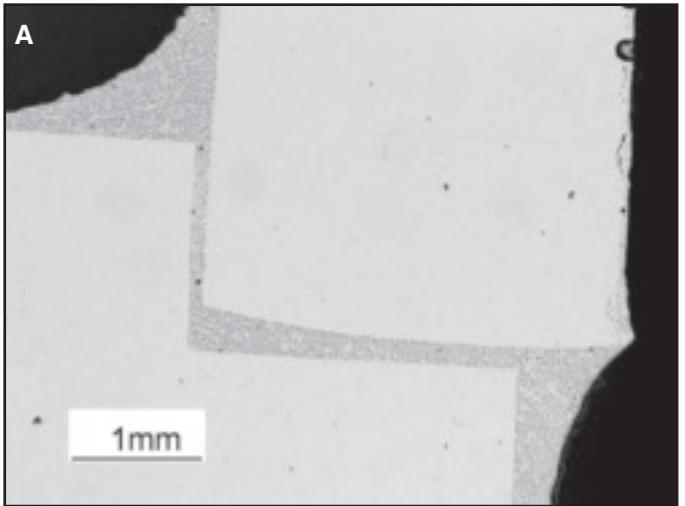
Figure 1 shows a portion of a typical winding of a transformer removed from an assembly plant. The winding consists of a thick-walled copper tube with cast copper pads brazed to the ends of the tube. The tube and pads are both pure copper conforming to the Copper Development Association Specification C11000, which is an electrolytic tough pitch copper alloy consisting of 99.9% copper with some residual oxygen. While the C11000 specification refers to wrought material, the same alloy was used to cast the winding pads. The brazing alloys used to join the transformer winding components are from a family of high-phosphorus-content alloys that require no fluxing to wet the copper substrate. The alloys used were either a Cu-18Ag-6.25P alloy (all values in wt-%) or a Cu-6Ag-6.1P alloy.

Fig. 1 — A portion of a secondary winding removed from a failed transformer. Dotted lines indicate section taken for braze joint evaluation.

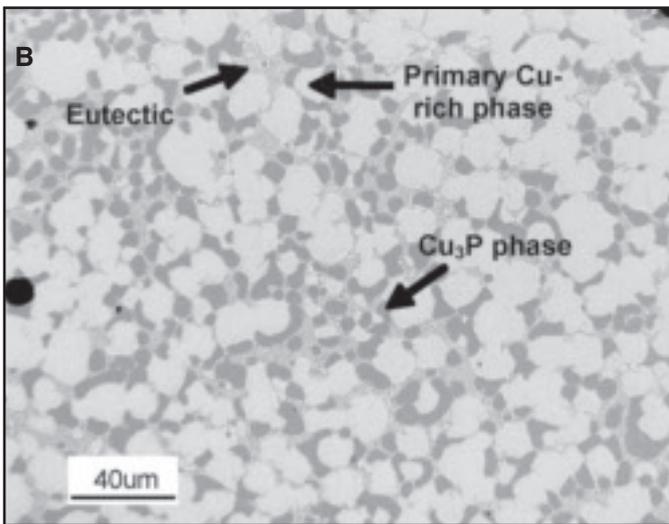
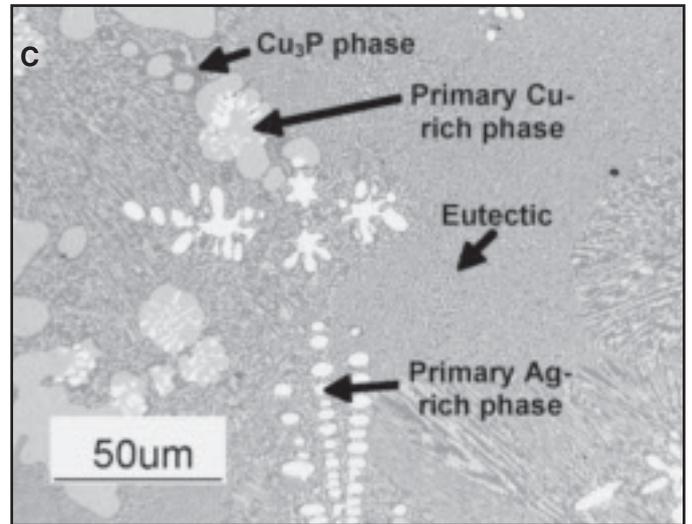
A cross section through a brazed joint made from the Cu-6Ag-6.1P alloy is shown in Fig. 2A. The left side of the joint is the side exposed to the atmosphere while the right side of the joint has cooling water running through it during use. Figure 2B shows the as-polished microstructure of the joint. Several phases are visible including primary pro-eutectic copper, which appears as light-gray particles, dark-gray copper-phosphide ( $\text{Cu}_3\text{P}$ ) particles, and a eutectic consisting of lamellae of copper and  $\text{Cu}_3\text{P}$ .

A typical microstructure for the Cu-18Ag-6.25P alloy is shown in Fig. 2C. In addition to the microstructural constituents found in the Cu-6Ag-6.1P alloy,

Fig. 2 — Cross sections of typical undamaged braze joints. A — An overview of a Cu-6Ag-6.1P braze metal joint; B — microstructure of brazed joint; C — microstructure of a higher-Ag filler metal, Cu-18Ag-6.25P, that contains globular primary Ag particles in addition to the constituents of the 6Ag alloy.

the higher-Ag braze metal contains primary Ag-rich particles deposited early in the solidification process. Those Ag-rich regions have the lightest color in Fig. 2C. The composition of this high-Ag alloy is close to the ternary eutectic so that the greatest volume fraction of the microstructure consists of copper and  $\text{Cu}_3\text{P}$  lamellae in eutectic form. Some  $\text{Cu}_3\text{P}$  particles are also visible.

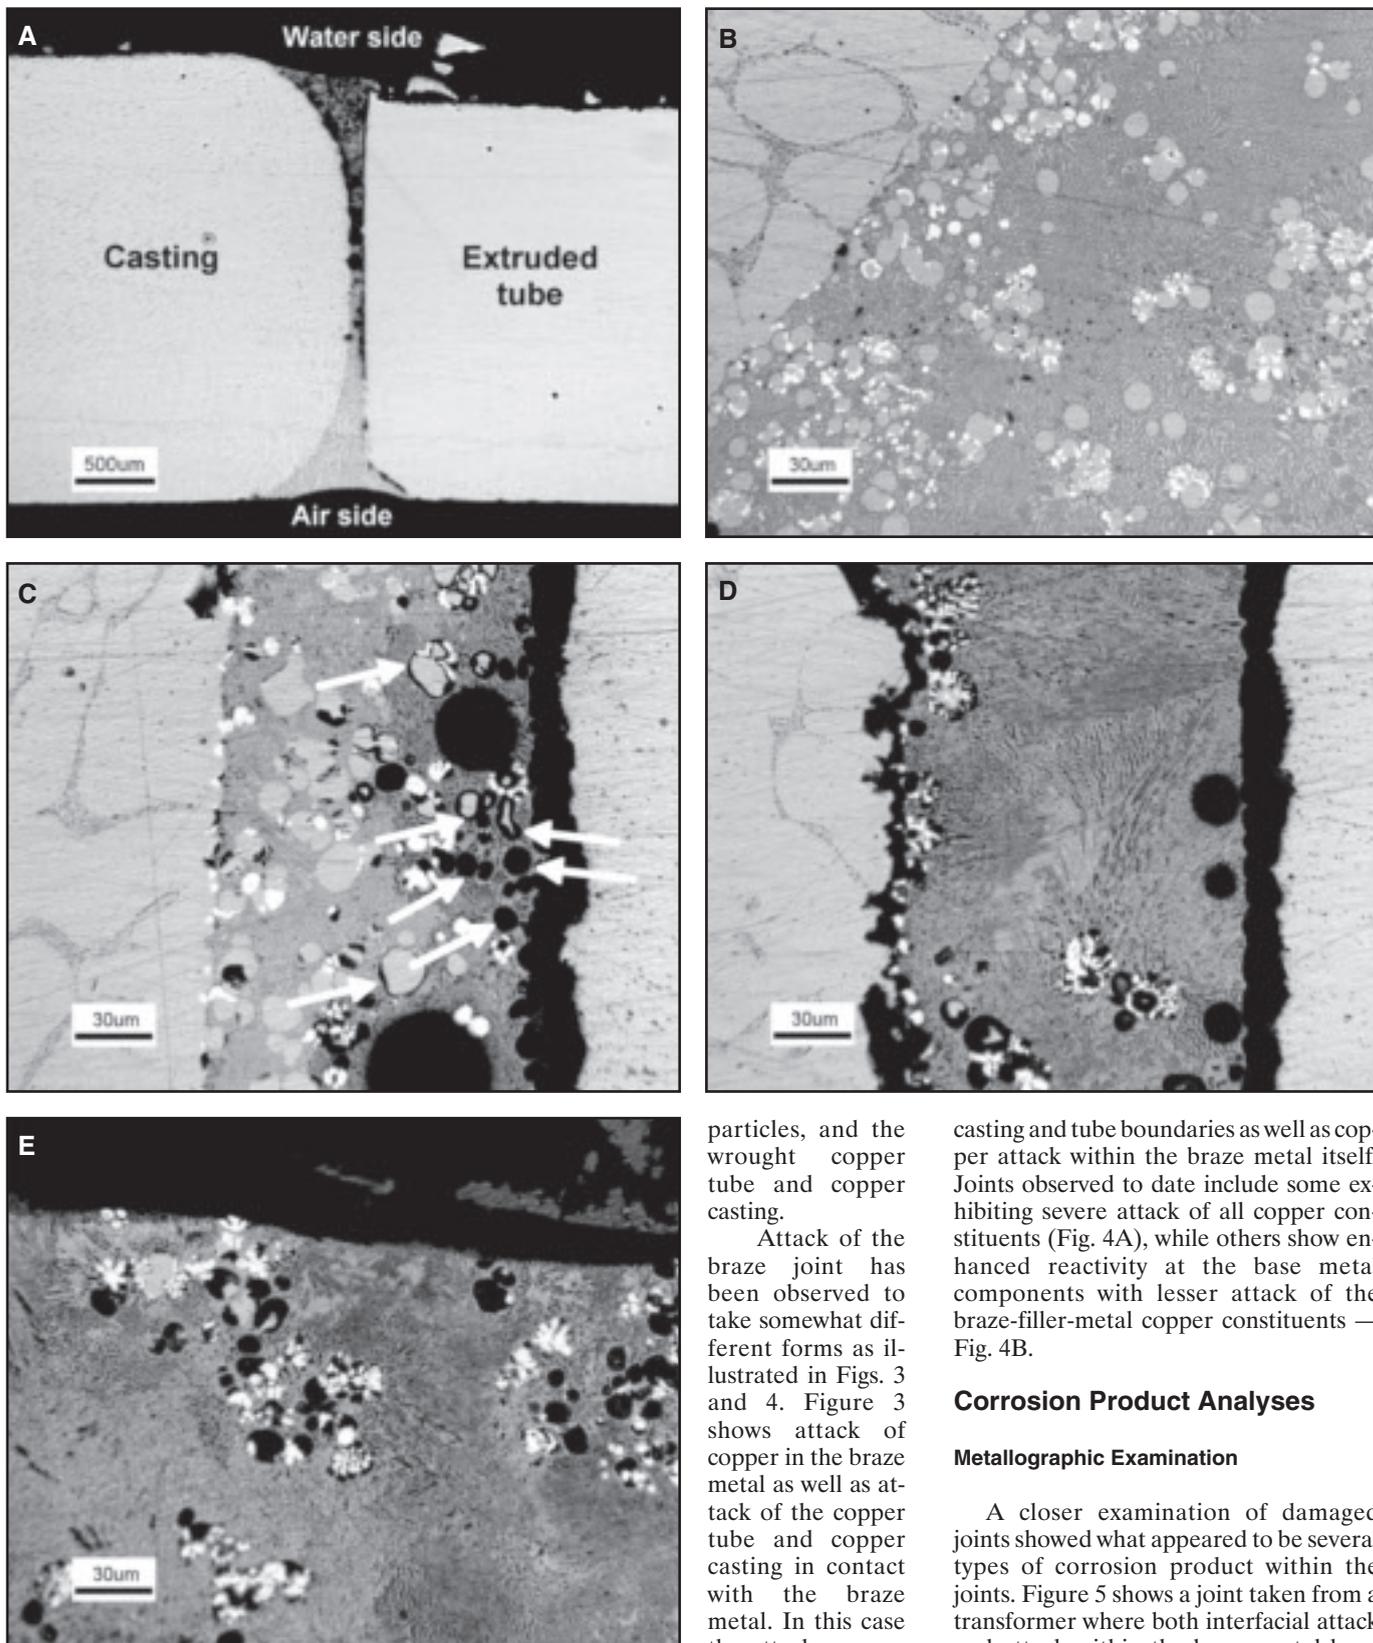
Numerous braze joints from corroded windings were evaluated in metallographic cross section. Figure 3 shows a butt joint brazed with the Cu-18Ag-6.25P alloy. The water side and air side of the joint are indicated. The braze metal itself appears dark toward the water side of the joint. In addition, dark areas define much of the

Figure 3B illustrates a typical joint microstructure near the undamaged “air-side” of the braze filler metal adjacent to the winding’s cast pad. Features of the braze microstructure include a large volume fraction of Cu/ $\text{Cu}_3\text{P}$  eutectic as well as Cu-rich and Ag-rich particles. The casting shows a large grain size of  $\sim 50\ \mu\text{m}$  with Cu-oxide particles outlining the grain boundaries. Toward the center of the braze joint is an area with significant damage — Fig. 3C. The two very large, round pores are likely gas porosity carried over from the brazing operation. Degradation of the joint has produced a large gap between the braze filler metal and the copper tube. Also, selective attack of copper lamellae in the braze has occurred and turned the eutectic dark in color. Finally, the primary copper particles were also at-

tacked as shown by some dark areas surrounding some of the particles and other particles missing completely (see arrows).

Figure 3D shows an area located closer to the water passage. In this micrograph, attack of both the copper tube and copper casting is apparent. In addition, extensive attack of copper particles as well as copper lamellae in the braze filler metal has occurred. Figure 3E shows a microstructure of the brazement adjacent to the water flow passage. With a few exceptions, the microstructure is nearly devoid of Cu-rich phases.

These micrographs illustrate a form of selective Cu attack that leaves the Cu phosphide phase intact, while dissolving/reacting/damaging any copper metal in contact with the copper-phosphide. The at-risk copper constituents include the copper eutectic lamellae, primary Cu-rich

Fig. 3 — Cross-sectional views of a damaged brazed joint. A — An overview; B — a location with no damage near the air side of the joint; C-E — locations with progressively more severe damage approaching the water side of the joint.

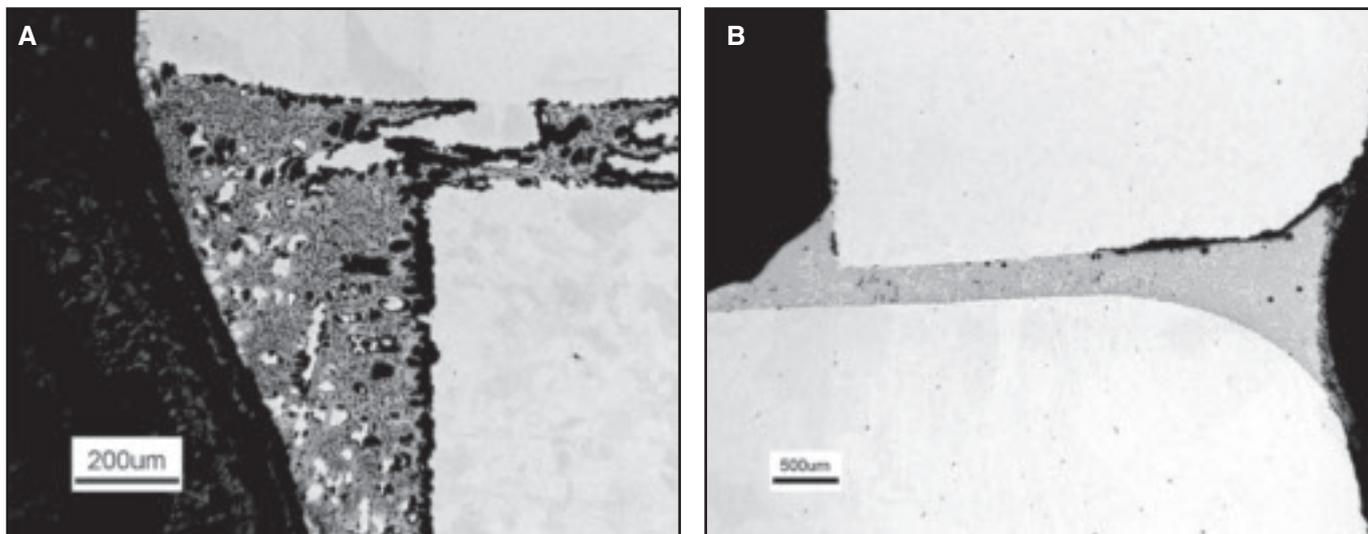
Attack of the braze joint has been observed to take somewhat different forms as illustrated in Figs. 3 and 4. Figure 3 shows attack of copper in the braze metal as well as attack of the copper tube and copper casting in contact with the braze metal. In this case the attack appears to progress inward from the water flow passage. Figure 4A shows an excellent example of interfacial attack occurring along both the

casting and tube boundaries as well as copper attack within the braze metal itself. Joints observed to date include some exhibiting severe attack of all copper constituents (Fig. 4A), while others show enhanced reactivity at the base metal components with lesser attack of the braze-filler-metal copper constituents — Fig. 4B.

Fig. 4 — Cross-sectional views of damaged brazed joints. A — Severe interfacial attack and attack within the braze; B — severe interfacial attack from the air side with limited interfacial and braze metal attack from the water passage.

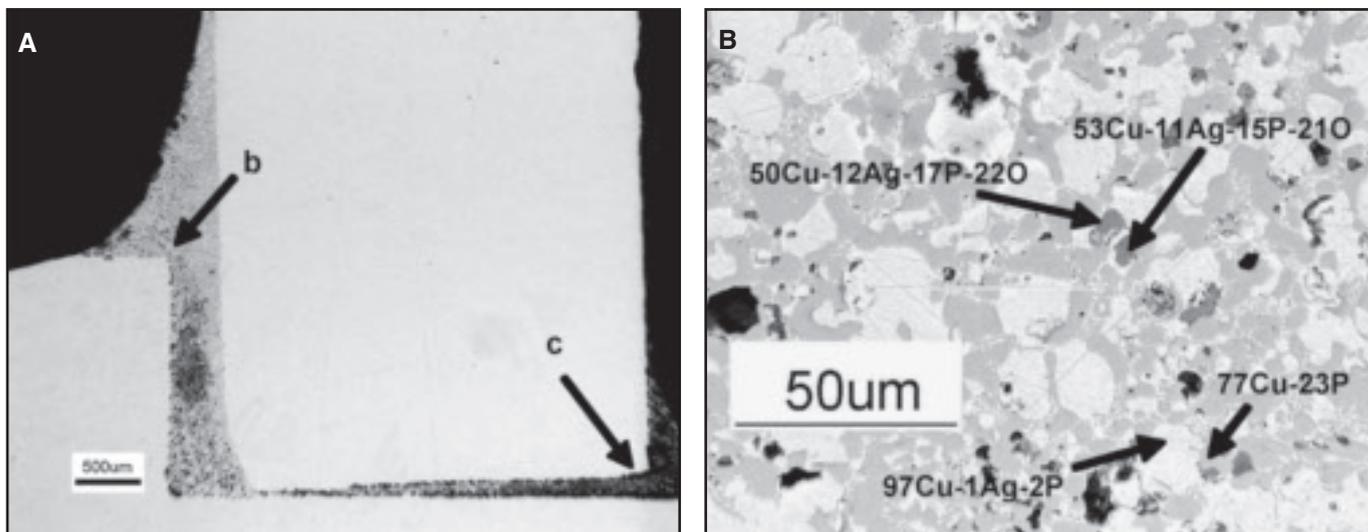
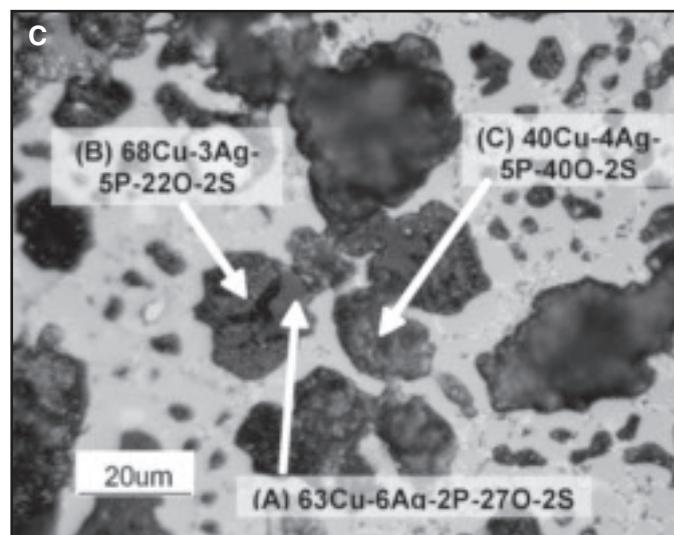
A closer examination of damaged joints showed what appeared to be several types of corrosion product within the joints. Figure 5 shows a joint taken from a transformer where both interfacial attack and attack within the braze metal have progressed from the water-flow side of the joint toward the air side of the joint.

Corrosion products in both Fig. 5B and 5C were analyzed with SEM energy-dispersive spectroscopy (EDS). Figure 5B shows analyses for a light-gray corrosion product that typically forms during the

early stage of joint degradation. Also shown for comparison are compositions of the primary copper and  $\text{Cu}_3\text{P}$  phases. The primary copper phase contained approximately 1 at-% Ag and 2 at-% P, while the phosphide phase showed no Ag. Compositions of the corrosion products displayed the expected high levels of O, but also contained (unexpected) high levels of both Ag and P: ~12 at-% Ag and ~16 at-% P. Hence, although the microstructural evidence most clearly showed attack of the copper, elemental analyses indicate that both Ag and P are involved in the corrosion process. Cu is also clearly removed from the joint area since the primary copper, which was once 97 at-% Cu, is replaced with a corrosion product containing only ~50 at-% Cu.

Figure 5C shows compositions of corrosion products located in a more severely damaged area of the joint. Several types of morphologies are evident. These include a

smooth dark-gray product (A), a porous dark-gray product (B), and a granular product (C) that is red in color. Relative to that found for the light-grey corrosion product in Fig. 5B, analyses of the dark-gray corrosion products revealed lower Ag and P levels, higher Cu levels, and the presence of about 2 at-% S. The granular red corrosion product (C) had higher oxygen levels as well as sulfur and is suspected of

Fig. 5 — Cross-sectional views of a damaged brazed joint. A — Low magnification; B — high magnification in an area with less severe attack; C — high magnification in an area with more severe attack. Compositional analyses done by SEM EDS with results expressed in at.-%.

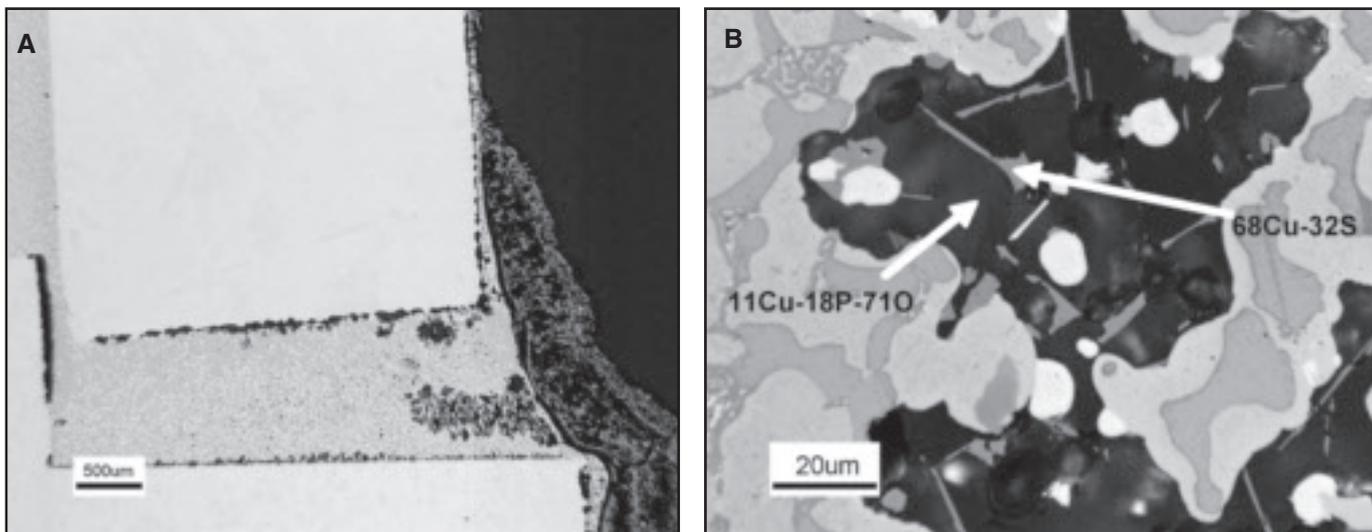
Fig. 6 — Cross-sectional views of a severely damaged brazed joint. A — Low magnification; B — high magnification. Compositional analyses were done by SEM EDS and expressed in at.-%.

An even more severe form of attack was found in one winding joint. Figure 6A shows a metallographic overview of the joint while Fig. 6B shows a high-magnification view along with results of EDS analyses. The joint cross section reveals angular particles that were identified as copper sulfide,  $\text{Cu}_2\text{S}$ . The dark phase surrounding the particles contained Cu and P with very high levels of O, and was thought to be a copper phosphate compound.

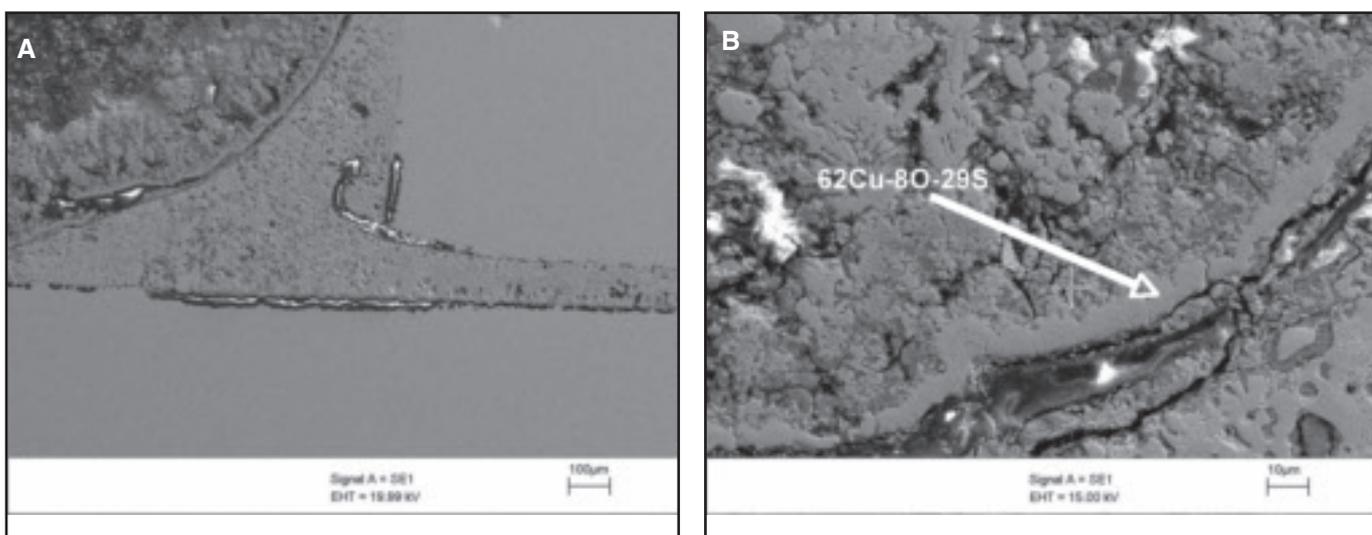
Fig. 7 — Cross-sectional views of a damaged brazed joint showing a heavy layer of copper sulfide on the braze metal surface in contact with the water passage. A — Low magnification; B — high magnification. Compositional analyses were done by SEM EDS and expressed in at.-%.

Another characteristic feature of the attacked brazed joints is that they all showed a thick layer of copper sulfide,  $\text{Cu}_2\text{S}$ , on the braze surface exposed to the water flow passage. Figure 7 shows an SEM image of braze metal area in contact with the water passage for a joint removed from a failed transformer. An EDS analy-

sis determined that it was copper sulfide.

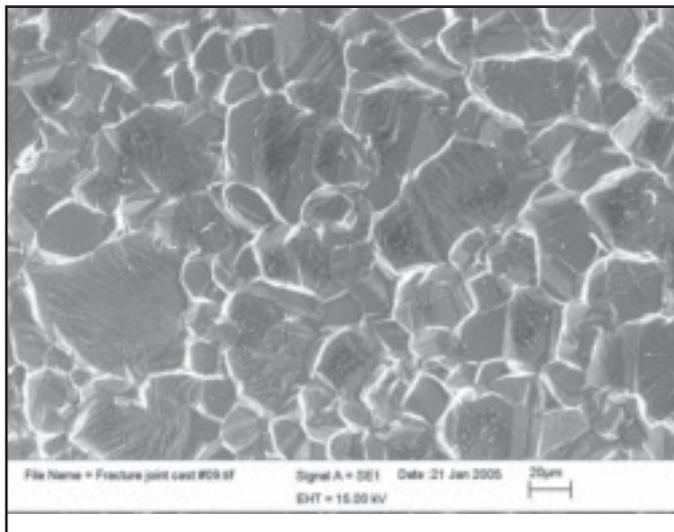
In many instances there was no residue on the surface of the adjacent copper component. Figure 8 shows an example of this for a cast copper pad removed from the adjacent tube. Braze metal had covered the cast pad within the water flow passage. Severe attack of the pad had occurred beneath the braze metal. Because of the extent of the damage, the braze metal was weakly attached and easily removed by hand. The figure reveals a strongly etched structure with the grain boundaries clearly revealed. No residue was obvious in this area.

Fig. 8 — SEM micrograph of the brazed joint showing the surface of the cast pad beneath corroded braze metal clearly revealing the grain structure.

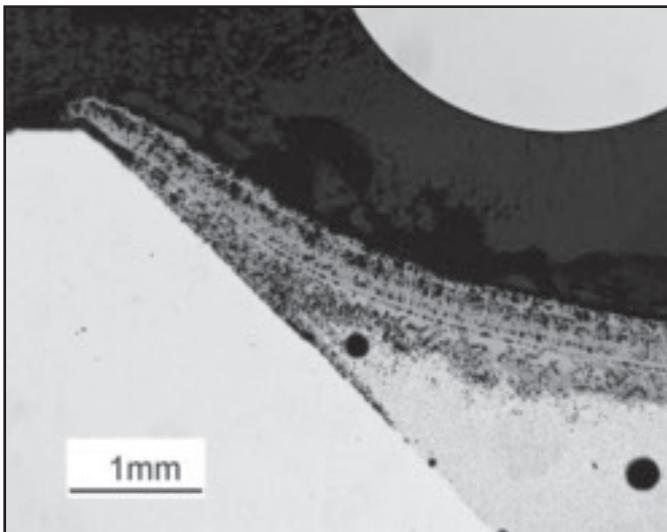
Fig. 9 — Simulated transformer brazed joint fabricated by torch brazing electronic-grade C11000 copper plate and Cu-6Ag-6.1P braze alloy after exposure to water at 60°C containing 160 ppm sulfide for three weeks. Joint damage, including penetration into the braze and interfacial attack, mirror that from damaged plant transformers.

After exposure, samples were sectioned metallographically for assessment of the corrosion damage. Figure 9 shows an example of the sulfide-induced corrosion damage. Its appearance replicates damage observed in transformer joints. Figure 10A–D shows cross sections taken at 1, 2, 3, 5, and 7 weeks, respectively. The sulfide scale thickness, depth of attack into the braze metal, and depth of attack along the copper/braze metal interface were all measured from micrographs of joint damage. Figure 11 gives the measurement data as a function of time exposed to the sulfide-containing water. It is apparent from the micrographs in Fig. 10 and the measurement data in Fig. 11 that the corrosion reaction begins slowly, but

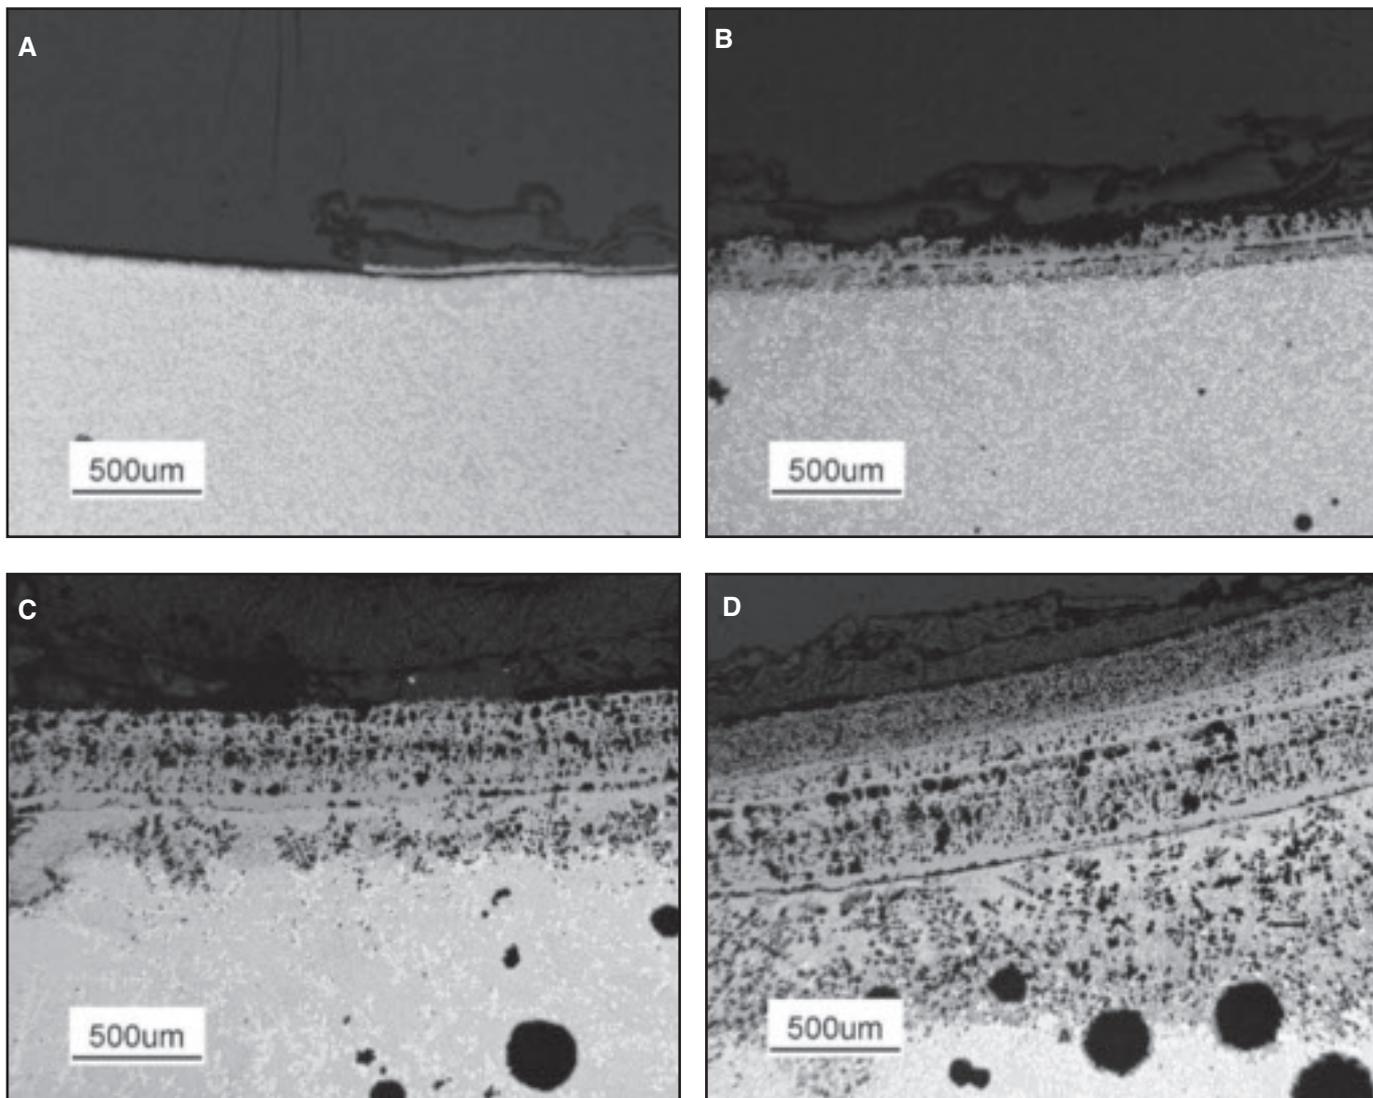
Fig. 10 — Simulated brazed transformer joint fabricated by torch brazing electronic-grade C11000 copper plate with Cu-6Ag-6.1P braze alloy after exposure to water containing 160 ppm sulfide at 60°C. A — 1 week; B — 2 weeks; C — 3 weeks; D — 5 weeks.

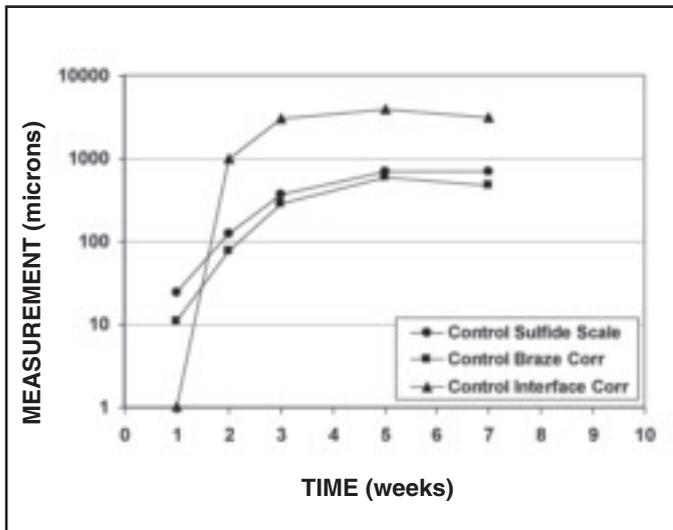
Fig. 11 — Corrosion penetration into the brazed joint after exposure to simulated weld water at 60°C containing 160 ppm sulfide.

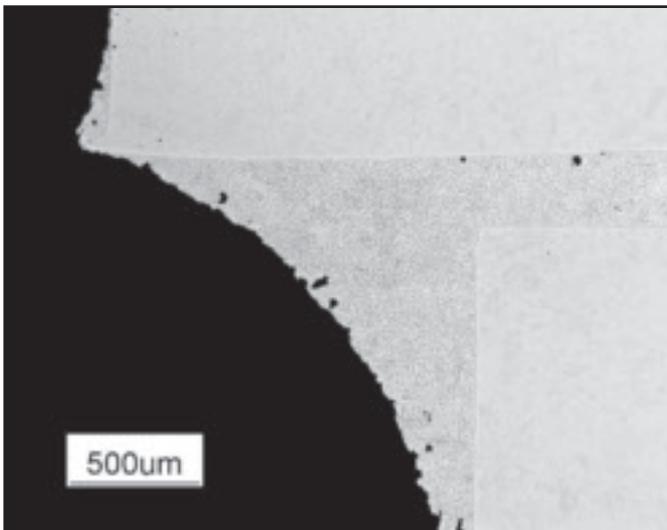
Fig. 12 — Brazed joint taken from a transformer that utilized a high-silver, phosphorus-free braze alloy. The joint shows no discernible corrosion after five months of exposure in a plant whose weld water system suffered from sulfide contamination.

At this time, a replacement braze metal has been identified and implemented. The Ag-Cu-Zn-Sn braze family was developed in response to the need for low-melting-point filler alloys that have low solidus temperatures, narrow melting ranges, and good corrosion resistance, but do not contain Cd. These alloys, though more expensive than the Cu-Ag-P family, have shown excellent corrosion resistance in practice. Because they are P-free, the catalytic presence of copper phosphide within the braze metal is removed. The specific alloy recommended is BAg-7, which is nominally 56% Ag, 22% Cu, 17% Zn, and 5% Sn, and is close to the eutectic composition. Figure 12 shows a joint from a transformer installed for five months in a plant with a history of sulfide contamination and corrosion. The joint shows no sulfide buildup and no corrosion whatsoever.
