Failure of Welded Floor Truss Connections from the Exterior Wall during Collapse of the World Trade Center Towers

Failure of connections, as a result of overloading, occurred within the heat-affected zone of the base metals

BY S.W. BANOVIC AND T. A. SIEWERT

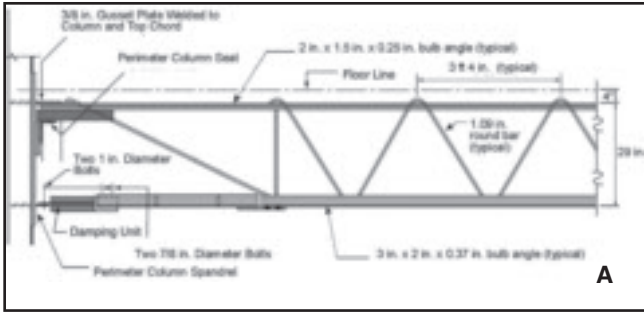
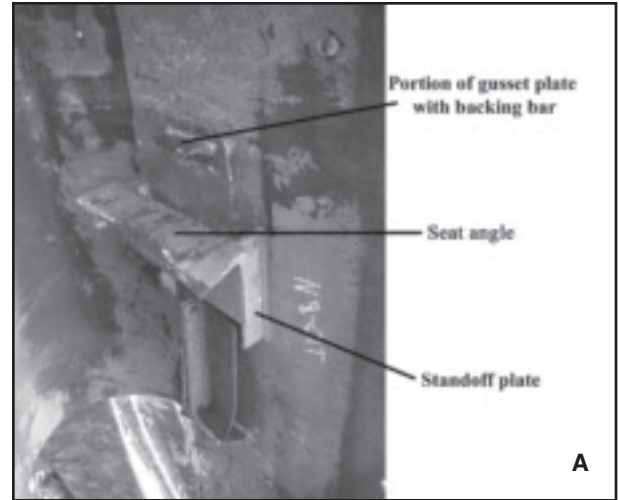
Fig. 3—A — Schematic showing attachment of the floor truss to the exterior wall; B — undated construction photograph showing the various features of the structural subsystems and their connections.

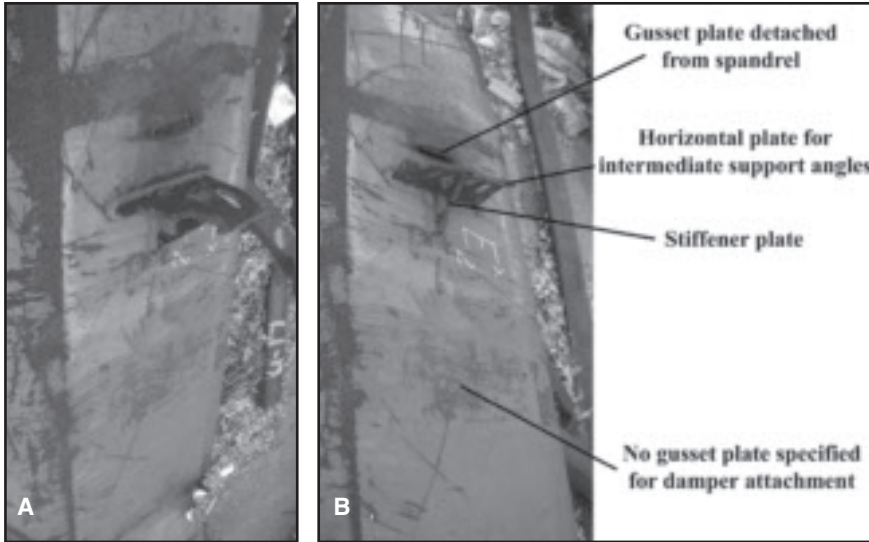
Fig. 5 — Example of an intermediate deck support angle seat from a recovered exterior panel (A451: 85–88). Connection shown is on column 452 at the 88th floor.

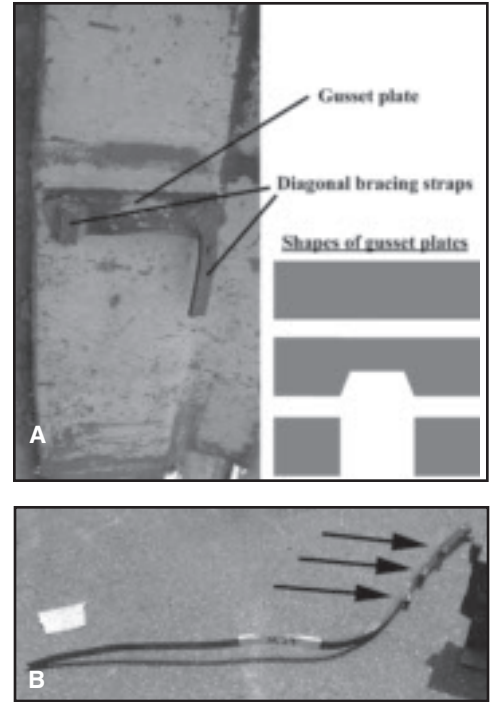
Fig. 6 — Example of a strap connection from a recovered exterior panel (A115: 89–92). A — Recovered gusset plate, from column 116 at the 90th floor, and observed variations; B — portion of a diagonal bracing strap with shear studs (arrows).

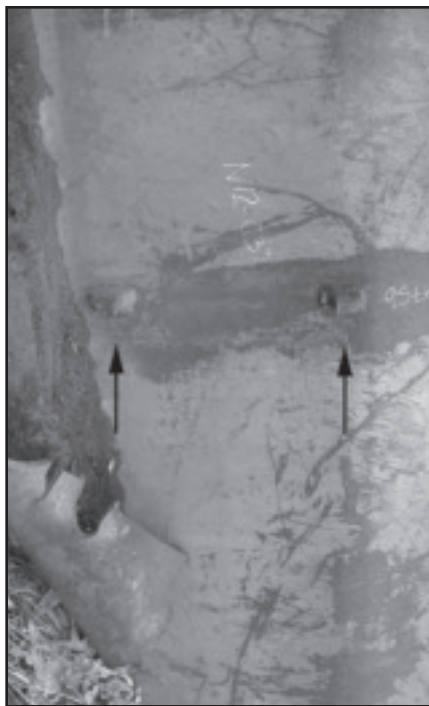
Fig. 7— Example of strap connections without a gusset plate from a recovered exterior panel (A206: 92–95). Connection shown is on column 205 at the 95th floor. Portions of diagonal bracing strap that were directly welded to the spandrel are indicated with arrows

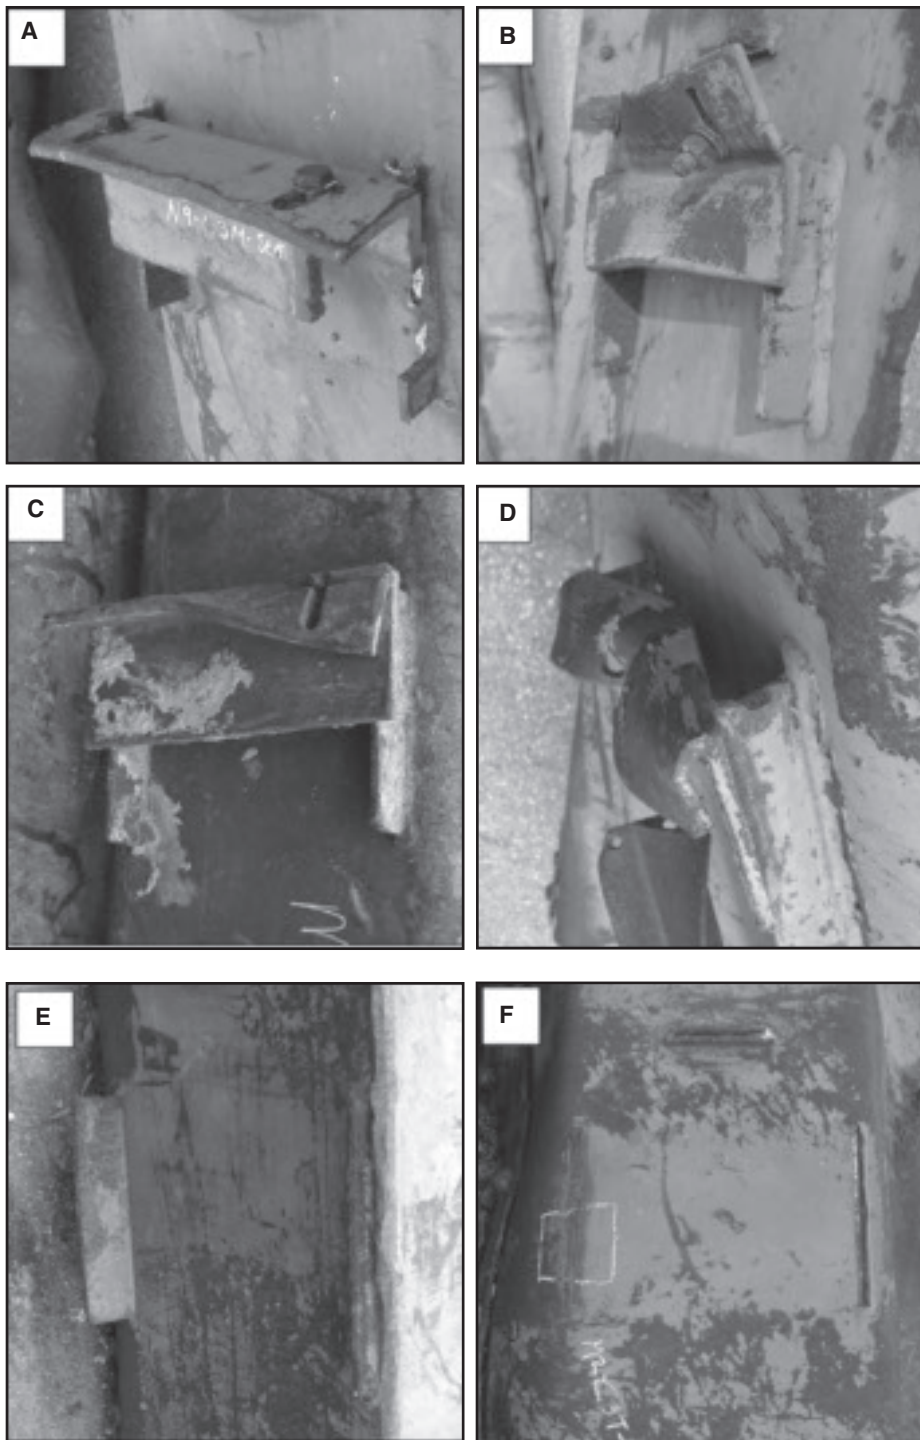
- seat angles intact and relatively undeformed — Fig. 8A,
- seat angles intact and bent up —

Fig. 8B,

- seat angles intact and bent down — Fig. 8C,
- seat angles intact and bent toward the spandrel — Fig. 8D,
- seat angles missing with standoff plates remaining — Fig. 8E, or
- seat angles missing with standoff plates missing — Fig. 8F.

Fig. 8— Description of main truss seat conditions from field observations. A— Intact and relatively undeformed from panel A154: 101–104 (connection is on column 153 at the 103rd floor); B— intact and bent up from panel A154: 101–104 (connection is on column 155 at the 102nd floor); C— intact and bent down from panel A130: 90–93 (connection is on column 131 at the 92nd floor); D— intact and bent toward the spandrel from panel B206: 83–86 (connection is on column 206 at the 84th floor). E— seat angle missing with standoff plates remaining from panel A124: 70–73 (connection is on column 123 at the 71st floor); F— seat angle missing with standoff plates missing from panel A130: 96–99 (connection is on column 129 at the 99th floor).

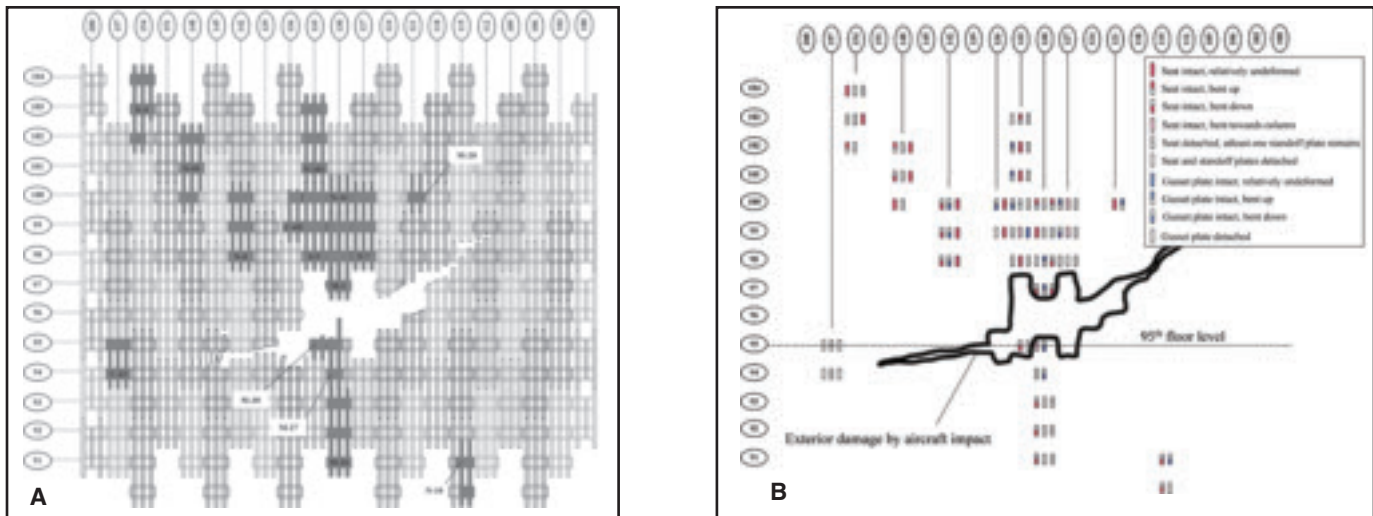
Fig. 9 — A — Damage diagram of WTC 1 north face showing the location of recovered exterior panels; B — observed condition of recovered floor truss connection; those at or below the 95th floor level are either missing or bent downward.

Failure of floor truss connections from WTC 1 were analyzed to determine whether connections above and below the impact region failed by different mechanisms. There were 51 observations at or below the 95th floor and 72 above the 95th floor. The spatial display of a fraction of this information for WTC 1 near the impact region of the north face is seen in Fig. 9. Both pictorially and statistically (Tables 2 and 3), an overwhelming majority of main truss seats and strap connections were either bent down or completely missing below the impact zone. Below the 95th floor level, 93% of the main truss seats failed by these modes compared with only 37% of the seats above

the 95th floor. For the strap connections, 96% were either bent down or torn off below the 95th floor and 74% were similarly deformed above this level.

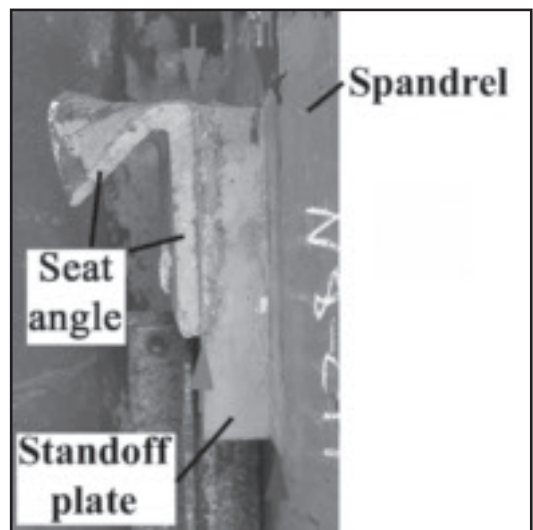
Fig. 10 — Location of the two welds analyzed from the main truss seats (A142: 97–100; column 143, 100th floor).

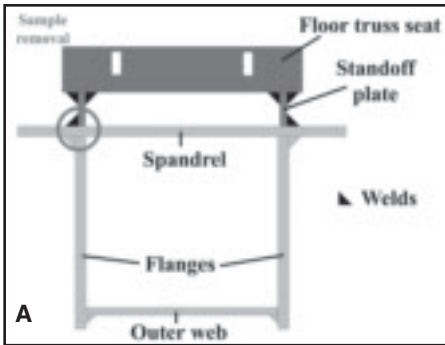
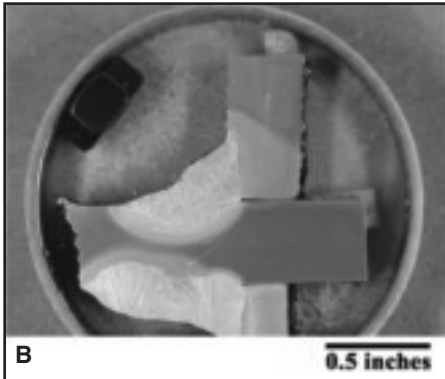
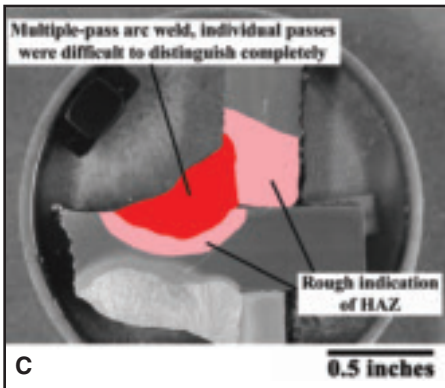
Figure 11 shows, in cross section, one of the undamaged welds between a standoff plate and a spandrel plate. Both plates are ferrite-pearlite steels with minimum yield strengths of 42 and 65 ksi, respectively (1 ksi equals 1000 lb/in.²). As stated previously, the two standoff plates were fillet welded directly to the spandrel plate. Multipass beads were observed only on the outboard face of the plates. The specific arc welding process was not found

Fig. 11 — Cross section of fillet weld between spandrel and standoff plate from an undamaged main truss seat (A157: 93–96; column 157, 94th floor). A — Schematic showing the location of sample removal; B — metallographically prepared specimen; C — HAZ and weld were determined via optical means. Two percent nital and four percent picral etch.

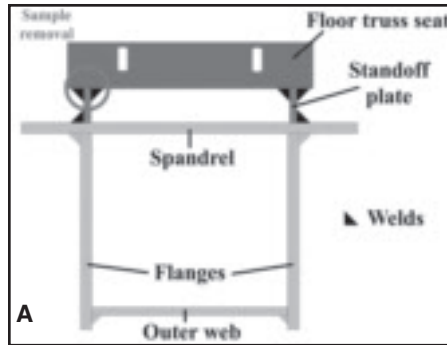
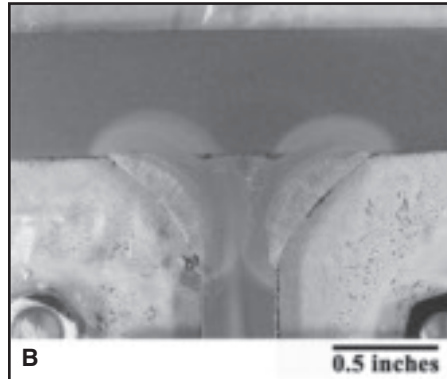
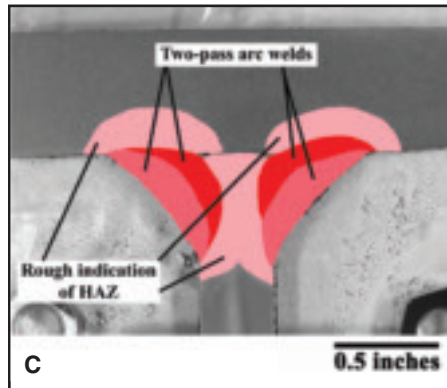
Fig. 12 — Cross section of fillet weld between standoff plate and seat angle from an undamaged main truss seat (A154: 101–104; column 153, 103rd floor). A — Schematic showing the location of sample removal; B — metallographically prepared specimen; C — HAZ and weld were determined via optical means. Two percent nital and four percent picral etch.

A two-pass fillet weld, on both faces of the standoff plate, joined the seat angles to the standoff plates — Fig. 12. This clearly indicates that the standoff plate/seat angle assemblies were prefabricated and then welded to the spandrel. Again, SMAW or FCAW was probably used for joining. The combined HAZ from both fillet welds spans the entire standoff plate. Again, the HAZ in the seat angle is shallower. All five welds

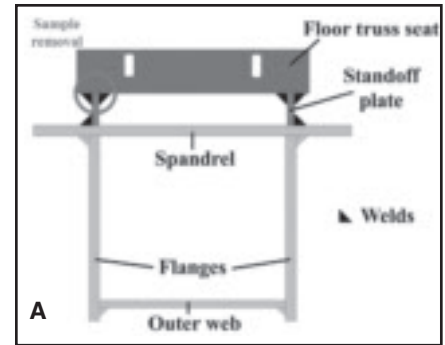
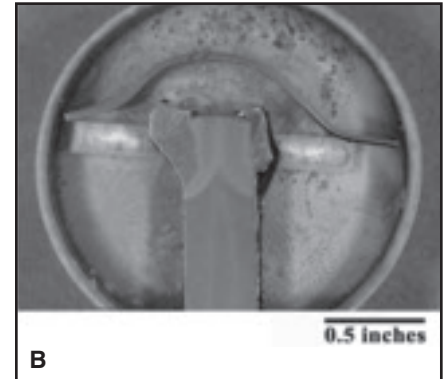
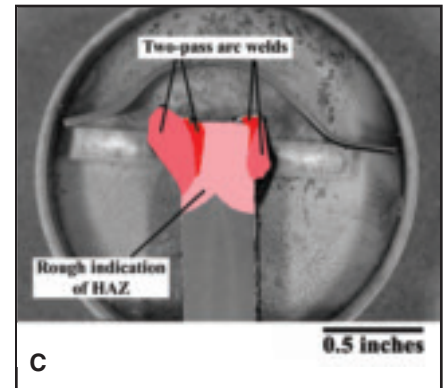
Fig. 13 — Cross section of fillet weld between standoff plate and seat angle from a damaged main truss seat (A157: 93–96; column 157, 94th floor). A — Schematic showing the location of sample removal; B — metallographically prepared specimen; C — HAZ and weld were determined via optical means. Two percent nital and four percent picral etch.

Table 1 shows that nearly 25% of the main truss seats at or below the impact regions had the seat angles detached with at least one of the standoff plates remaining. Again, the seat angles probably detached via a shear mechanism as the buildings section collapsed. Figure 13 shows the failed cross section of one of these joints. Failure occurred within the weld metal at the weld-seat angle interface. Similar failure features were observed on other samples

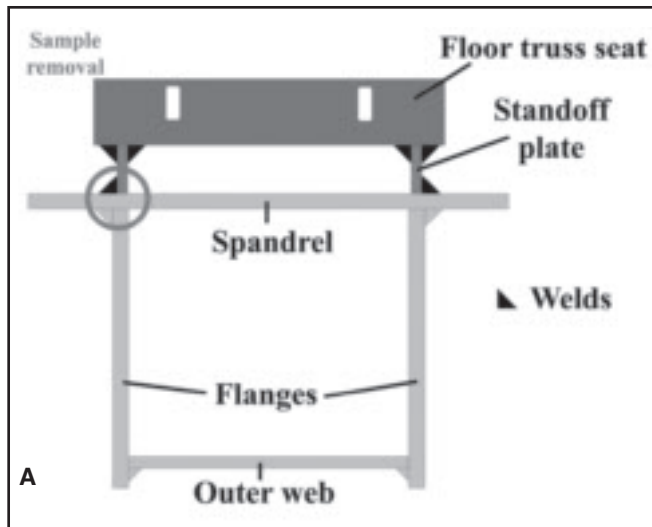
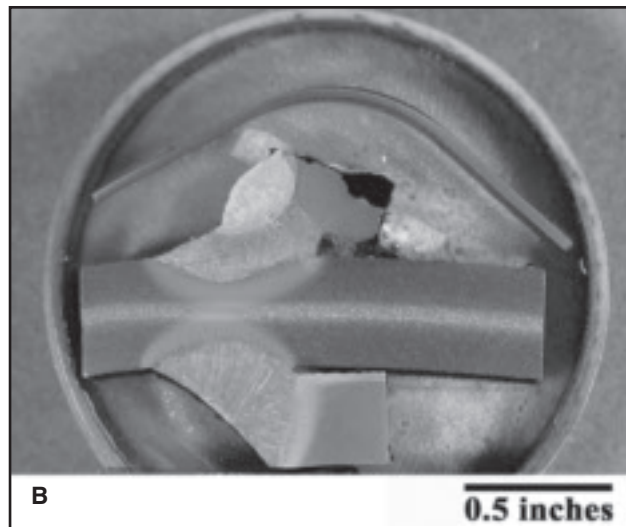
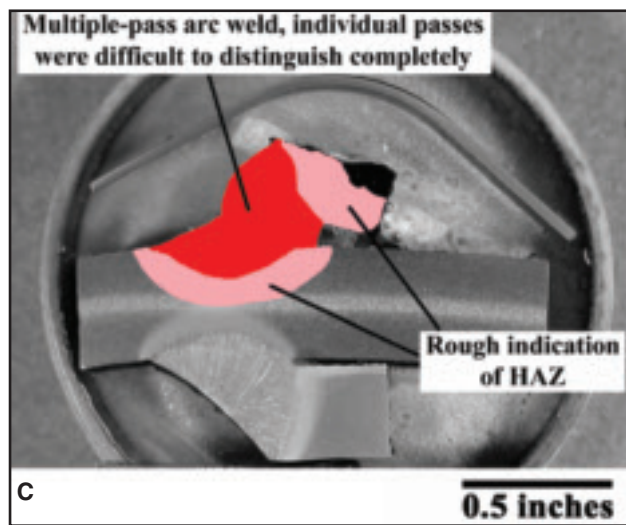
Table 1 also shows that nearly 40% of the main truss seats at or below the impact regions from both towers had at least one of the standoff plates detached from the spandrel in the process of removing the seat assembly from the column. The plates probably detached via a shear mechanism as the buildings collapsed due to the overloading of the floors. Figure 14 shows one of these failed joints in cross section. Failure occurred almost exclusively within the HAZ of the standoff plate. Similar failure features were observed on all samples metallographically analyzed that had a failed joint between the spandrel plate and standoff plates.

Detached main truss seats failed near one of two welded joints associated with the standoff plates. Inspection of the weld failures showed that fracture typically occurred in the location with the lowest cross-sectional area. The joints between the standoff plate and spandrel failed primarily in the HAZ of the standoff plate because this path is shorter than the one that traverses the stronger weld material. Additionally, the standoff plate had the lowest cross-sectional area for load transfer at this joint. Conversely, when the seat angles were detached from the standoff plates, failure occurred in the weld metal at the seat angle/standoff plate interface. Figure 12 shows that the fillet weld between the standoff plate and the seat angle did not fully penetrate the portion of the standoff plate in contact with the seat. Thus, the joint failed there because that location had the lowest cross-sectional

Fig. 14 — Cross section of fillet weld between spandrel and standoff plate from a damaged main truss seat (A130: 96–99; column 129, 99th floor). A — Schematic showing the location of sample removal, B — metallographically prepared specimen, C — HAZ and weld were determined via optical means. Two percent nital and four percent picral etch.
