38 - LIQUID METAL ASSISTED CRACKING OF GALVANIZED STRUCTURAL STEEL SECTIONS

38 LIQUID METAL ASSISTED CRACKING OF GALVANIZED STRUCTURAL STEEL SECTIONS

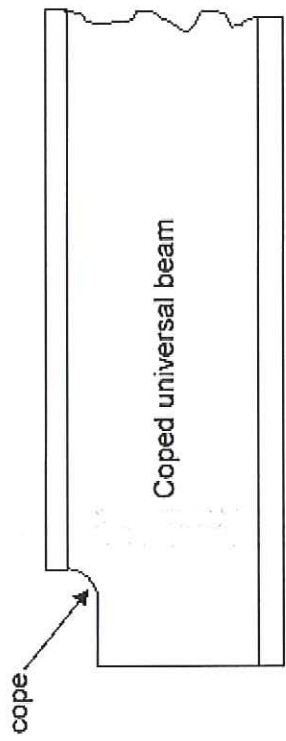
Crack propagated from angle flange after galvanizing or arising from liquid metal cracking.

These large galvanized sections, have all been 'cope cracked' in the c
