## **Pressure Vessel Failure during Hydrotest-Nov. 2007 in China**

**January 9, 2008**

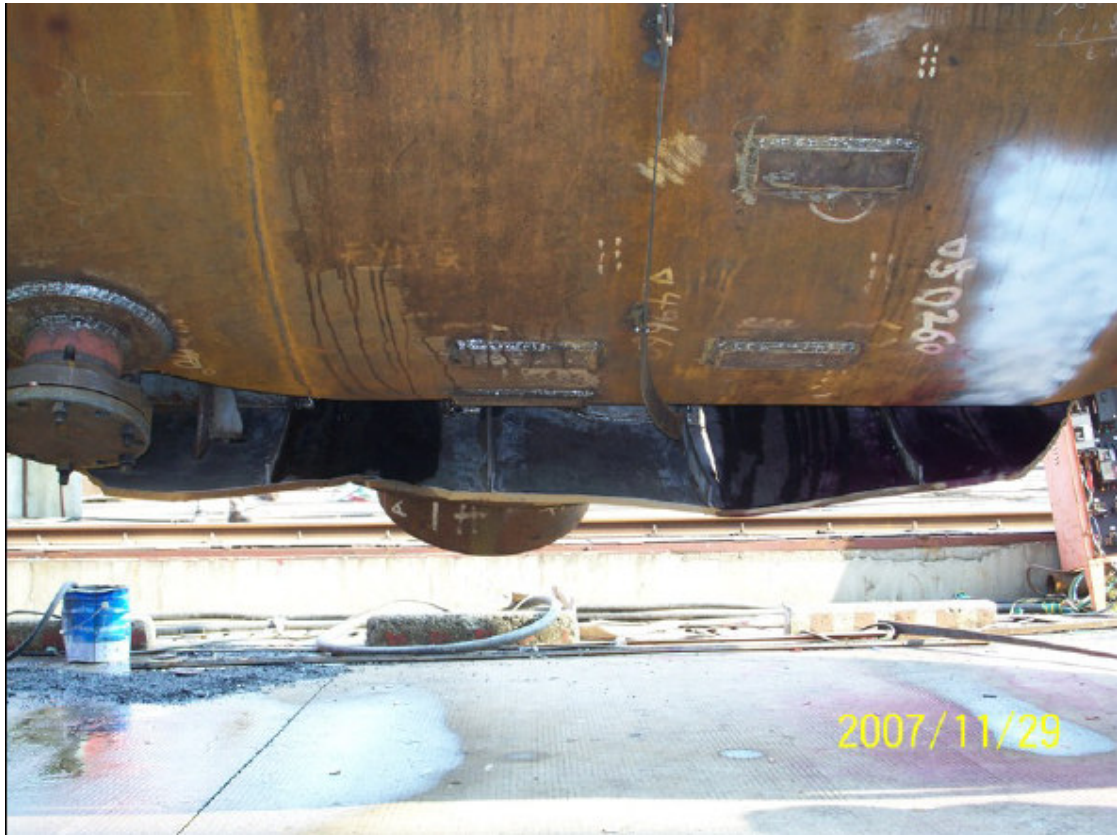
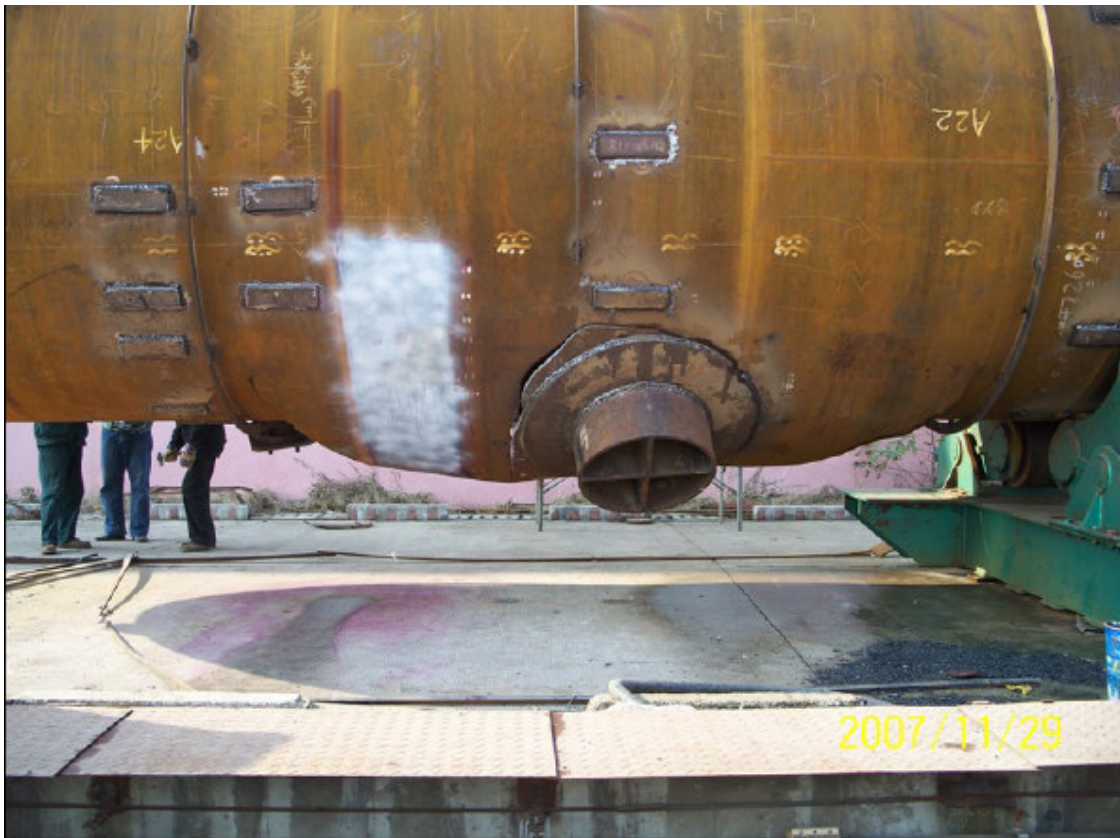
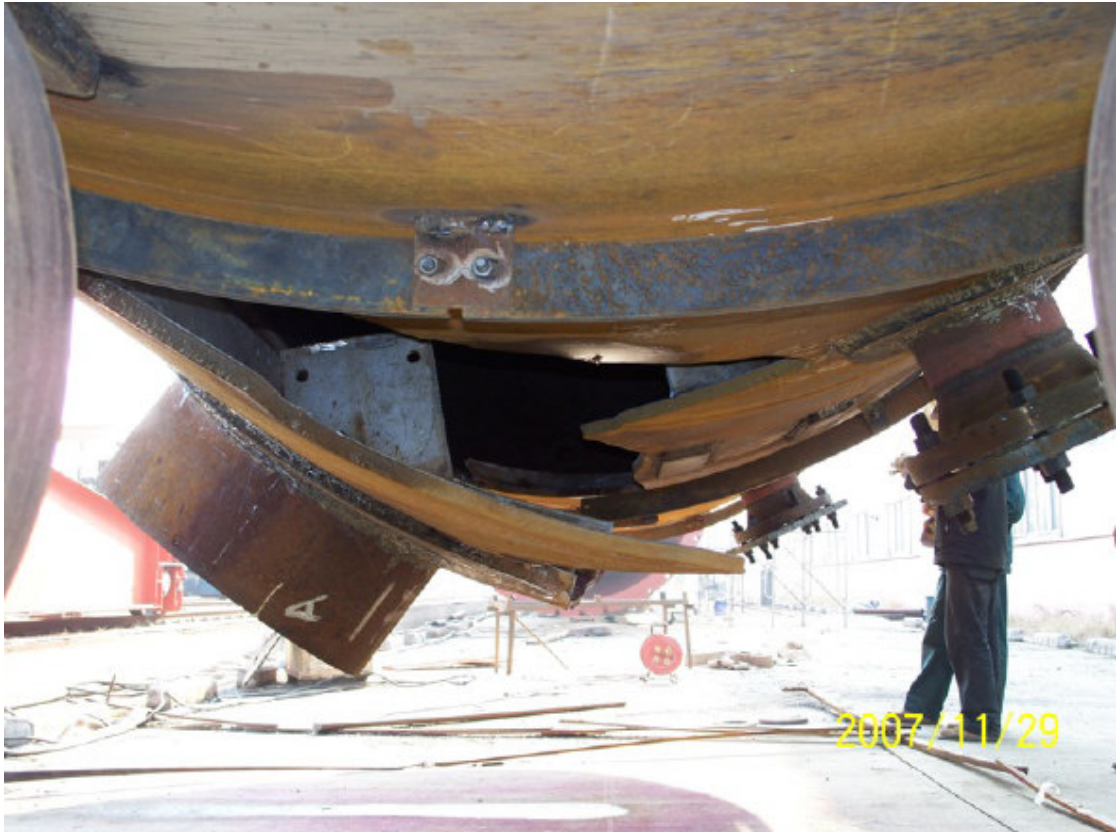
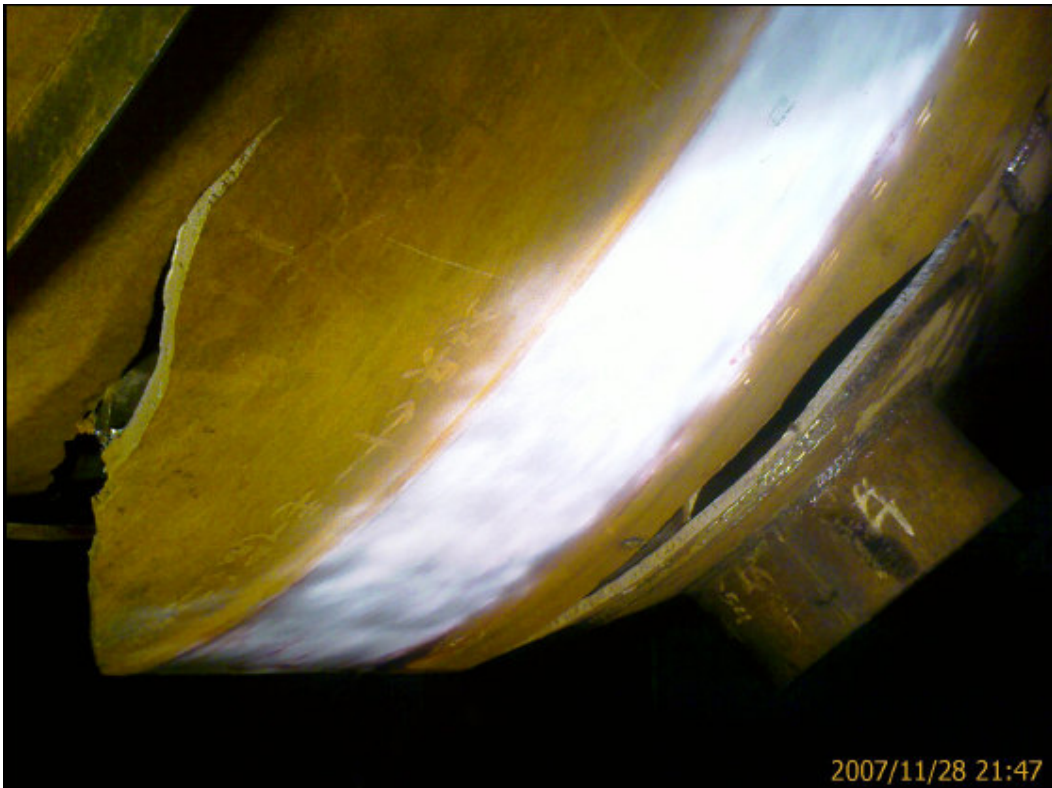
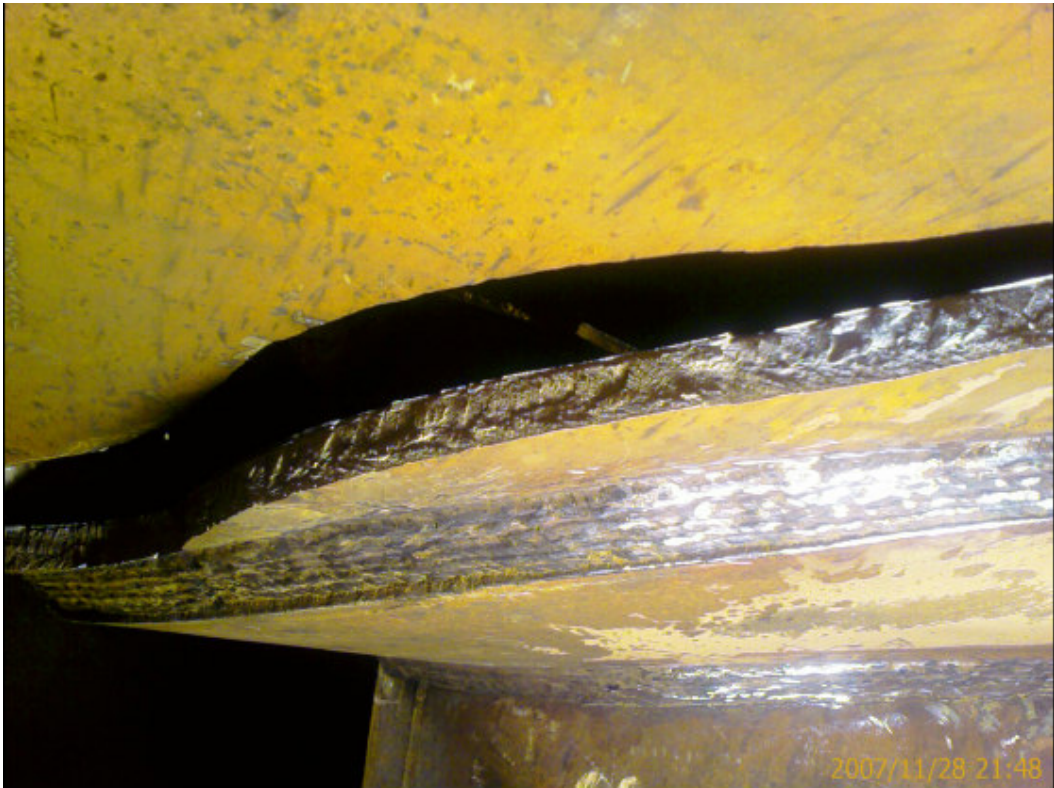
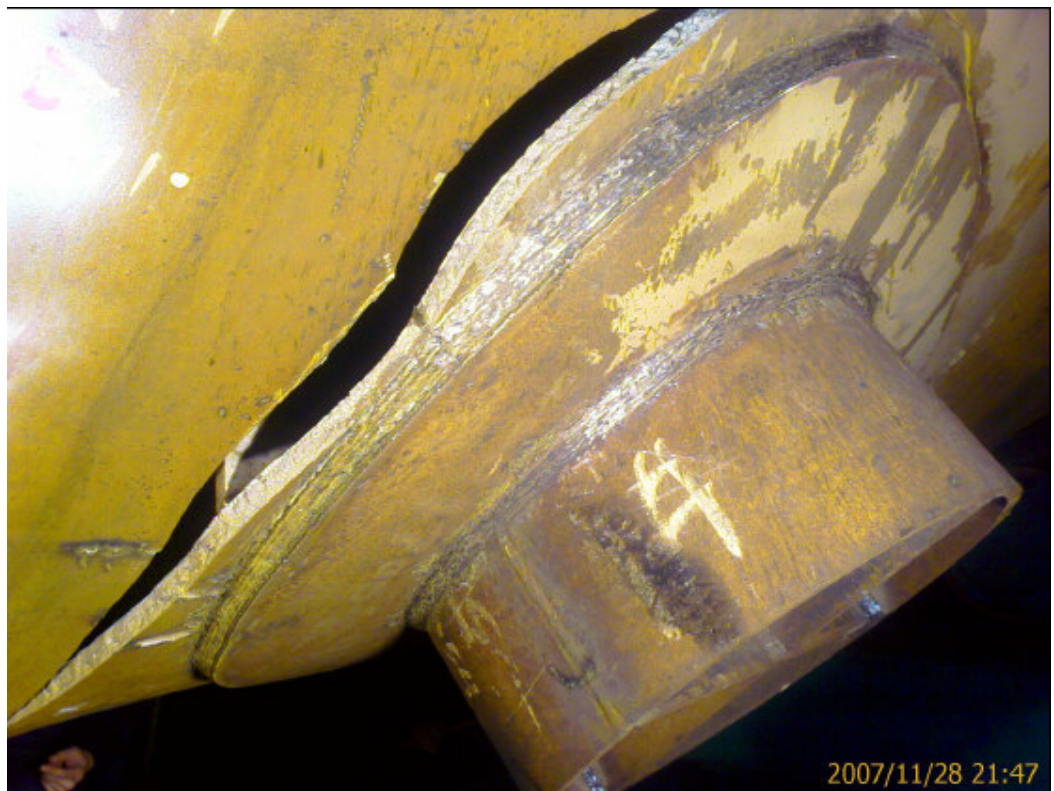
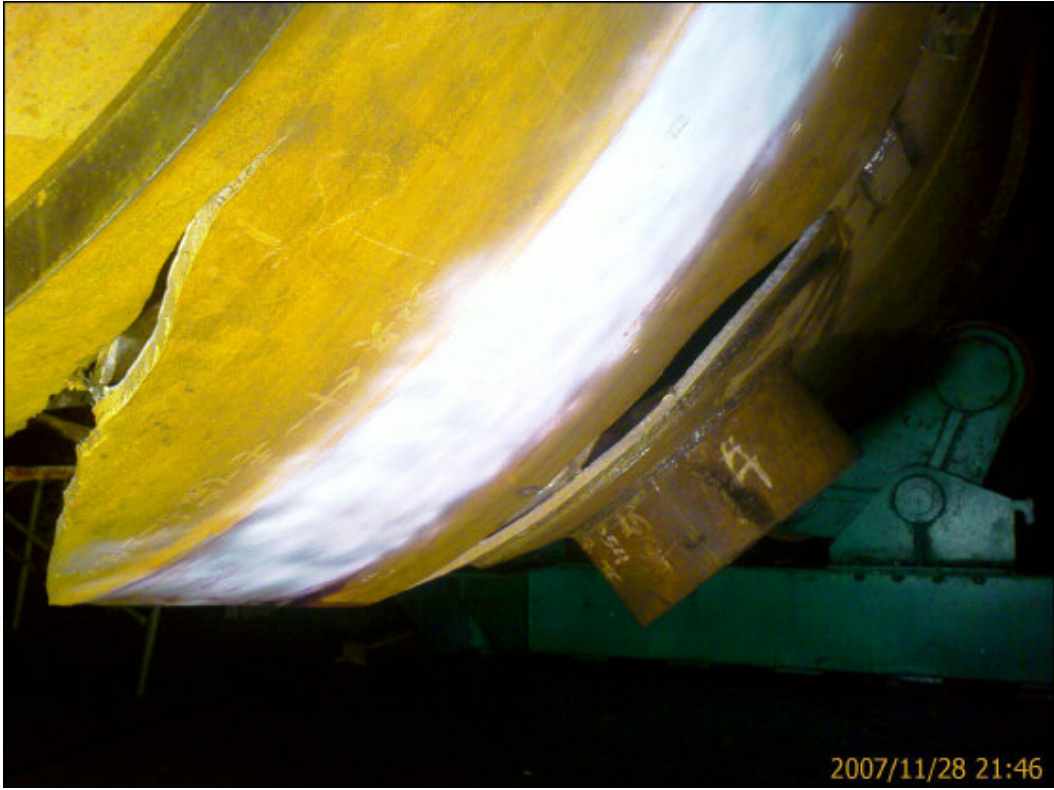
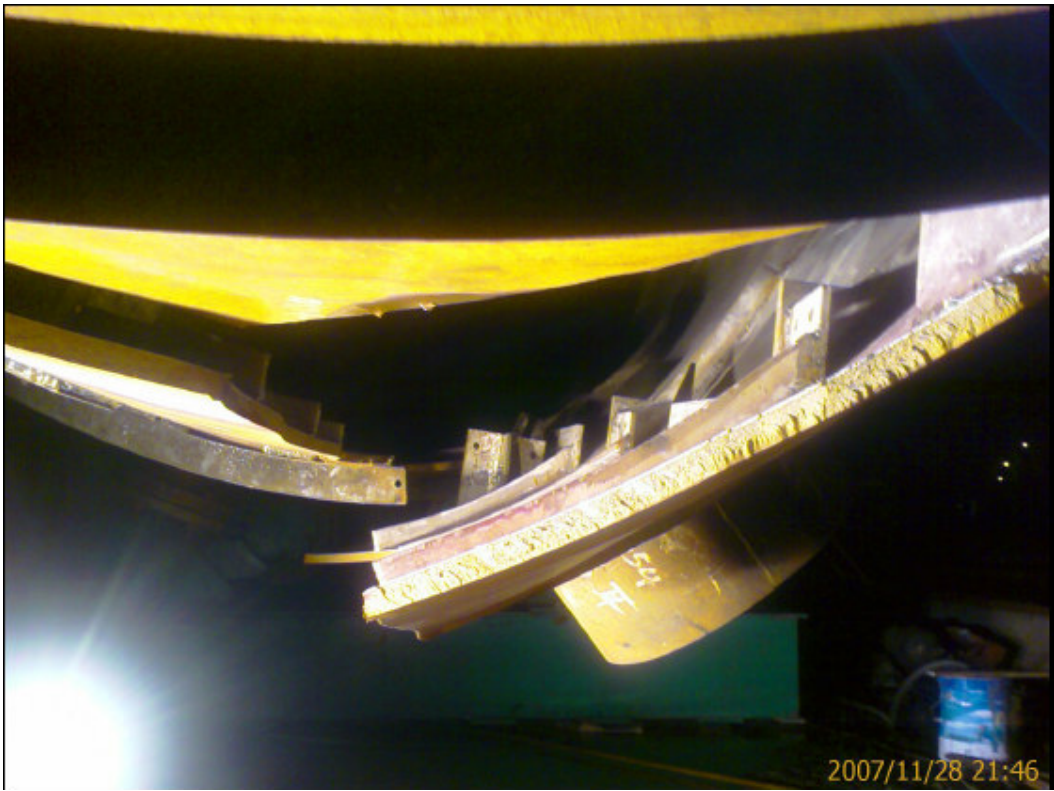
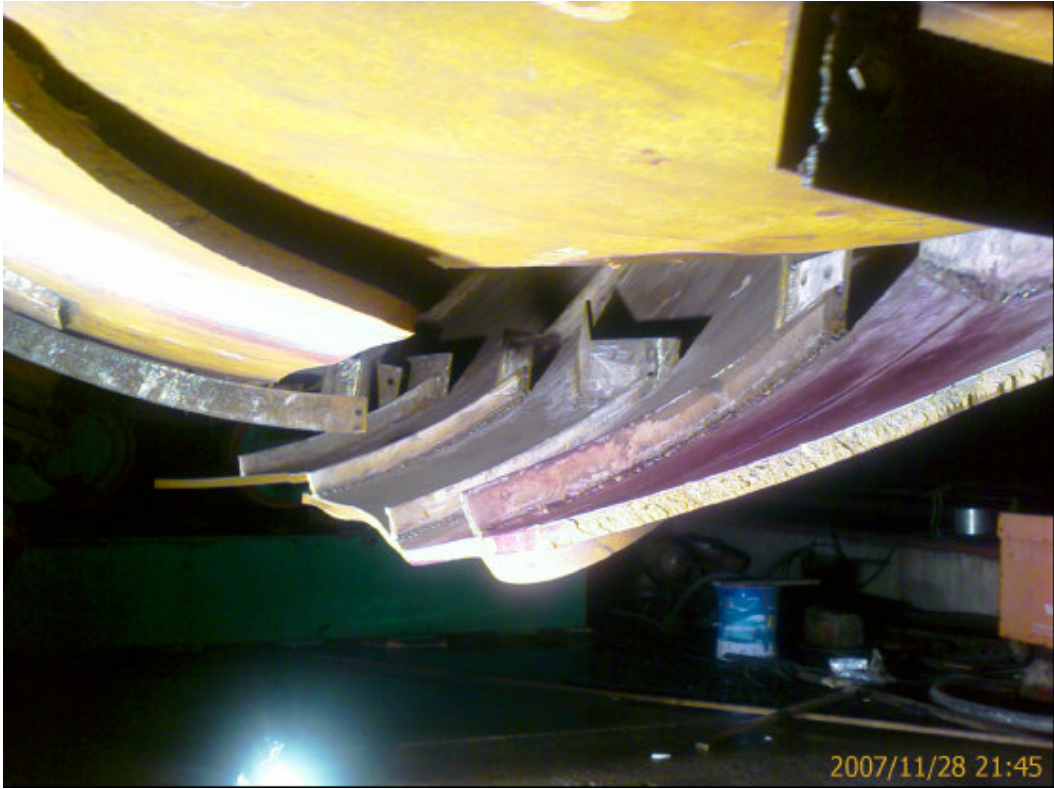
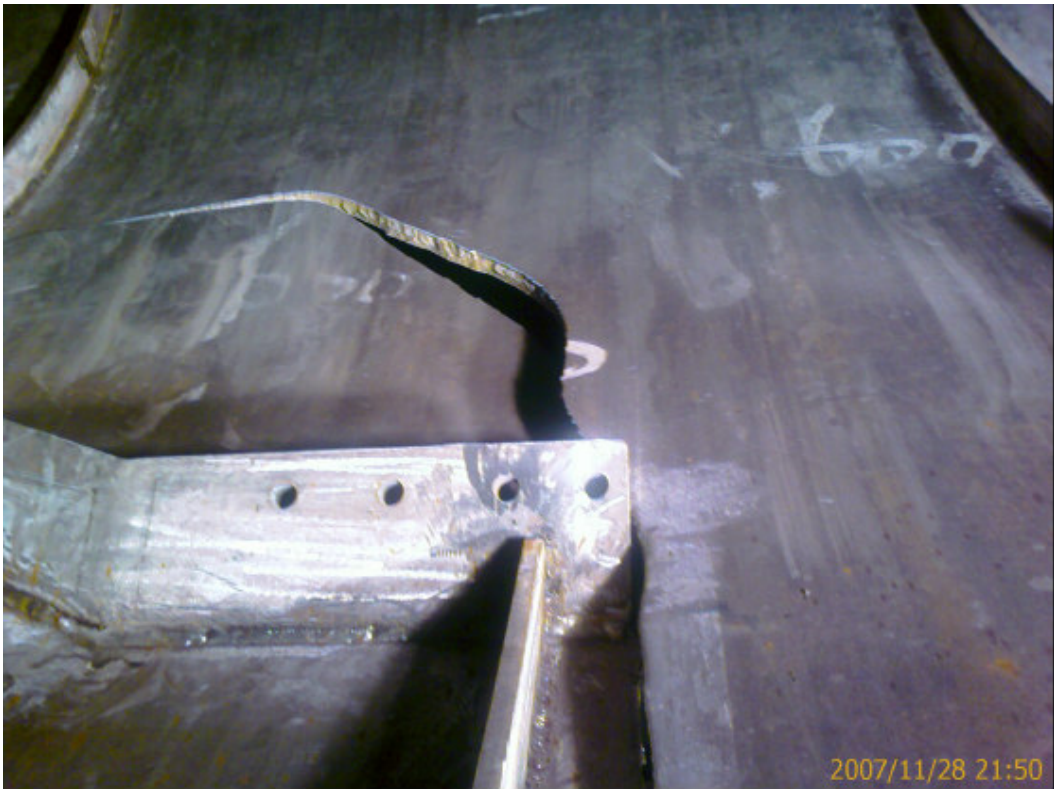
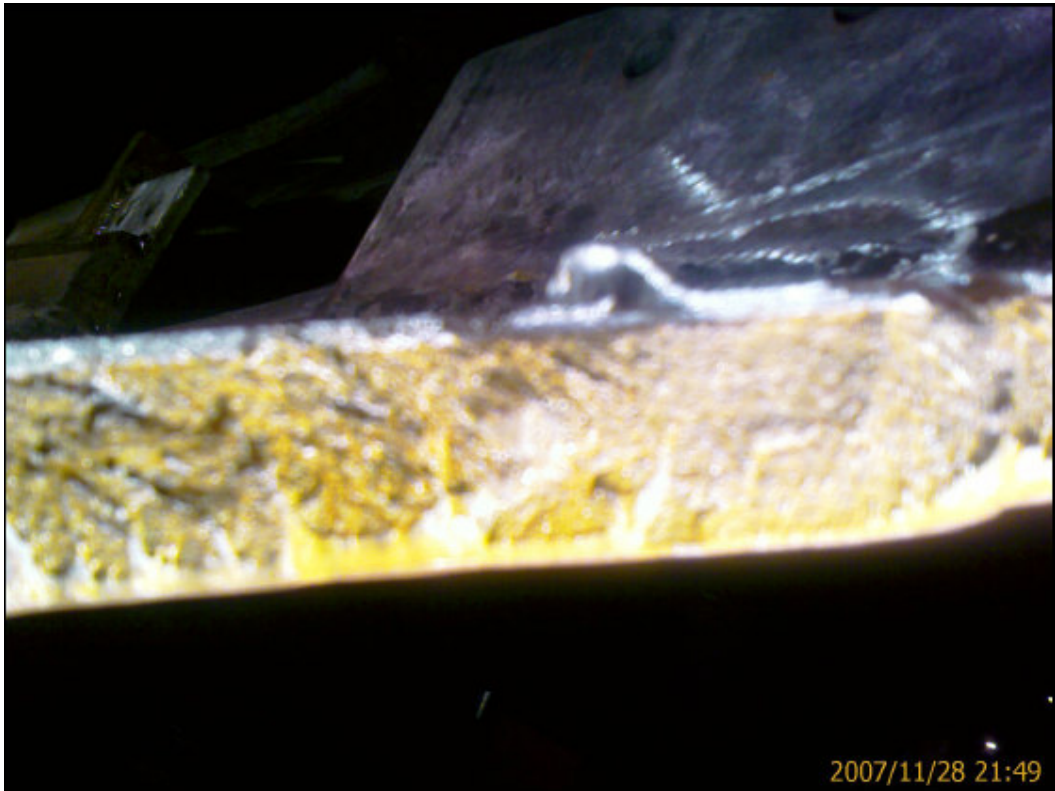
Please find attached photos of a pressure vessel that recently failed whilst under hydrotest during post fabrication testing. This vessel was manufactured by a vessel vendor in China and the plate was of Chinese mill origin. Unfortunately this is another example of serious equipment/material failures with equipment being sourced out of the rapidly developing economies such as China, Eastern Bloc and others. These examples are becoming almost a weekly occurrence now and are exhibiting failure modes not seen in the mature manufacturing economies since the 1930's. Again we need to ensure vigilance in the acceptance of manufacturers and once more I stress the need to know where the base materials are sourced from.

Apparently this pressure vessel had reached fifty percent of the required test pressure when the shell ruptured. A metallurgical failure report is not available however from the photographs a number of observations could be made regarding the quality of the material and the welding.

- (1) All base metal requirements shall be specified in P.O Requisition per project/Industry Code requirements.
- (2) Consult specialists (i.e., Materials and Corrosion Engineers) whenever you doubt.
- (3) All inspection (from base materials to final products) should be performed per the codes, specs & standards.
- (4) Especially when you selected the manufacturers in China, the above (1), (2) & (3) will be a very important message.
