Tool Degradation Characterization in the Friction Stir Welding of Hard Metals

Microstructural characterization identified tool-life degrading mechanisms for three tungsten-based FSW tool materials

BY B. THOMPSON AND S. S. BABU

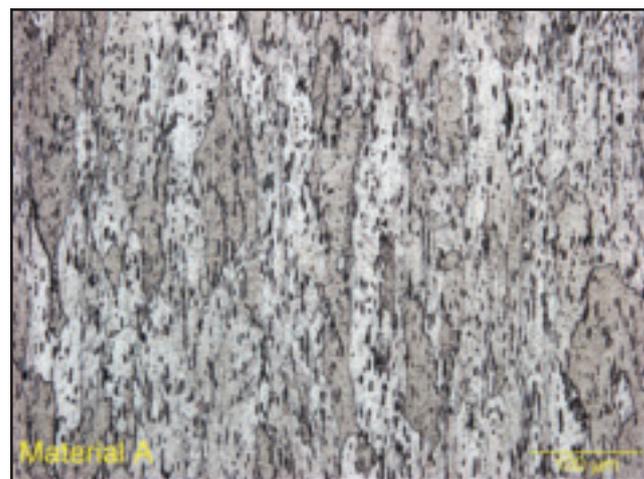
Fig. 3 — Material A raw stock microstructure.

The raw stock of Material A is characterized by long vertical grains running parallel to the central axis. Average grain size is approximately 0.006 in. (150 μ m) long and 0.002 in. (50 μ m) wide — Fig. 3. When welding with this material, the tool visually deformed especially during the plunge sequence. As the tool traversed down the weld, it progressively mushroomed until the original shape was no longer recogniz-

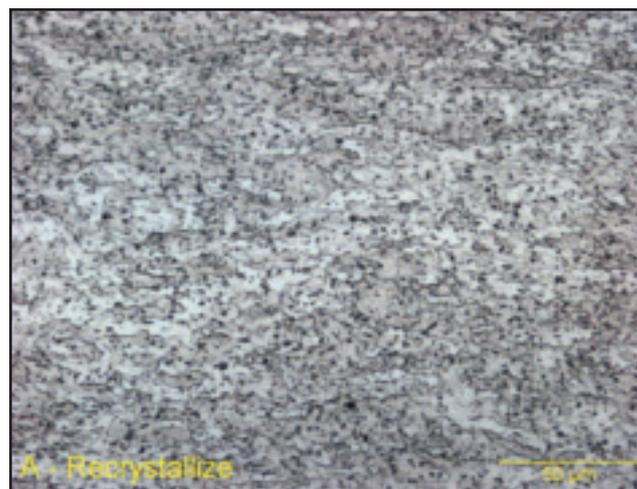
Large areas of recrystallization were also noticed on both sides of the pin tip — Fig. 6. Material A (T_m of 3473 K) has a recrystallization temperature of 1873 K (Ref. 14), while typical temperatures during the FSW of steel reach approximately 900° to 1100°C (1173 to 1373 K) (Ref. 4). Recrystallization cannot occur in this material at FSW temperatures alone. Therefore, it is concluded that the combination of high temperatures and local deformation drove the recrystallization process to occur at a lower temperature.

Fig. 6 — Recrystallized area in W-La pin tip.
