Factors Influencing Strain-Age Cracking in Inconel X-750

A study is undertaken to determine the mechanical response of an age-hardenable superalloy—Inconel X-750—to tensile loads in temperatures from 1000-1750° F to identify any microstructural changes that accompany deformation in this temperature range

BY A. W. DIX AND W. F. SAVAGE

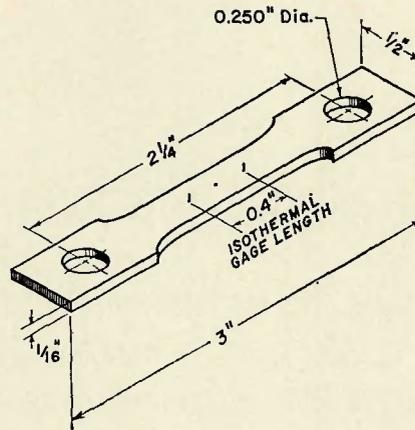
Fig. 1—Isometric representation of specimen geometry

tensile specimens as shown in Fig. 1. Two 0.010 in. wires were percussion welded 0.4 in. apart, and symmetrically located relative to the specimen center to provide an identifiable gage length. To prevent any slippage in the jaws during testing, locking pins were inserted in the 1/4 in. holes in the ends of specimens and butted against the holding grips.

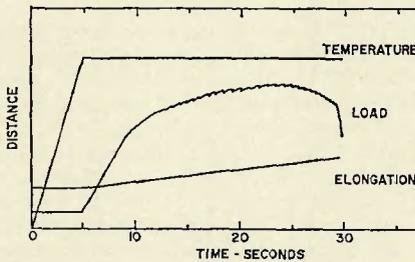
Fig. 2—Schematic representation of an oscillographic recording of an elevated temperature tensile test

Figure 2 is a schematic representation of a typical oscillographic recording of load, total elongation (i.e. platen motion), and temperature as a function of time. In addition to the actual elongation in the 0.4 in. gage length, the fracture area, and the time to fracture were measured.

Tensile deformation in the temperature range of 1000–1660° F was accompanied by serrated yielding as shown schematically in Fig. 2. The actual number of serrations or load drops decreased sharply as the temperature was increased in this range. Samples tested above 1660° F did not exhibit this type of yielding. The number of load drops was also found to decrease as the strain rate was increased.

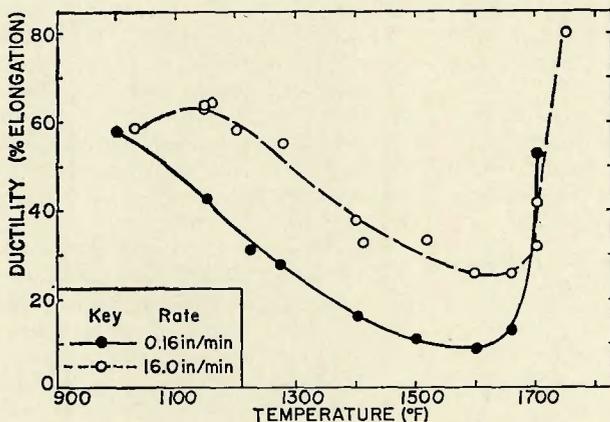
Fig. 3—Effect of testing temperature on ductility at two different strain rates

Figure 3 shows the ductility as a function of testing temperature for Inconel X-750 in the temperature range of 1000–1750° F for two strain rates, 0.16 and 16.0 ipm. It should be recalled that these rates are actually

The results shown in Fig. 3 indicate that Inconel X-750 exhibits the classical ductility minimum⁷ for both strain rates. Note that the present elongation decreased from 56% at 1000° F to 9% at 1600° F for the slower strain rate, but showed a smaller decrease to 25% at 1600° F and 1660° F for a strain rate of 16 ipm. As the testing temperature was increased above the value where the ductility minimum occurred, the ductility increased rapidly for both strain rates.

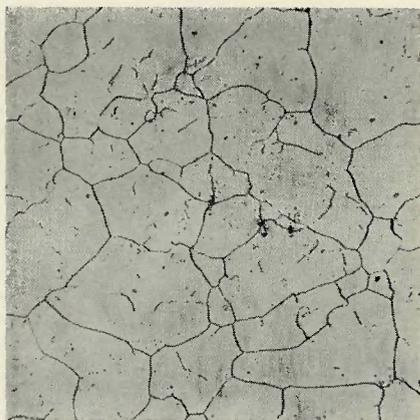
Fig. 6—Microstructure of Inconel X-750 after solution annealing for 2 hr at 2000° F. $\times 100$ (reduced 35% on reproduction)

Figure 6 is a photomicrograph taken at X100 of the solution annealed Inconel X-750 used in this investigation. The microconstituents present have been well documented⁸ and consist of a gamma matrix containing $M_{23}C_6$, (Cb, Ta)C and Ti (CN) particles. Furthermore, since the alloy is relatively simple, only one additional constituent, namely gamma prime (γ'), forms during the aging treatment. Gamma prime, Ni_3 (Al, Ti), is formed in the temperature range of 1300–1600° F as a coherent precipitate. The shape of this γ' depends upon the previous thermal history,⁹ being spherical if formed at low aging temperatures and cubic when formed by long exposures to high aging tem-

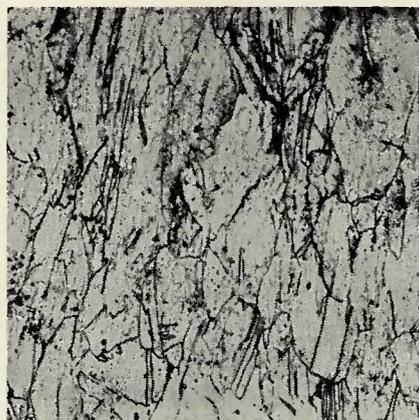
Fig. 7—Microstructure produced by heating to 1275° F and loading to failure at a rate of 16.0 ipm. $\times 100$ (reduced 35% on reproduction)

Figure 7 is a photomicrograph at X100 showing the structure formed by heating to 1275° F and loading to failure at a rate of 16.0 ipm. The microstructure is characteristic of a severely cold worked material, as indicated by the elongated grain structure and the tendency for the twins to become aligned with the direction of loading. This sample exhibited a total ductility of 56%. The fracture appeared to be predominantly transgranular.

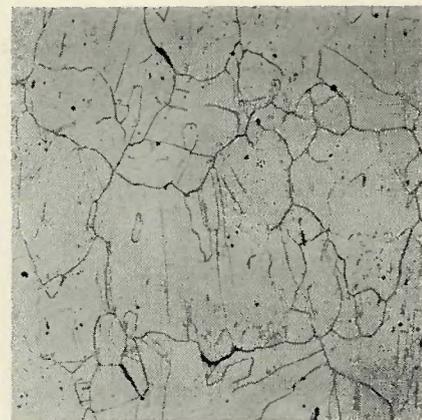
Fig. 8—Microstructure produced by heating to 1270° F and loading to failure at a rate of 0.16 ipm. $\times 100$ (reduced 35% on reproduction)

A significant effect of strain rate on the deformation characteristics can be seen by comparing Figs. 7 and 8. The latter is a photomicrograph at X100 showing the structure formed by heating to 1270° F and loading at a rate of 0.16 ipm. The appearance of the microstructure indicates that both grain boundary sliding and transcrystalline slip occurred simultaneously.

The former produces wedge shaped voids at grain boundary intersections,¹⁰ while transgranular slip "bends" the normally straight sided annealing twins. This photomicrograph shows much less evidence of grain elongation and preferred orientation of the twins. This is consistent with the observed reduction in ductility as compared to the sample shown in Fig. 7 (29% vs. 56%).

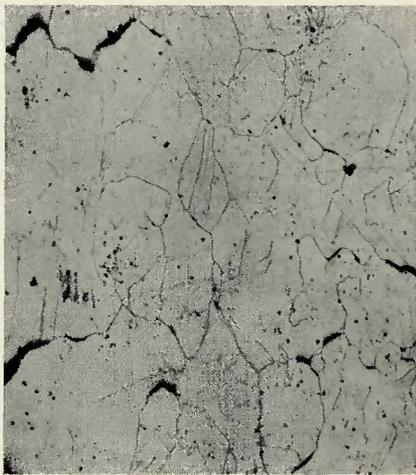
Fig. 9—Microstructure produced by heating to 1600° F and loading to failure at a rate of 16.0 ipm. $\times 100$ (reduced 35% at reproduction)

Figure 9 is a photomicrograph at X100 showing the structure formed by heating to 1600° F in 5 sec and loading at a rate of 16.0 ipm. Attention is drawn to the similarity between both the ductility and the microstructures of the specimens shown in Figs. 8 and 9. Both samples exhibit an elongation of 29% and show evidence of both grain boundary sliding and transgranular slip. However the sample tested at 1600° F and 16.0 ipm (Fig. 9) exhibits more intergranular

cracking than the sample tested at 1270° F and 0.16 ipm (Fig. 8). The shorter time for grain boundary relaxation associated with the faster strain rate of 16.0 ipm apparently increased the likelihood of crack initiation at the highly stressed triple points. On the other hand, at the slower strain rate of 0.16 ipm more time is available for this relaxation and the cracking tendency appears to have decreased. The effect of temperature on grain boundary sliding at the slow strain rate is best illustrated by considering Fig. 10

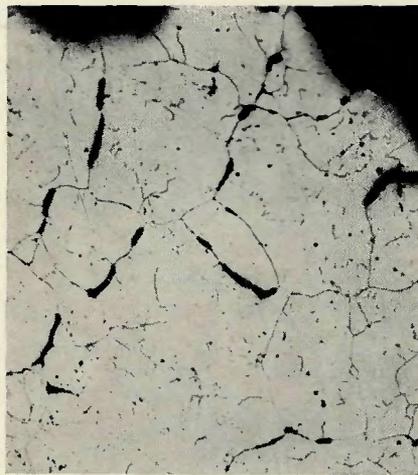
Fig. 10—Microstructure produced by heating to 1600° F and loading to failure at a rate of 0.16 ipm. $\times 100$ (reduced 35% on reproduction)

Figure 10 is a photomicrograph at X100 of the structure formed by heating to the ductility minimum temperature of 1600° F and straining at a rate of 0.16 ipm. Not only does the elongation show a minimum of 9%, but also the amount of intergranular cracking is much greater than that shown in either of the two previous samples. Both wedge cracks formed at grain boundary intersections and secondary cracks located between the grain boundary triple points are evident in Fig. 10. The mechanism of formation of this second type of crack also necessitates grain boundary sliding.¹²

Attention is also drawn to the grain structure of the sample shown in Fig. 10. The grain boundaries etch much faster than the annealing twins, which are not as readily visible as in previous figures. When visible, however, the twin boundaries appear straight indicating that relatively little transgranular deformation has taken place. Also there is no evidence of preferred orientation of the grains which is further indication that grain boundary sliding is the controlling deformation mechanism for slow strain rates at 1600° F.

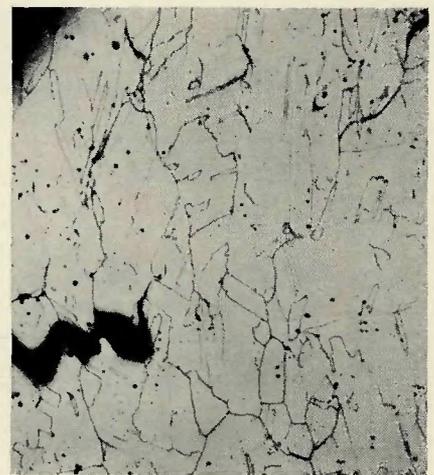
Fig. 11—Microstructure produced by heating to 1700° F and loading to failure at a rate of 16.0 ipm. $\times 100$ (reduced 35% on reproduction)

Figure 11 is a photomicrograph at X100 of the structure formed by heating to 1700° F and loading at a rate of 16.0 ipm. Attention is drawn to the similarity of this structure and

the structures shown in Figs. 8 and 9. All three microstructures show evidence of both grain boundary sliding and transgranular deformation. Careful examination of Fig. 11, however, indicates one difference: recrystallization has occurred at a few grain boundaries and at the crack tips.

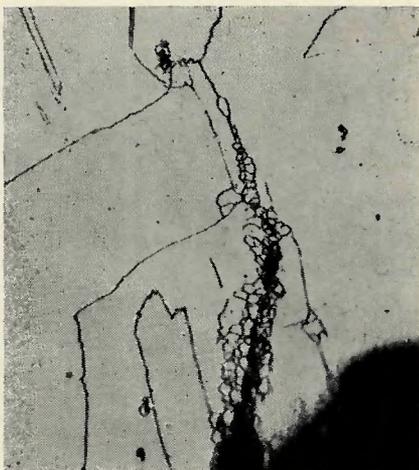
Fig. 12—Microstructure produced by heating to 1700° F and loading to failure at a rate of 16.0 ipm. $\times 500$ (reduced 35% on reproduction)

Careful examination of the sample tested at 0.16 ipm revealed secondary cracking associated with carbide particles as may be seen in Fig. 12. This cracking is associated with both intragranular and intergranular carbides, indicating that deformation did occur by a combination of the two modes discussed above.

Figure 12 is a photomicrograph at X500 showing the start of this recrystallization. Small equiaxed recrystallized grains formed along the prior grain boundary appear to have hindered further growth of the existing crack. The result is an increase in the ductility from 25% elongation at 1600° F to 32% at 1700° F.

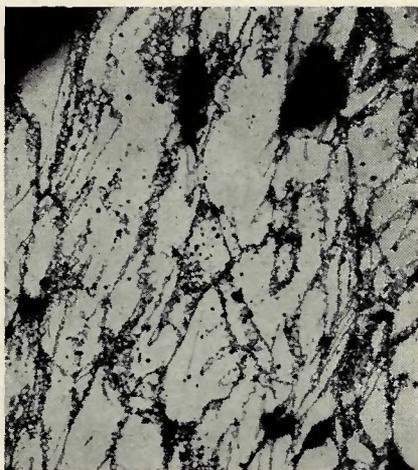
Fig. 13—Microstructure produced by heating to 1700° F and loading to failure at a rate of 0.16 ipm. $\times 100$ (reduced 35% on reproduction)

The structure formed by heating to 1700° F and loading at a rate of 0.16 ipm is shown in Fig. 13. This photomicrograph, taken at X100, shows that recrystallization has occurred in the regions extensively deformed by grain boundary sliding to a much greater extent than in the specimen tested at 16.0 ipm (Figs. 11 and 12). The new recrystallized grains appear to have hindered the propagation of the grain boundary cracks. Thus more plastic deformation is necessary to cause failure at 1700° F with a 0.16 ipm strain rate than with a 16.0 ipm rate. This increase in the total elongation to 53% elongates the grains and reorients the twins as may be seen in Fig. 13.

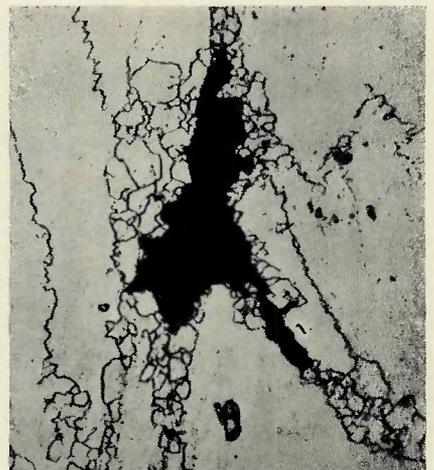
Fig. 14—Microstructure produced by heating to 1700° F and loading to failure at a rate of 0.16 ipm. $\times 500$ (reduced 35% on reproduction)

Figure 14 is a photomicrograph at X500 showing the "isolation" of cracks by regions of recrystallization. It is also of interest to note the tortuous appearance of the grain and twin boundaries in regions where no equiaxed recrystallized structure is present. This is attributed to strain induced migration of the boundaries through highly strained regions leaving behind a strain-free recrystallized structure.¹³

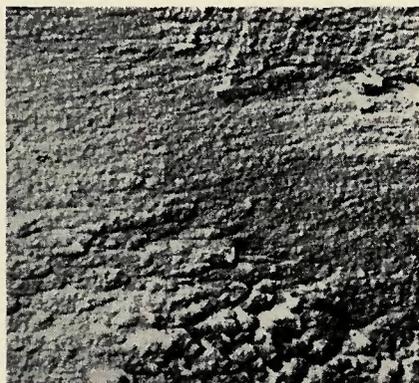
Fig. 15—Electron micrograph of the fracture surface of a specimen heated to 1600° F and loaded to failure at a rate of 16.0 ipm. $\times 4000$ (reduced 28% on reproduction)

Figure 15 is an electron micrograph at X4000 of a sample heated to 1600° F and loaded at a rate of 16.0 ipm. This factograph shows both a region of grain boundary sliding devoid of dimples and a region exhibiting a fine dimpled structure. This dimple size should be compared with that revealed in Fig. 16, which shows the fracture surface of a sample heated at 1275° F and loaded at the same strain rate of 16.0 ipm. Note that the size of the dimples is much coarser in Fig. 16 than in Fig. 15. Note also that many of the dimples shown in Fig. 16 are associated with carbides.

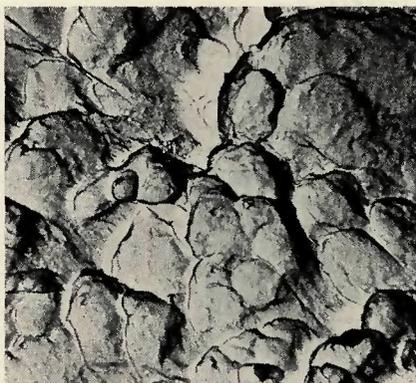
Fig. 16—Electron micrograph of the fracture surface of a specimen heated to 1275° F and loaded to failure at a rate of 16.0 ipm. $\times 4000$ (reduced 28% on reproduction)

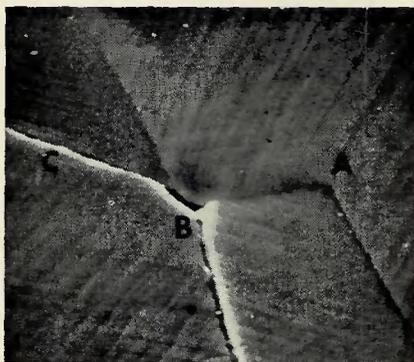
Fig. 18—Scanning electron micrograph of the surface of a prepolished sample heated to 1500° F and strained 0.100 in. at a rate of 40 ipm. $\times 1000$ (reduced 40% on reproduction)

Evidence for both of the deformation modes previously discussed can be found in Fig. 18. This figure is a scanning electron micrograph at X1000 of the surface of a prepolished sample heated to 1500° F and strained 0.100 in. at a rate of 40.0 ipm. The slip lines visible in each of the grains indicate that an appreciable amount of transgranular deformation occurred. More important, however, is the evidence of grain boundary sliding. The height differences revealed at points A and B indicate that grain boundary sliding must have occurred even at this rapid rate of loading. Further evidence of grain boundary sliding is provided by the presence of two types of intergranular cracking—a wedge crack at a triple point at B and other voids located along the grain boundary near C.
