SUPPLEMENT TO THE WELDING JOURNAL, MAY 1972

A High Speed Photographic Analysis of Spot Welding Galvanized Steel

BY
W. R. UPTHEGROVE
AND J. F. KEY

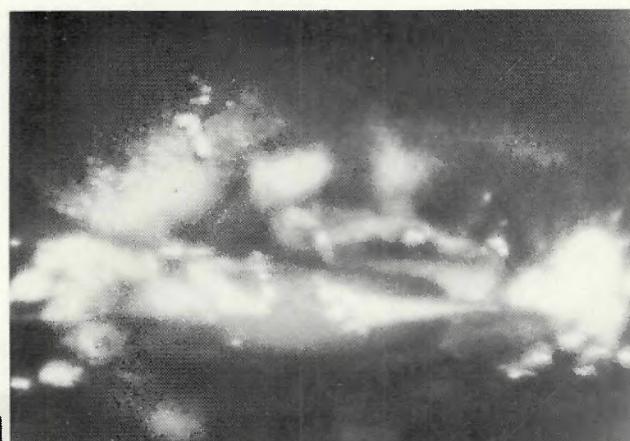
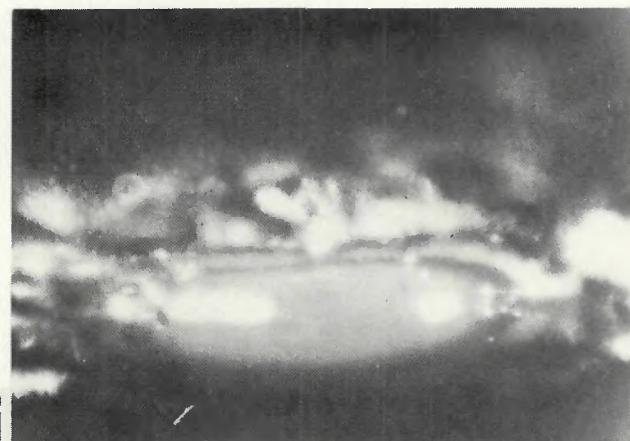
As soon as the nugget was plastic and fully developed, molten steel began to appear in the center and spread toward the edges as shown in Figs. 4g and 4h. Figure 4i shows a fully molten nugget. A rapid mixing of the molten steel was observed and ascribed to electromagnetic stirring. This phenomenon was previously recorded on film of projection welding by Cunningham and Begeman.⁹ However, no exact stirring patterns could be detected in the thin sheet parts. Rapid heat conduction by the water-cooled electrodes maintained a solid surface which prevented nugget collapse.

Fig. 4 (continued)—(g) plastic nugget begins to melt, (h) nugget partially molten, (i) completely molten nugget, (j) solidification begins, (k) solidification nearly complete, (l) solidification complete.

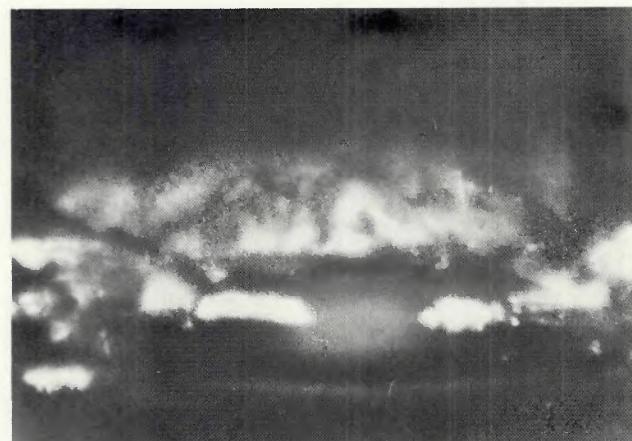
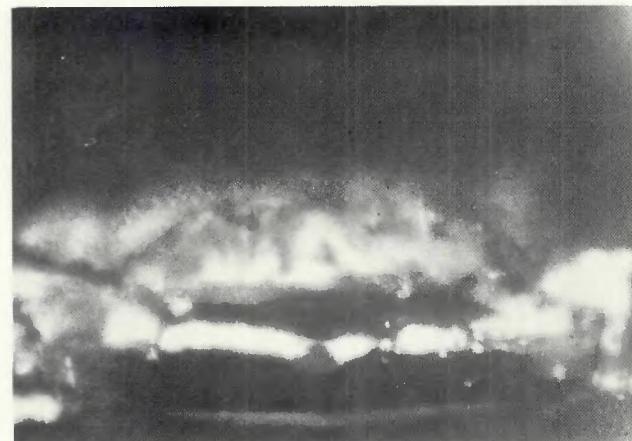
Termination of the weld current was indicated by the cessation of fluid motion in the nugget. As heat continued to be dissipated into the electrodes and surrounding material, solidification began at the boundaries of the nugget and progressed to the center (Figs. 4j to 4l).
