# A Metallurgical Approach to Cracked Solder Joints

*Observations made on the structure  
of failed joints lead  
to some useful conclusions but  
also indicate the need  
for more research*

BY D. T. NOVICK

D. T. NOVICK is Corporate Staff Metallurgist and Industrial Consultant, Alpha Metals, Inc. Paper presented at the AWS First International Soldering Conference held at the AWS Annual Meeting in Detroit, April 10-14, 1972.

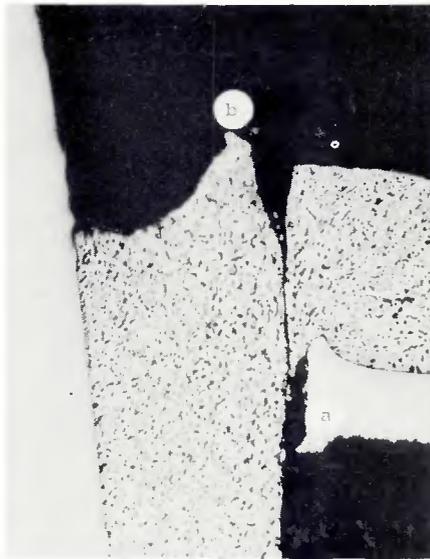
Figures 1 and 2 show examples of cracks appearing in Type I and Type III solder joints. The failure of Type I joint (Fig. 1) is a crack emanating from the edge of the copper conductor pad. No wetting has taken place at this interior surface. Likewise, the crack following the component lead in the Type III solder joint (Fig. 2) shows points along the lead devoid of solder. With no matching interfacial intermetallic compound in the solder to indicate fracture at the component-intermetallic face following wetting, it must be concluded that wetting had not taken place. Under the particular mechanical conditions applied to this joint, the voids created by the non-wetting conditions act as crack nuclei. It is evident that anything preventing good solderability of the surfaces to be joined is a potential contributor to cracked solder joints.

Fig. 1—Type I joint showing failure due to nonwetted surface. (a) Unwetted surface; (b) fatigue protrusion

Figures 1 and 3 are excellent examples of the results of thermal fatigue cycling. Here one sees the protrusions that typically result from the "back and forth" motion of the solder. Also, we can see the orientation of the crack with respect to this deformed region. Figure 3 shows, through heavy coarsening of the deformed region, how severe the deformation was.

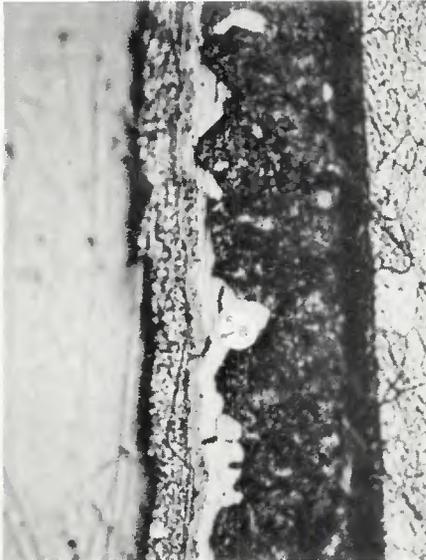
Figures 7 and 8 show the effects of impurity pickup. In Figure 7 solder has reacted extensively with most of the gold present as a protective layer over an iron-nickel alloy lead. The resultant impurity-induced secondary phase deposited at the interface is brittle, and, under stress, has shattered, leaving small fissures and voids which act as the microcracks for failure propagation. Had this material been completely dissolved into the molten solder, it might have resulted in a widely dispersed phase adding to joint strength by a precipitation hardening mechanism. This, too, if overaged, could shatter under stress and lead to ultimate creep or fatigue failure.

Fig. 7—Early stage intermetallic cracking at joint interface. (a) Crack region

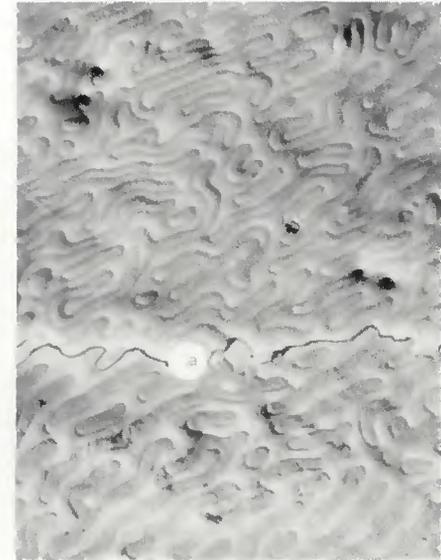
Fig. 9—Crack due to cooling effects. (a) Microcracked eutectic colony boundary

By thermal shock, one generally means sudden cooling or quenching of a solder joint during the soldering process. One must consider a solder joint as being a type of casting. If the molten solder is suddenly quenched, inadequate filling in the through hole occurs with shrinkage, leaving small internal fissures. Figure 9 is an example of a type of crack caused by the opposite effect. Too slow cooling has produced solidification shrinkage cracks, and a long grain boundary microcrack results. Wild<sup>27</sup> reports finding cracks induced in this manner.
