Precipitation in EB Welded Beryllium Ingot Sheet

Study reveals association of aluminum — rich precipitates with intergranular cracks and reports solute banding in the particular material investigated

BY F. J. FRAIKOR, G. K. HICKEN AND V. K. GROTSKY

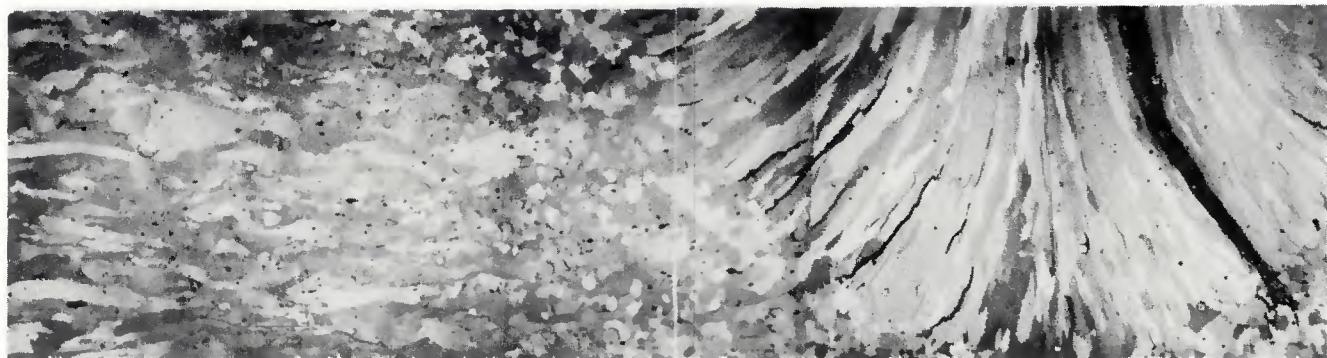
Fig. 2 — Optical photomicrograph showing various weld zones across transverse cross-section of an electron beam welded beryllium sheet specimen. (Polarized light)

Although polarized light illuminations successfully revealed the transition between the various weld zones (Fig. 2), bright field illumination of electrolytically polished and etched specimens was necessary to clearly resolve the substructure in some portions of the weld. Details of the technique can be found in Reference 14.

Optical and electron metallography revealed a clear structural transition in some specimens between the various weld zones as illustrated in the low magnification photograph of Fig. 2. Beginning with the unaffected zone at the edge of the Be sheet, the specimen exhibited the expected correlation between the temperature gradient and the microstructure.

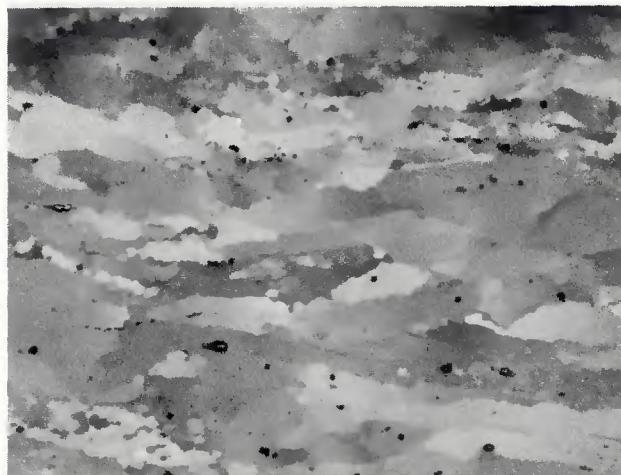
Fig. 3 — Optical photomicrograph of the unaffected zone. Note the elongated microstructure of the as-rolled beryllium ingot sheet. (Polarized light, X100, reduced 28%)

The as-rolled condition of the unaffected portions of the weld samples consisted of a warm-worked substructure of dislocation cell walls and sub-boundaries (Figs. 3, 4, and 5). Such a microstructure is the result of rolling the beryllium sheet slightly below the recrystallization temperature so that little or no recrystallization occurs during and after the final rolling pass. The subgrains are 1 to 10 microns in diam, although the size varies depending on the thermal and rolling history of each particular billet.

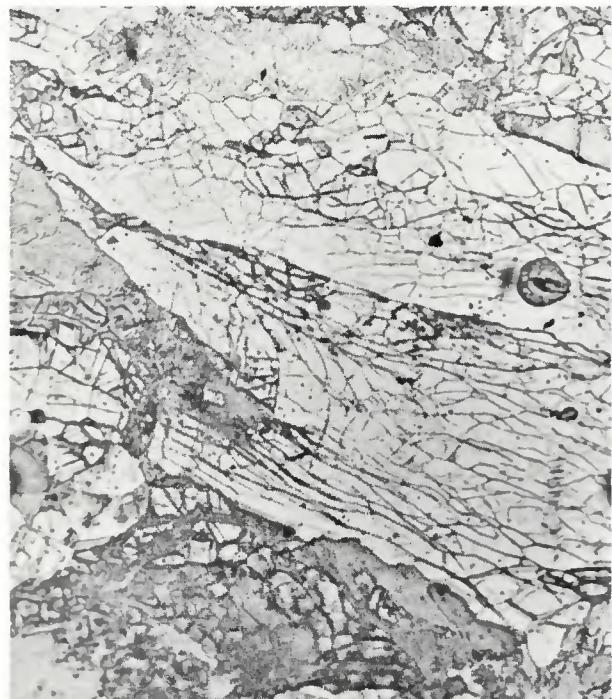
Fig. 4 — Optical photomicrograph of the unaffected zone showing the sub boundaries of the as-rolled microstructures. (Bright field, X500, reduced 28%)

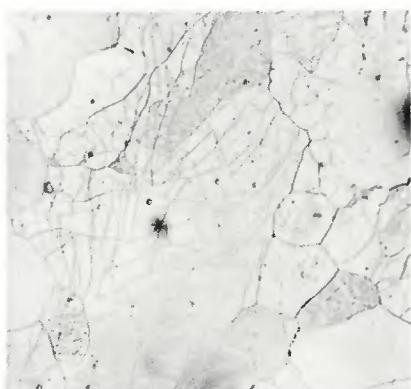
Fig. 6 — Partly recrystallized zone. Note the equiaxed recrystallized grains among the substructure of the as-rolled beryllium ingot sheet. (Bright field, X400, reduced 43%)

Figures 6 and 7 show the microstructure of the partly recrystallized area of the weld specimen. Figure 6 is an optical photomicrograph taken under bright field illumination and the etch clearly shows some new equiaxed grains among the as-rolled substructure. The transmission electron photomicrograph in Fig. 7 further reveals that recovery by the process of polygonization has taken place in the

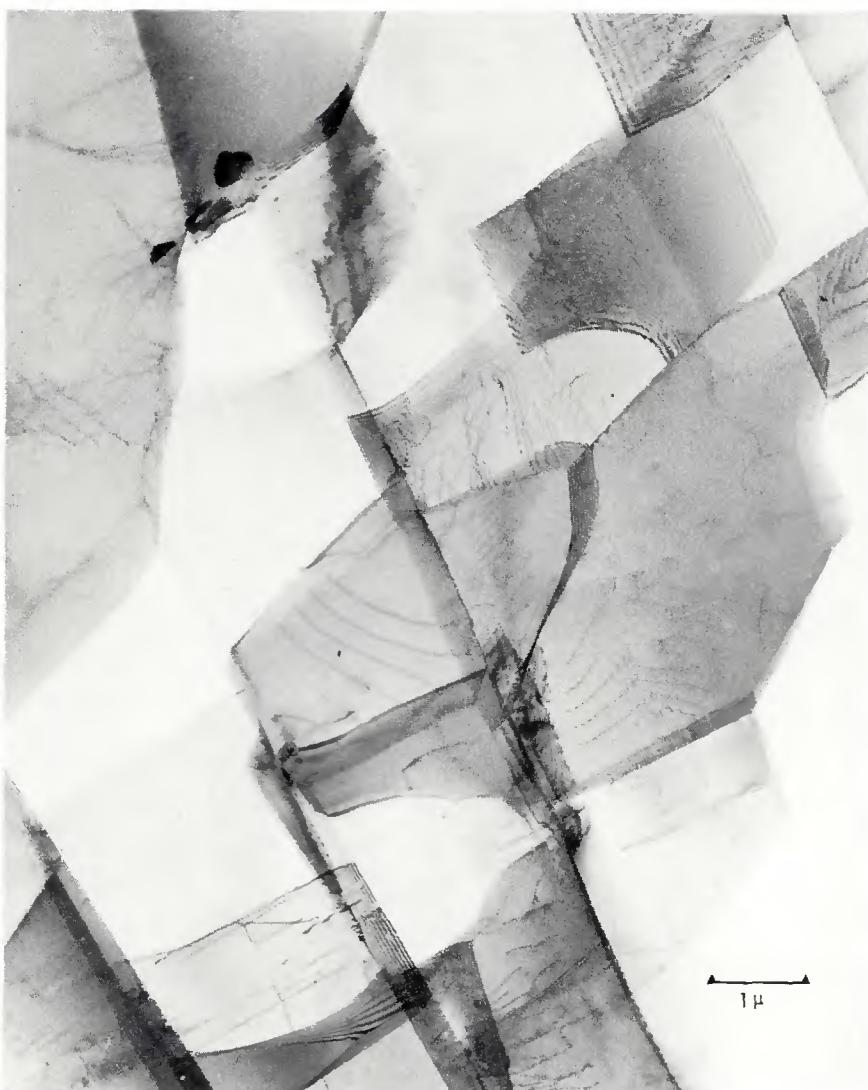
Fig. 7 — Shows dislocation arrays and well defined sub-boundaries as a result of polygonization at the outer edge of the heat-affected zone

remaining as-rolled substructure. That is, sufficient thermal energy was provided at this weld perimeter to allow the dislocations to migrate into narrower cell walls and to assume more metastable equilibrium con-

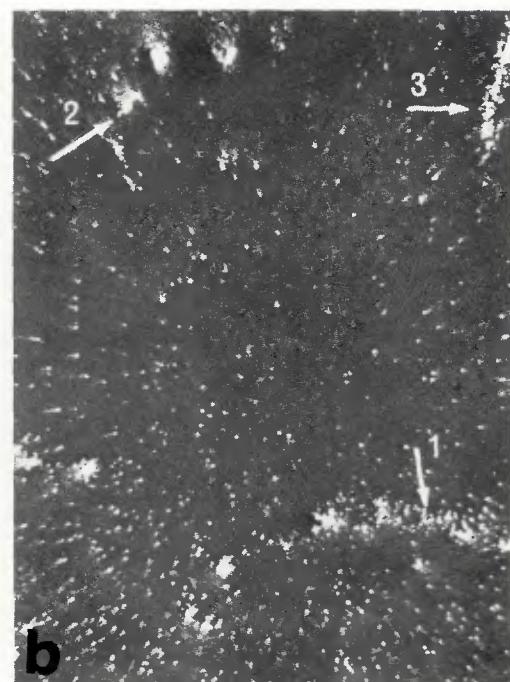
Fig. 11 — Optical photomicrograph of recrystallized area (a) showing three intergranular cracks (marked 1, 2 and 3); (b) Raster scan (aluminum- $K\alpha$ radiation) of the intergranular crack area

The results reveal an association of aluminum-rich areas with the intergranular cracks. For example, Fig. 11 (a) shows three small cracks along the grain boundaries in the fully recrystallized portion of the heat-affected zone. These particular cracks were chosen for examination because they did not extend into the fusion zone and, therefore, clearly originated in the heat-affected zone of the electron beam weld. A raster scan of aluminum-K α radiation was then performed on this area. Although the data were qualitative, Fig. 11 (b) shows that aluminum is present along the crack areas.

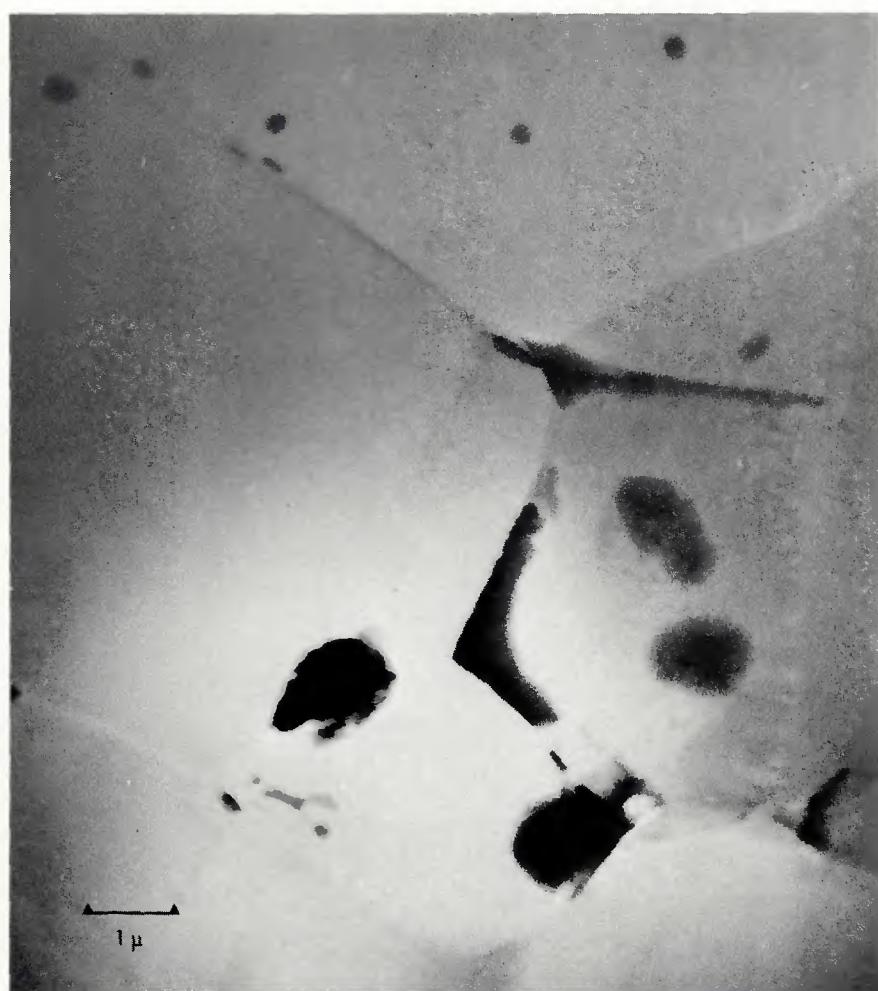
Fig. 12 — Extensive aluminum-rich precipitation along grain boundaries in the vicinity of intergranular cracks in the heat-affected zone

Furthermore, transmission electron microscopy in the vicinity of microcracks revealed extensive grain boundary precipitation as illustrated in Fig. 12. This observation confirms the association of intergranular cracks in beryllium welds with grain boundary segregation noted by Hauser and Monroe⁴ by replica techniques. Diffraction patterns from these large precipitates were generally complex, but in some instances the particles could be analyzed as of the AlMBe₄ type. On the basis of previous studies^{11,12,13} of quenching Rocky Flats Be ingot sheet from above 900 C, aluminum-rich, grain boundary precipitates can be expected with moderately rapid cooling rates. Whereas, slower cooling rates permit transition element diffu-

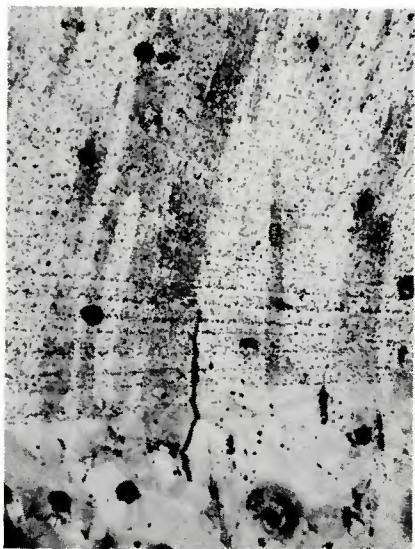
Fig. 13 — Solidification bands across the columnar grains near the edge of the fusion zone. Note the absence of banding in the heat-affected zone at right. (Bright field, X150, reduced 32%)

An interesting feature of the fusion zone of the electron beam welds in the ingot sheet was the appearance, after proper electro-polishing, of transverse solute bands. These were more pronounced near the edge of the fusion zone and were approximately normal to the direction of solidification (Fig. 13, optical photomicrograph). D'Annensa¹⁶ has attributed this phenomenon to cyclic variations in growth rate, resulting from thermal fluctuations in the weld pool. Therefore, it was particularly interesting to directly observe the fusion zone microstructure by transmission electron microscopy in an effort to identify the origin of these

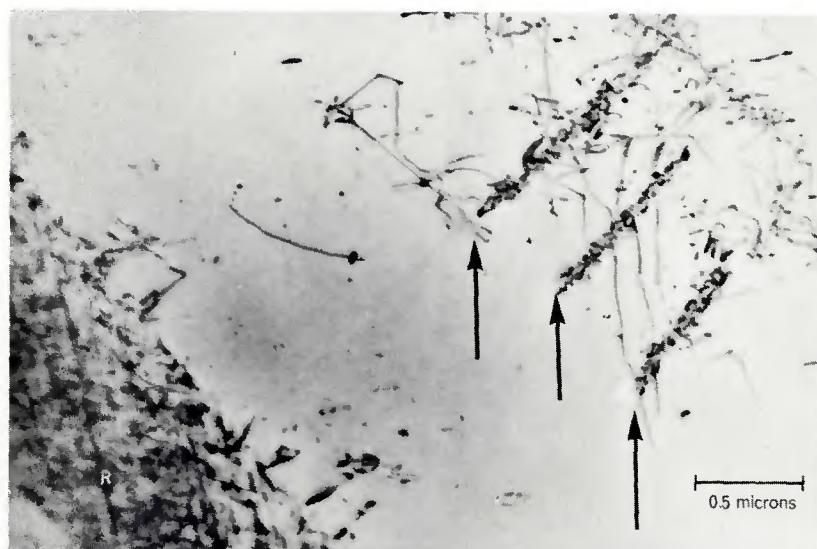
Fig. 14 — Row of platelet shaped precipitates (arrows) inter-connected by dislocation tangles. Another parallel row is noted in region R

The photomicrographs of the fusion zone revealed that these solidification bands consisted of rows of both irregular-shaped and platelet precipitates interconnected by dislocation sub-boundaries (Figs. 14, 15 and 16). The platelet precipitates shown in Figs. 14 and 15 reached a length of 2 microns in some instances and were subsequently identified by electron diffraction as the binary compound FeBe_{11} . Thus, in areas where there was insufficient aluminum to form the ternary AlFeBe_4 , precipitation continued in the form of the binary, MBe_{11} . Both the rows of precipitates and the interconnecting dislocation tangles preferentially etched during electropolishing to produce the solute bands. In the center of the weld, the transverse solute banding was not as pronounced, and Fig. 16 reveals that complex precipitation occurred throughout the microstructure.
