The Nature and Morphology of Fissures in Austenitic Stainless Steel Weld Metals

Fissures occur primarily along grain boundaries in the HAZ from the previous weld deposit, and fissuring is enhanced by multiple thermal cycling in the HAZ and is more likely to occur in ferrite-free areas.

BY C. D. LUNDIN AND D. F. SPOND

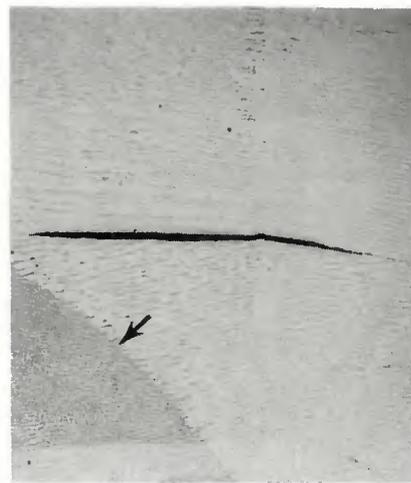
Fig. 1 — Light micrograph of a fissure along a grain boundary near an interpass boundary (see arrow) in a polished and etched sample of Type 316L austenitic stainless steel weld metal (0.5 FN), un-bent, transverse section. X100 (reduced 30% on reproduction)

All fissures examined in this investigation, regardless of weld metal type, were located along weld metal grain boundaries in the HAZ of a subsequently deposited bead. For example, Fig. 1, a light micrograph showing a fissure in a polished and etched, transverse, unbent section of a Type 316L stainless steel weld pad (0.5 FN), illustrates that the fissure occurs entirely within the weld metal and is located along a grain boundary. In addition, it is to be noted that the fissure is proximate to an interpass boundary (see arrow) and is in the HAZ of the succeeding weld bead.

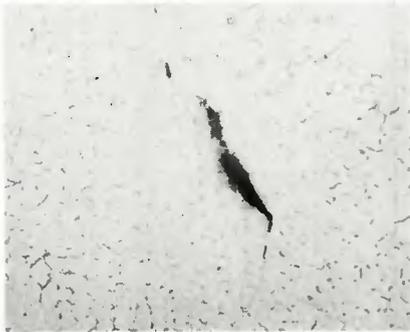
Fig. 3 — Light micrograph of a fissure in a ferrite-free area of Type 316 stainless steel weld metal (avg. 2.5 FN), bent, longitudinal, top view section. X250

The result of ferrite variation within the microstructure is clearly illustrated by a consideration of data presented in a previous article (Ref. 25) and the micrographs shown in Figures 3 and 4. Figure 3 is a light micrograph showing a fissure in a polished and etched metallographic specimen taken from a bent 316 weld pad (average 2.5 FN). This particular weld pad exhibited two penetrant indications which was considered unusual since the average ferrite level was higher than that determined to be necessary to prevent fissuring in 316 weld metal. One of the indications was identified as a small area of lack of fusion between two weld beads

which was not removed during pad surface preparation. The second indication proved to be the fissure shown in Figure 3. The ferrite in this figure is the dark constituent appearing predominantly along the cellular boundaries on the left and right sides of the micrograph. It is to be noted that the ferrite content in the immediate vicinity of the fissure is significantly lower than that in the surrounding areas.

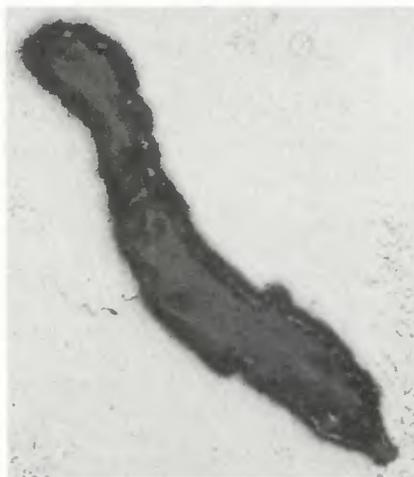
Fig. 4 — Light micrograph of a fissure in a ferrite-free area in a polished and etched sample of Type 308L stainless steel weld metal (4.0 FN), bent, longitudinal, top view section. X150

The occurrence of fissures in ferrite-free areas was also observed in 308L weld metal. It had been previously determined that a ferrite level of approximately 3 FN in 308L weld metal is sufficient to prevent fissuring. However, in one bent weld specimen of 308L with a ferrite level of approximately 4 FN, six closely grouped fissures were found. These fissures were approximately 0.010 to 0.020 in. in length and were all located within 0.20 in. of each other near an interpass boundary. The ferrite level of this general area was recorded to be 4.0 FN when measured with a Magne Gage. Metallographic evaluation of a polished and etched sample taken to include these six fissures revealed that they were located in an essentially ferrite-free area. One of these six fissures discussed above is shown in the light micrograph in Figure 4. From this figure it is clear that the fissure is in an area devoid of ferrite, but high concentrations of ferrite exist in close proximity to the fissure.

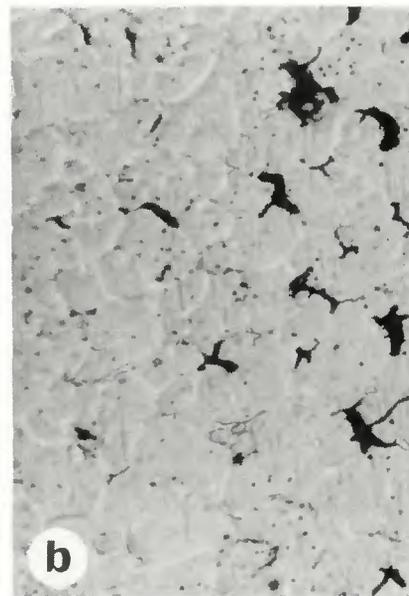
Fig. 5 — Light micrograph of grinding tears in a polished and etched sample of Type 308L stainless steel weld metal (2.5 FN), bent, longitudinal, top view section. (a) — X250; (b) — X500

One type of indication is illustrated in Figs. 5a and 5b, which are light micrographs of the surface of a polished and etched, bent sample of 308L weld metal (2.5 FN). These figures show, at 250X and 500X respectively, tears along cellular intersections where austenite and ferrite exist. The tears were caused by surface grinding during weld pad

preparation and they were detectable by fluorescent penetrant testing. Tears such as these occurred in areas of high ferrite content and they did not appear in areas almost wholly austenitic. The observation of these grinding tears in high ferrite areas is in contrast to the occurrence of fissures which generally appear in ferrite-free areas.
