# Friction Welding Alloy 800

*A high quality solid-state weld results when joining pins to the outer wall of tubing for a high-temperature gas-cooled reactor*

BY K. H. HOLKO

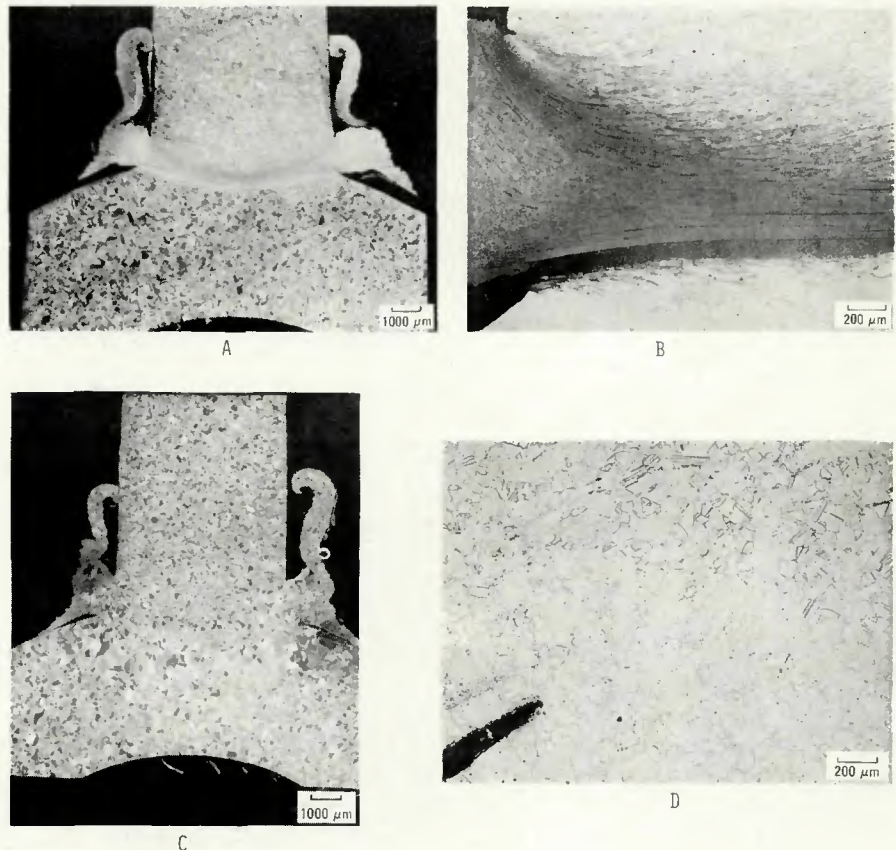
Fig. 4—Metallographic sections through friction welds in Alloy 800; etchant—oxalic acid, electrolytic; A,B—as-welded condition; C,D—postweld heat treated

tures and microstructures are shown for the 0.218 in. (0.55 cm) pin size in Fig. 4. Structures were similar for the other two pin sizes.

The as-welded structure (Fig. 4A,B) is highly worked and has a very fine grain size. There appear to be numerous elongated grain boundaries perpendicular to the tube axis within this

worked material. It is difficult to resolve the grain size with light microscopy.

Postweld heat treatment is effective in causing recrystallization and grain growth of the worked material, as shown in Fig. 4C,D. A slight difference in contrast from etching between the pin and tube materials locates the original weld interface. Significant grain growth has occurred across this interface. An ASTM grain size of 5 to 6 was measured in the vicinity of the weld line, indicating that the pin and tube grain size had been restored.

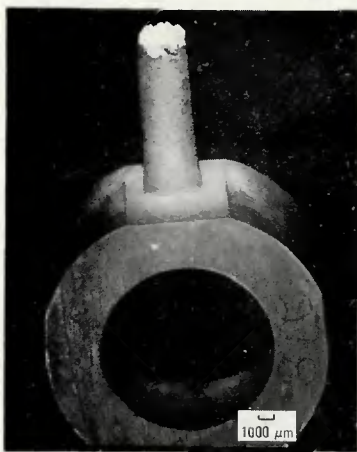
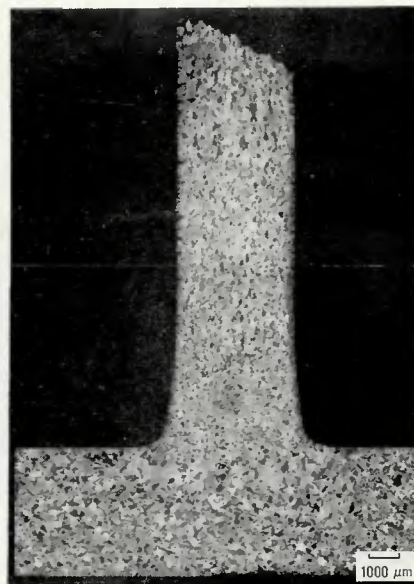
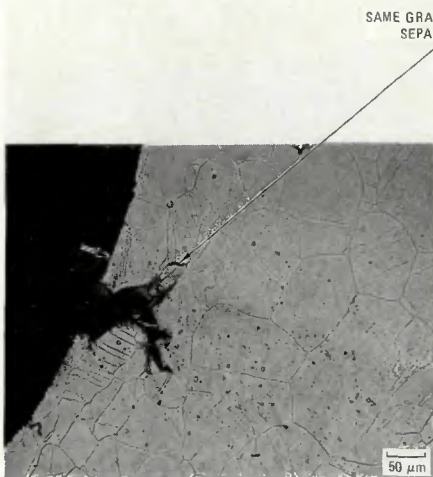
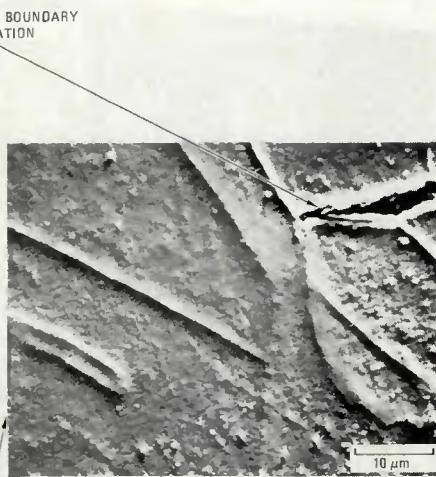
Fig. 5—Creep-rupture fracture in as-welded friction weld, No. 218-3; etchant—oxalic acid, electrolytic: A—planar view; B—macrosection; C—microsection; D—SEM section

Figure 5 illustrates a typical as-welded creep-rupture failure. Fracture has occurred at aligned grain boundaries as would be expected from the combination of elevated temperature and low strain rate.<sup>2</sup> The scanning electron microscope (SEM) photographs taken at the fracture surface show grain boundary separation around the small grains. The small grain size is probably responsible for the poor creep-rupture life in the as-welded condition.
