Some Effects of Yttrium on Ti-5522S Alloy Welds

Losses in toughness are apparently caused by a bead-like grain boundary phase that consists of pores and is not correspondent with any chemical segregation

BY J. W. CHASTEEN AND M. H. HOROWITZ

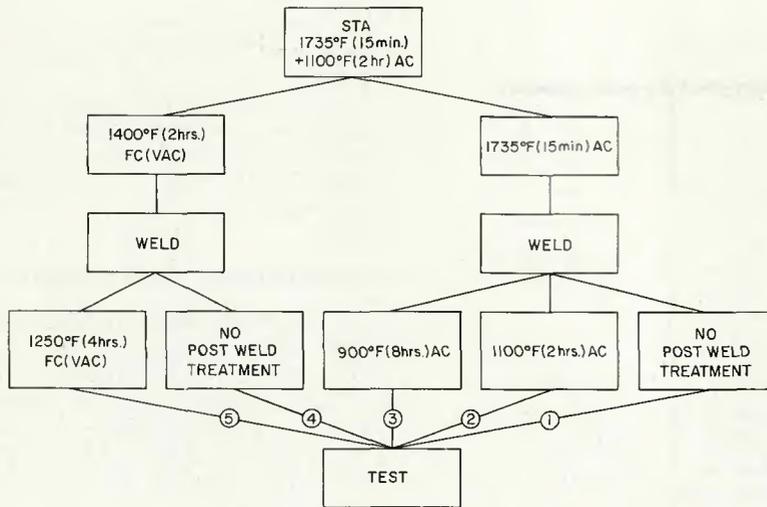
Fig. 1—The five metallurgical histories of this study

The five histories are most readily seen by reference to Fig. 1. Metallurgical histories 1, 2, and 3 were chosen in order to parallel the data reported by Hall, *et al.*¹ Histories 4 and 5 were chosen to parallel the data reported by Day.⁹

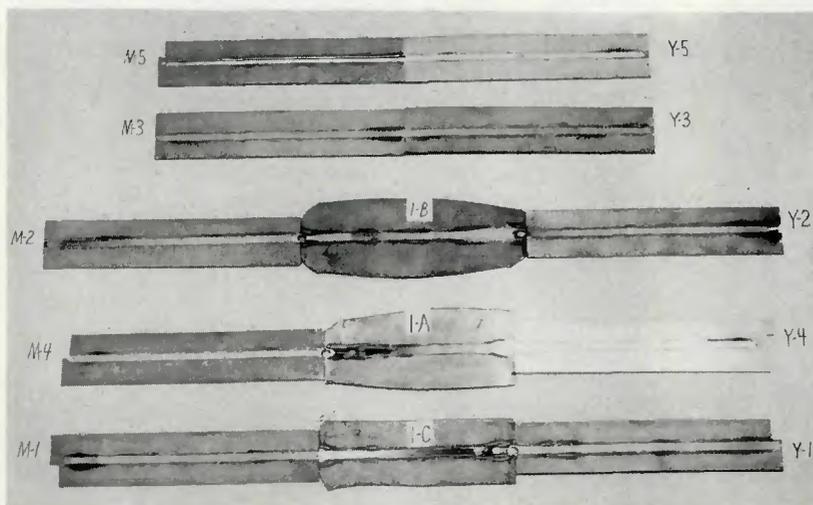
Fig. 2—BOP welded Ti alloy sheets: A (left)—face side; B (above)—root side

In order to minimize end losses and thus conserve the non-yttriated Ti-5522S, these materials were welded by sandwiching each sheet between two sheets of yttriated material. Figure 2 shows both the face side and the root side which serves to exemplify the

meaning of the term bare penetration.

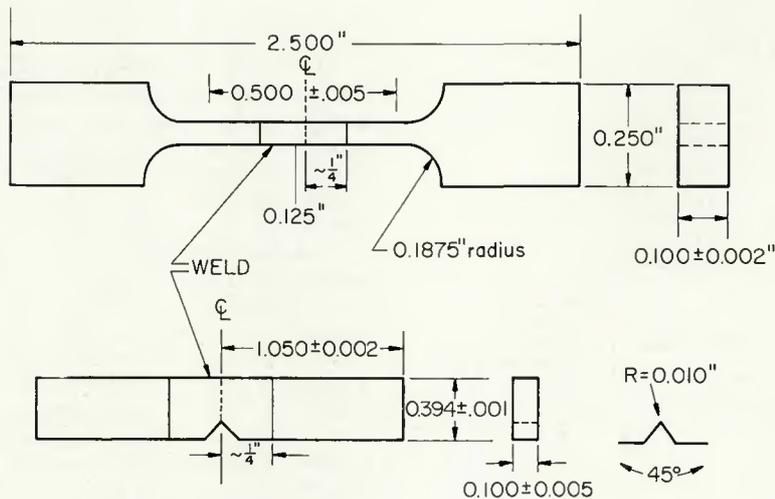
Fig. 3—Machine drawing of the tensile specimen and the Charpy V-notch specimen

When the metallurgical histories indicated in Fig. 1 were complete, metallographic specimens were prepared by use of 1 μ diamond paste with a 0.05 μ alumina final polish. Etching, where employed, was accomplished with Kroll's reagent. Charpy V-notch and tensile specimens (Fig. 3) were prepared and tested to ascertain fracture toughness and ultimate tensile strengths of the weldments.

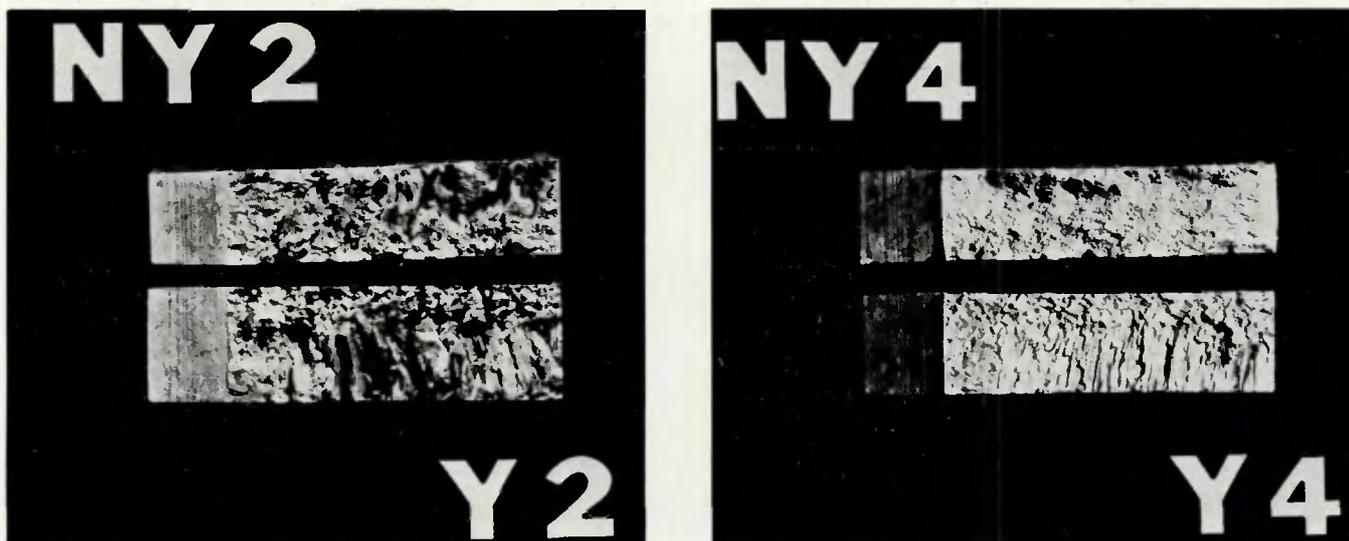
Fig. 4—Charpy specimen fracture surfaces which show gradations in intergranular failure

The manner of failure is best shown by low magnification photographs of the fracture surfaces. Figure 4 includes such photographs of the slow bend Charpy specimens; it includes samples from histories 2 and 4 for both yttriated and non-yttriated Ti-5522S weldment fractures.

Comparison of Fig. 4 with the data of Table 1 reveals that low toughness values are associated with large prior beta grains and intergranular failure. The relatively high toughness of the non-yttriated Ti-5522S with no postweld heat treatment is marked by transgranular failure. From this observation, it appears that postweld heat treating of non-yttriated Ti-5522S causes degradation of the prior beta grain boundaries. It also appears that, when yttrium is added to the subject alloy, such grain boundary degradation is inescapable.

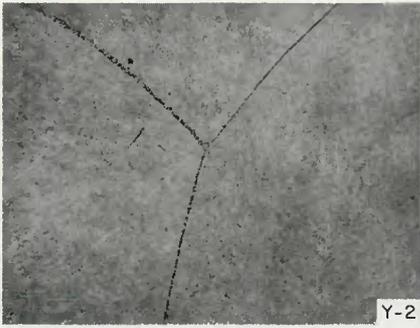
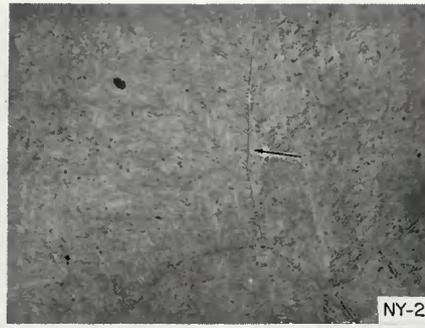
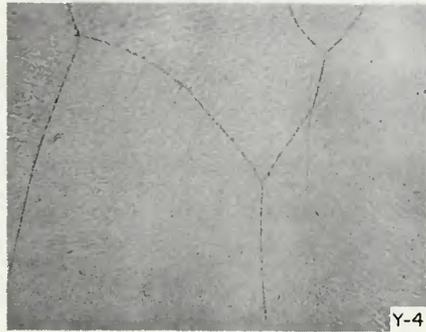
Fig. 5—Pertinent microstructures of Yttriated and Non-Yttriated Ti-5522S alloy. Kroll's etchant; $\times 200$ (reduced 49% on reproduction)

Figure 5 is a set of photomicrographs of the yttriated and non-yttriated Ti-5522S from histories 2 and 4. From these and the data of Table 1, it may be concluded that low toughness and intergranular failure in the yttriated material is provoked by a grain boundary phase which appears as a string of beads; each bead is about 0.1μ in diameter.

The low toughness and partial intergranular failure in the non-yttriated material is apparently caused by a continuous grain boundary phase

which appears upon postweld heat treatment. When the Ti-5522S is not yttriated and no postweld heat treatment is performed, the grain boundary phase does not appear and the resulting weld is more crack propagation resistant.

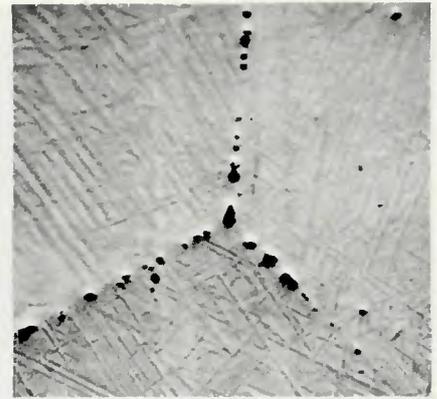
Fig. 6—Grain boundary intersection in Yttriated Ti-5522S alloy. Kroll's etchant; $\times 2000$ (reduced 37% on reproduction)

Figure 6 is an electron-photomicrograph of a grain boundary intersection in yttriated Ti-5522S from history 2. The specimen had been etched with Kroll's reagent and, at this magnification, the grain boundary particles appear to be pores. Electron probes of these particles (pores) did not reveal any chemical segregation. This observation conflicts with scientific expectation as well as past observations.⁵

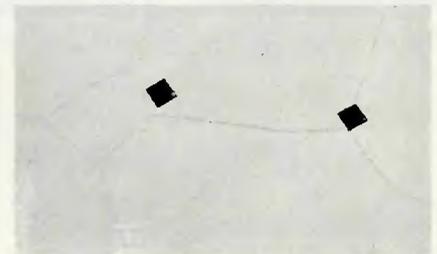
Fig. 7—Electron photomicrograph showing heavily decorated grain boundary with two microhardness indentation markers

Figures 7-9 contain representative results of the above described efforts. The element distributions shown were determined by conventional energy dispersive/wave length dispersive techniques. The etched photomicrograph of a heavily decorated grain boundary and its microhardness indentation markers may be seen in Fig. 7. The results of the energy dispersive X-ray analyses may be seen in Fig. 8. The lower right photographs in Fig. 8 are back-scattered electron images of the field of analysis; these serve to show the smoothness of the polished surface and the position of one of the micro-indentations. The other indentation would appear in the upper left, if the field of analysis were bigger. Thus, the grain boundary of interest proceeds from the lower right to the upper left in the field of view. It should be noted that the grain boundary does not appear to be associated with any chemical segregation.

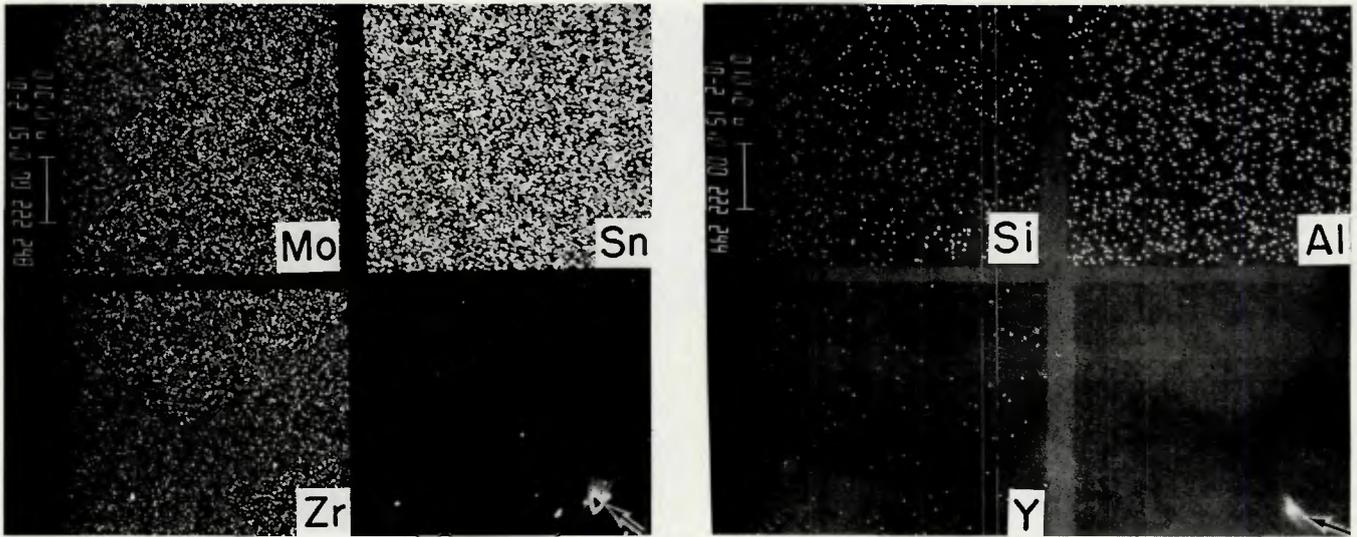
Fig. 8—Energy dispersive X-ray scans for ascertaining chemical segregation in Yttriated Ti-5522S alloy (also see Fig. 7)

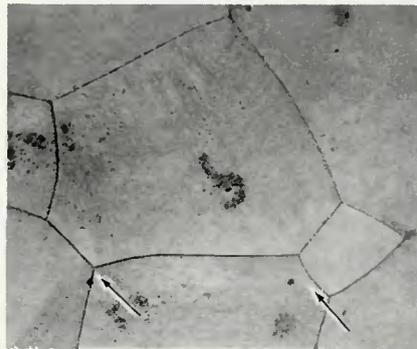
Fig. 9—Re-etched specimen (compare with Figs. 7 and 8)

Figure 9 is a view of the reetched specimen and shows that whatever phenomenon is causing the appearance of the beads upon etching must have been there during the chemical analysis. Yet, it did not show as chemical segregation.

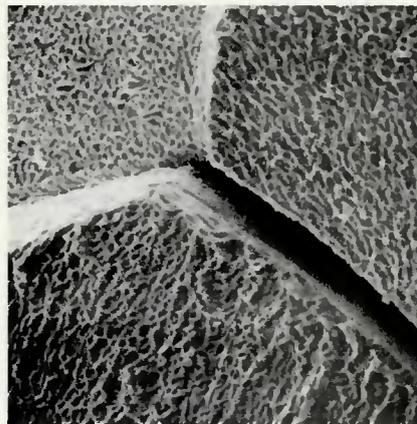
Fig. 10—Weldment tensile fracture surface in Yttriated Ti-5522S alloy; $\times 2000$ (reduced 38% on reproduction)

On the basis of the evidence presented here, the bead-like boundary phase appears to be either a hole which is covered with disturbed metal in the as-polished state, or it is a high local strain energy site which etches preferentially. This conclusion is supported by Fig. 10.

Figure 10 is a high magnification electron photomicrograph of a yttriated Ti-5522S weld fracture surface. With reference to the dimpled surfaces in this photomicrograph, it is unlikely that the pits were ever filled with solid precipitate because, if so, at least a few of the particles would have remained imbedded in the fracture surface. One is then led to believe that most of the fracture surface dimples are, in fact, fractured pores.
