# Behavior of Brazed Nickel Alloy Under Cyclic and Thermal Load

*Filler metal microstructure and brazing faults are shown to influence the fatigue properties of high temperature brazed Nimonic 80A*

BY U. DRAUGELATES AND K.-H. HARTMANN

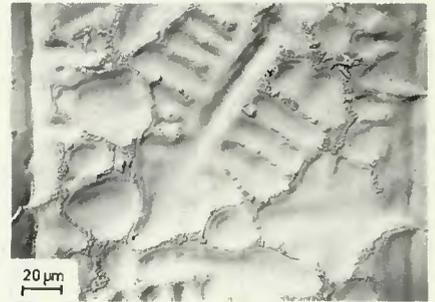
Fig. 3—Micrograph of a brazed seam

The results of fatigue tests at RT happened to be poor compared to those for the base metal. Scattering of the number of cycles to failure was to a large extent at the tested stress levels—Fig. 2. As a result of thorough examination it was proved that the major reason for both low fatigue strength and wide scattering was the brittleness of certain microscopic areas in the brazed seam—Fig. 3.

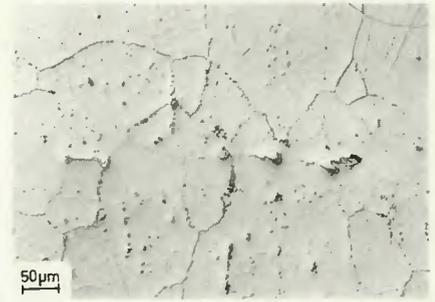
Fig. 4—Microstructure of brazed joint post-braze heat treated

and silicon have been identified. The microhardness of these phases depends on the chromium content and ranges up to 1350HV0,005. The brittle phases hang together in an aged solid-solution matrix, building a continuous crack path. It has been proved then that added heat-treatment after brazing, as shown in Fig. 1, causes solution and coagulation of the brittle phases and provides increased toughness of the seam,<sup>1,2</sup> which after this treatment looks like a diffusion welded zone—Fig. 4.
