A Simple Test for Dissimilar-Metal Welds

Using a simple fixture, it is possible to quickly develop cracks similar to those found in steam tube welds after long-time elevated temperature service

BY R. L. KLUEH, J. F. KING AND J. L. GRIFFITH

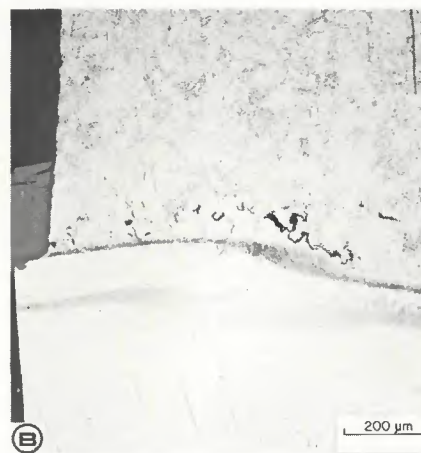
Fig. 7—Cracks formed in specimen tested at 138 MPA at 593°C (1099°F) for 2300 h and 64 cycles. Before test, specimen was tempered 10 h at 732°C (1350°F). A—unetched; B—etched in 2% nital

After the first test exposure (~2300 h at 593°C, i.e., 1099°F, and 64 cycles), cracks were observed metallographically on all specimens. Upon further exposure, the extent of cracking (depth and width of cracks) increased, but there was no noticeable change in the general characteristics of the cracks. Examples of the observed cracks are shown in the micrographs of Figs. 5 to 8.

Most of the penetrations had the appearance of a single continuous crack proceeding in from the specimen surface—Figs. 5–7. However, several penetrations took more tortuous routes in from the surface—Fig. 8. These penetrations were found to follow 2¼ Cr-1 Mo steel grain boundaries, but at a somewhat greater distance from the fusion line than did the penetrations having a single-crack appearance.

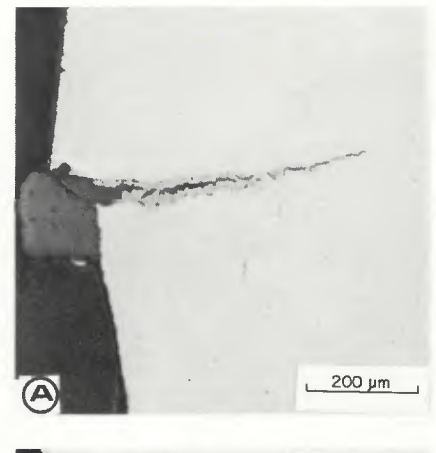
Fig. 8—Cracks formed in specimen tested at 207 MPa (30 ksi) at 593°C (1099°F) for 5000 h and 123 cycles. The specimen was not tempered prior to test. A—unetched; B—etched in 2% nital

There is also an indication that tortuous cracks proceed along $2\frac{1}{4}$ Cr-1 Mo steel grain boundaries further back from the fusion line. These cracks were generally observed within regions that appeared to be highly decarburized. This was true for both types of penetrations—Figs. 8 and 10. From the qualitative comparisons made in the present tests, all indications are that the cracks observed in specimens tested using the new test apparatus are similar to those that occur in an operating fossil-fired boiler.
