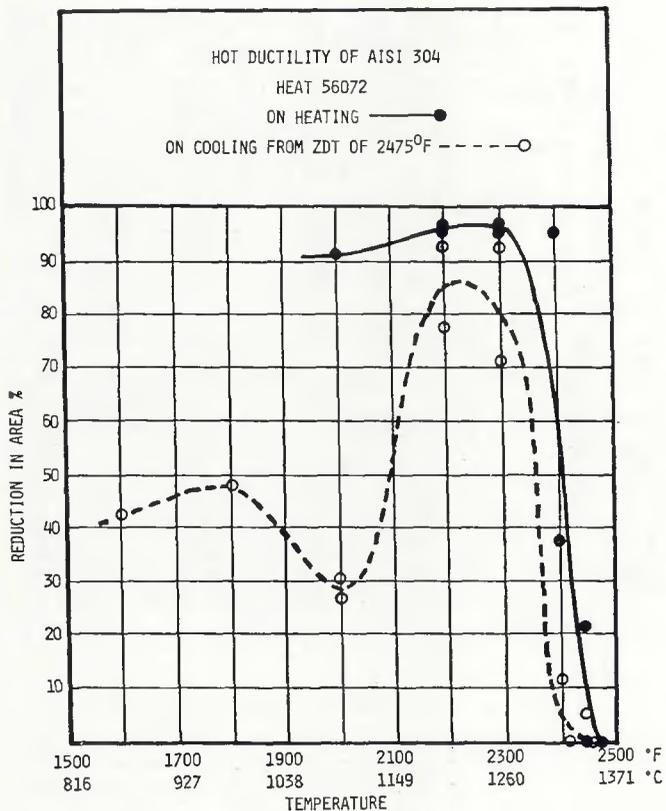
Fig. 4—Hot ductility test results for 56072 (304)

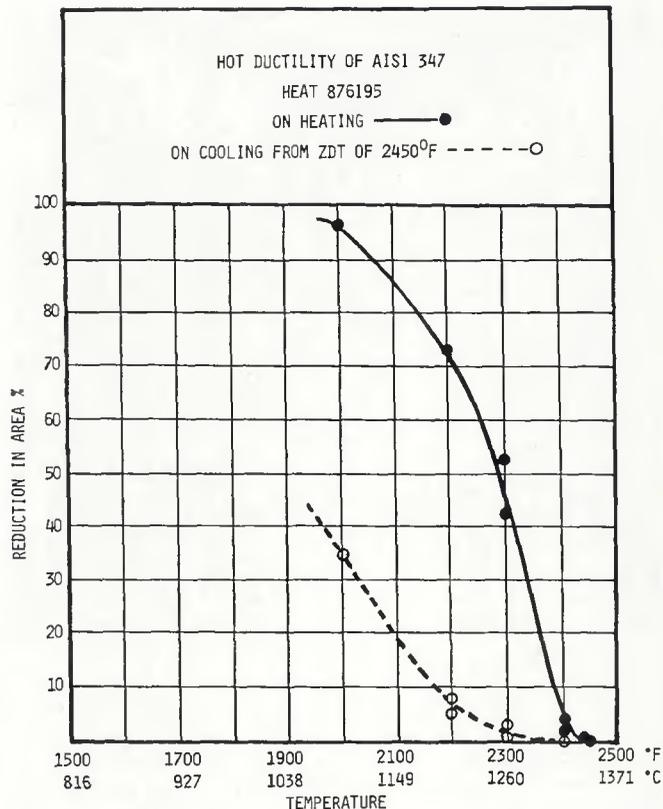
Fig. 5—Hot ductility test results for 876195 (AISI 347)

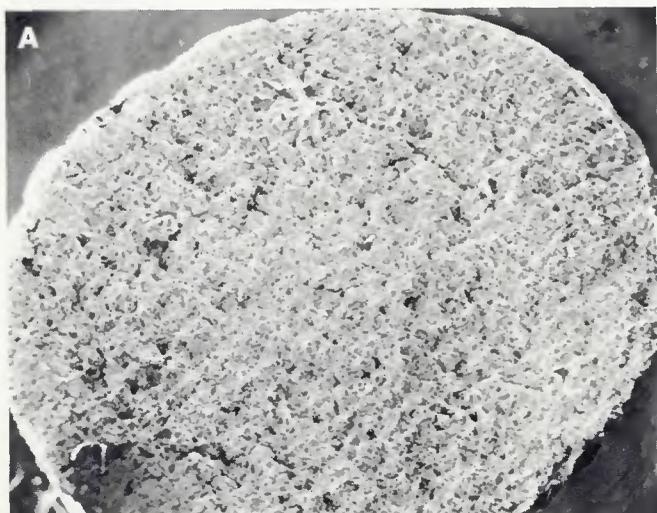
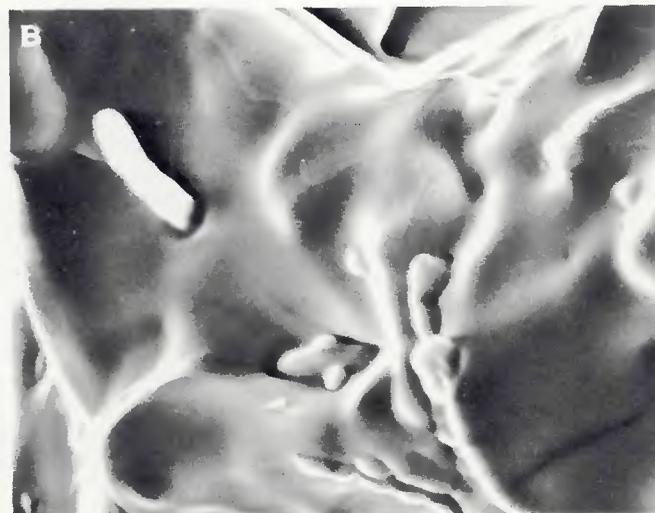
Fig. 6—Typical fracture surface in heat 0A1090 (303) tested on-heating to a ZDT of 2500°F. SEM. A—20X; B—5000X

A typical fracture surface from AISI 303 (Heat 0A1090) tested on-heating at the ZDT of 2500°F (1371°C) is shown in Fig. 6A at 20X. The higher magnification fractograph in Fig. 6B shows evidence of a

liquid film which existed at the instant of fracture. However, the microfracture mode is difficult to discern due to the extensive prior liquid film on the fracture surface. The intergranular nature of the fracture is clearly seen in the longitudinal section of the hot ductility sample shown optically at 300X in Fig. 7A. Secondary cracking in regions near to the fracture surface can also be seen. In Fig. 7B, evidence of grain boundary liquation that occurred during the thermal cycle and the subsequent propagation of cracks

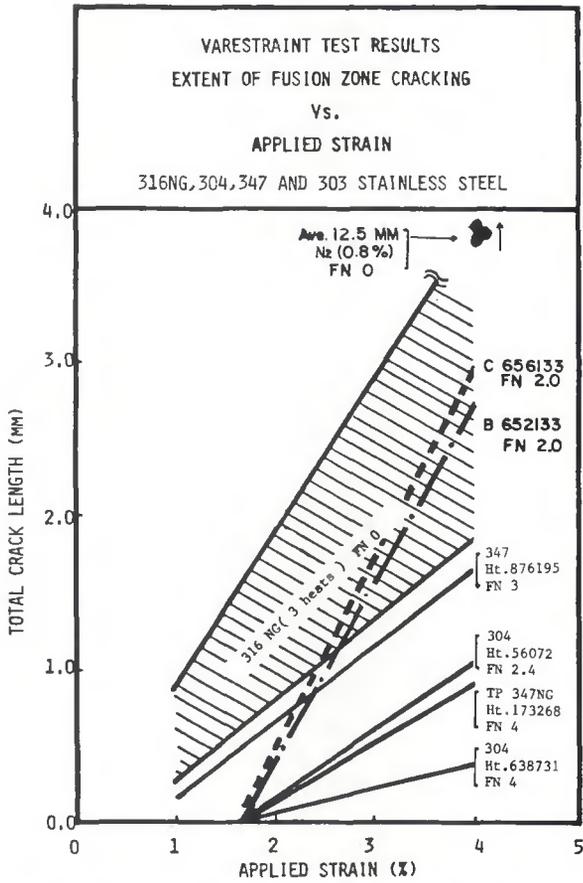
Fig. 8—Extent of fusion zone cracking vs. applied strain in 303 (B652133 and C656133), 304, 347 and 316NG steels

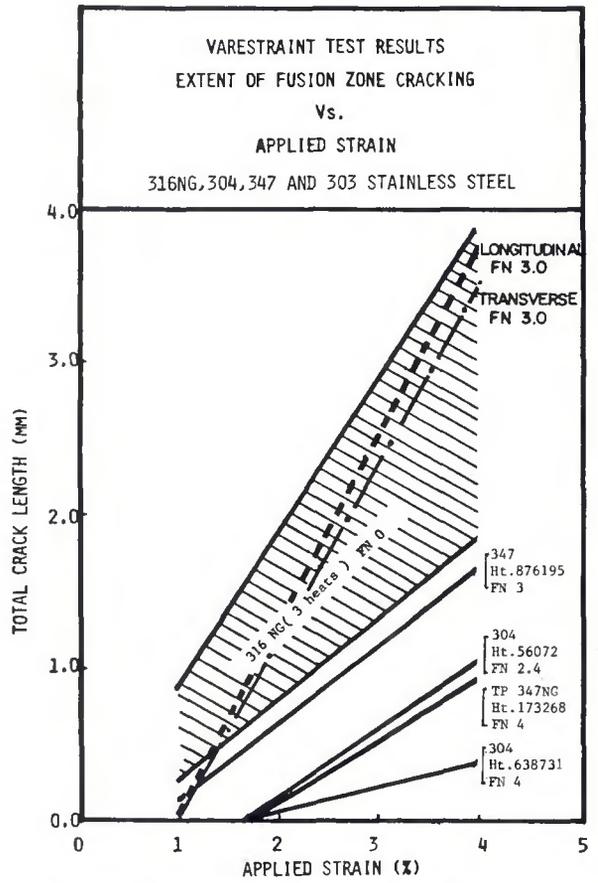
Fig. 9—Extent of fusion zone cracking vs. applied strain in 303 (656471), 304, 347 and 316NG steels

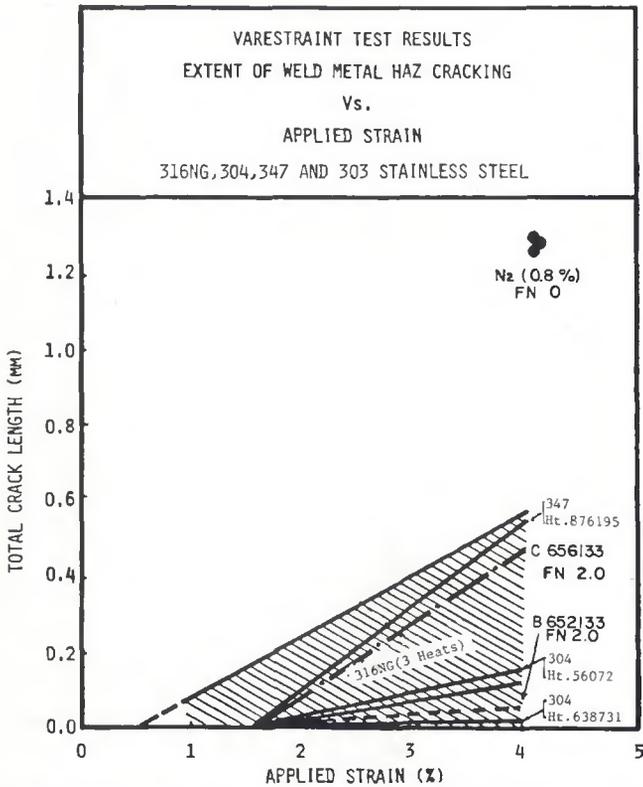
Fig. 10—Extent of weld metal HAZ cracking vs. applied strain in 303 (B652133 and C656133), 304, 347 and 316NG steels

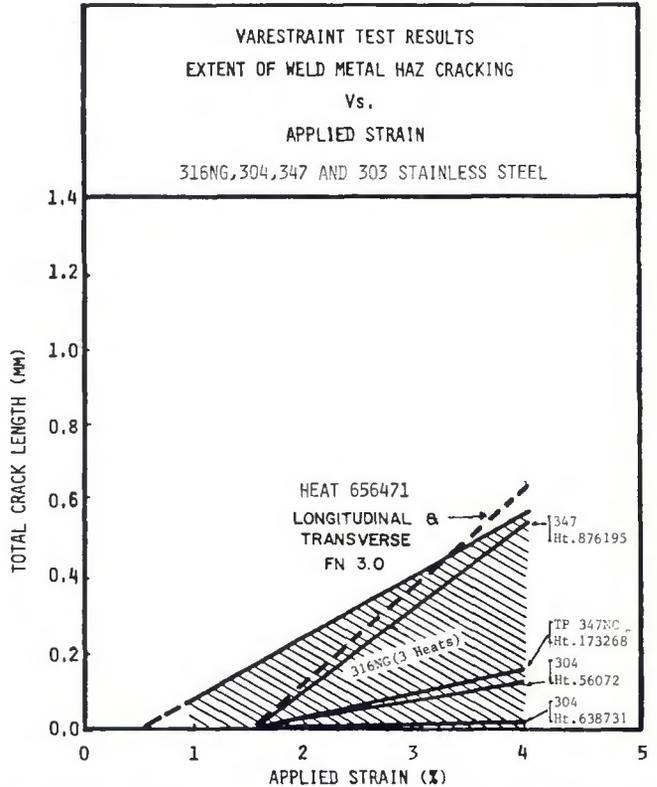
Fig. 11—Extent of weld metal HAZ cracking vs. applied strain in 303 (656471), 304, 347 and 316NG steels

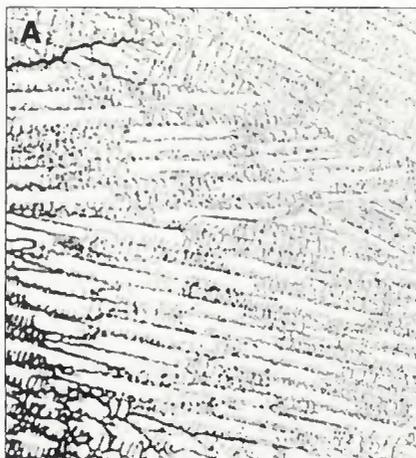
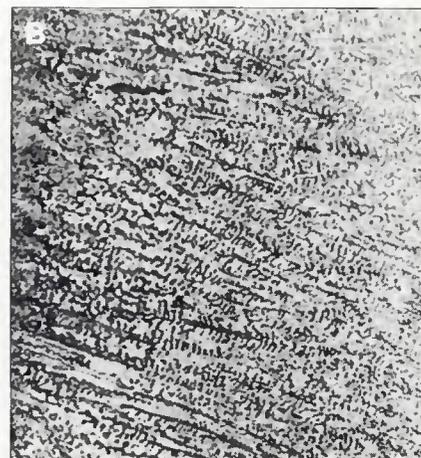
Fig. 19—Instantaneous microstructure of the solid-liquid interface region. A—Ar + 0.8 vol-% N<sub>2</sub>; B—100% Ar. 100X. OLM

The instantaneous microstructures at the solid-liquid interface regions of 303 Heat B652133, under Ar + 0.8 vol-% N<sub>2</sub> and Ar shielding conditions, are shown in Figs. 19A and B, respectively. In the etched condition (chrome-acetic acid solution), the  $\alpha$ -ferrite appears dark and the  $\gamma$ -phase has a light appearance. In the sample welded with 100% Ar shielding (Fig. 19B), the darkly etched dendrite stems have advanced to the solidification interface, revealing that the sample has a primary ferrite solidification mode. However, in the sample welded with the small

addition of nitrogen (0.8 vol-% N<sub>2</sub>) to the shielding gas (Fig. 19A), the well-defined lightly etched dendrites are close to the solidification front, indicating that the cellular dendrites solidified as austenite in the early stages of freezing. Thus, with the small addition of nitrogen, which is a strong austenite stabilizing element, the solidification changed from a primary ferritic to a primary austenitic mode. The darkly etched regions between the primary and secondary dendrite arms, in regions next to the S-L interface, are not  $\delta$ -ferrite, but were liquid at the moment of the sudden quenching in ice water and have retained their own segregation pattern upon rapid cooling. The existence of liquid at the moment of quenching is clearly seen at a higher magnification in Fig. 20A. Figure 20A further shows that during quenching, a crack formed and propagated along a grain boundary.

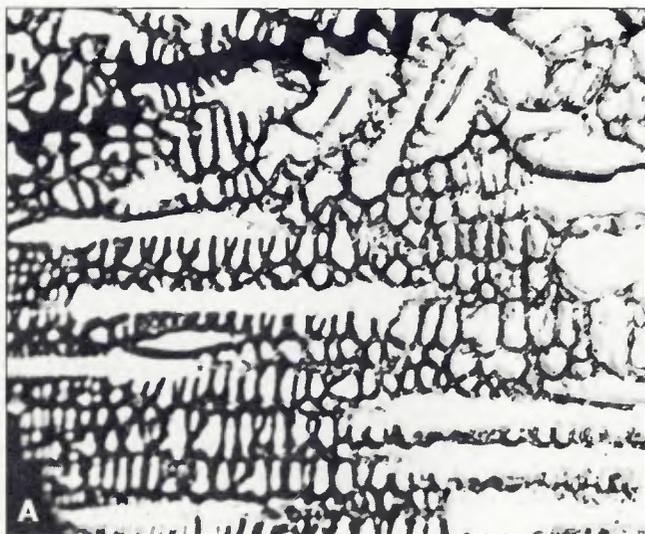
Fig. 20—Higher magnification of microstructures in Fig. 19. 300X. OLM

quenching also can be noted in the sample tested with 100% Ar shielding, as shown in Fig. 20B. The prior liquid drops are indicated by arrows. Figure 20B reveals that the region near the solidification front (A) has a ferrite content greater than 60% at the high temperature at the moment of quenching. In regions behind the solidification front (B and C), which were at lower temperatures than region A at the moment of quenching, the ferrite level is less, due to the partial transformation of ferrite to austenite during cooling below the solidification temperature.
