Electron Beam Welding

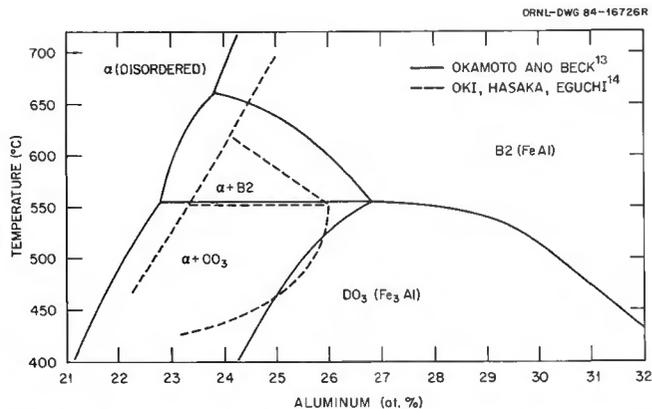
Fig. 1—The iron-aluminum phase diagram showing the phases of interest to this study

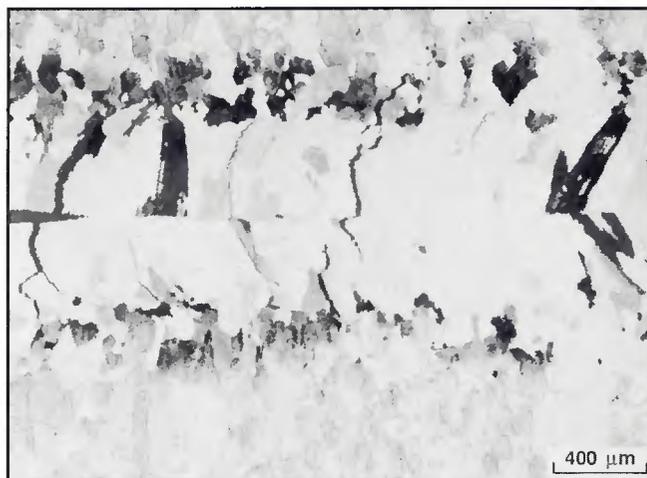
Fig. 2—Optical micrograph showing a typical transverse crack in the Fe₃Al alloy weldments

All of the EB welds made at the higher speeds in the base alloys showed intergranular cracks in the fusion zone with some of the cracks extending well into the base metal. Figure 2 shows a typical
