# Examination of Types 308 and 308CRE Stainless Steels after Interrupted Creep Testing

*The theory that the absence of a well-defined carbide network in modified Type 308 improves creep resistance is tested*

BY J. M. VITEK, S. A. DAVID AND V. K. SIKKA

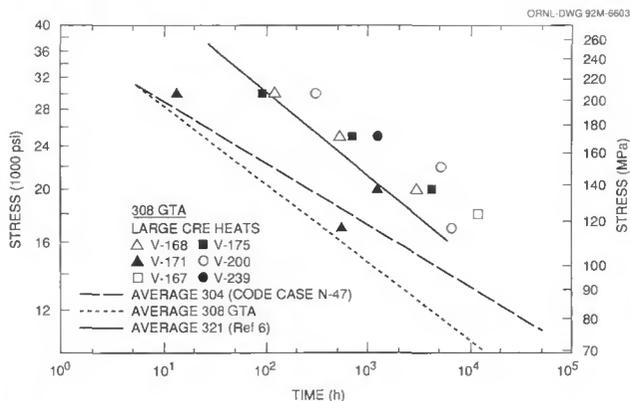
Fig. 1 — Creep-rupture stress vs. creep-rupture time at 650°C. A significant improvement in creep properties is shown for Type 308CRE steels in comparison to Types 304 or 308 steel. Data for Type 321 stainless steel are from Ref. 6.

308CRE stainless steel. A stress-rupture plot that demonstrates the improved creep properties of Type 308CRE weld metal is shown in Fig. 1. Also included in Fig. 1 are data for the stress-rupture properties of Type 321 stainless steel, which is basically a Type 308 stainless steel with titanium additions (Ref. 6). It can be seen that in wrought stainless steels, a titanium addition improves the creep-rupture properties in the same way as CRE additions (including titanium) do in Type 308 stainless steel weld metal. Similar improvements in creep properties of wrought stainless steels resulting from boron and phosphorus, as well as titanium, additions have been found by other investigators (Refs. 7–10).

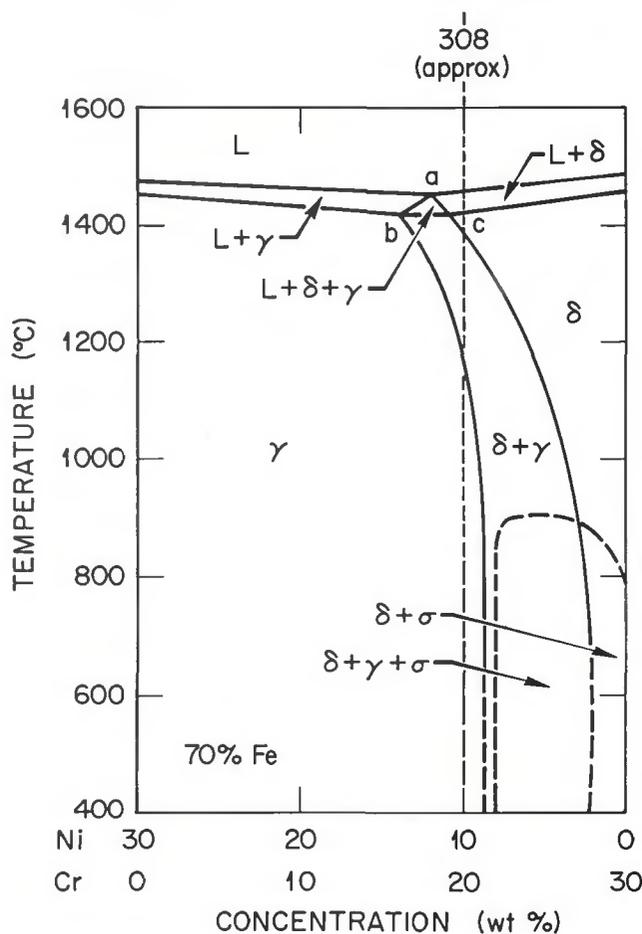
Fig. 2 — Section of the iron-chromium-nickel ternary phase diagram with the approximate location of the Type 308 stainless steel composition superimposed. Below approximately 1100°C, ferrite is not an equilibrium phase.

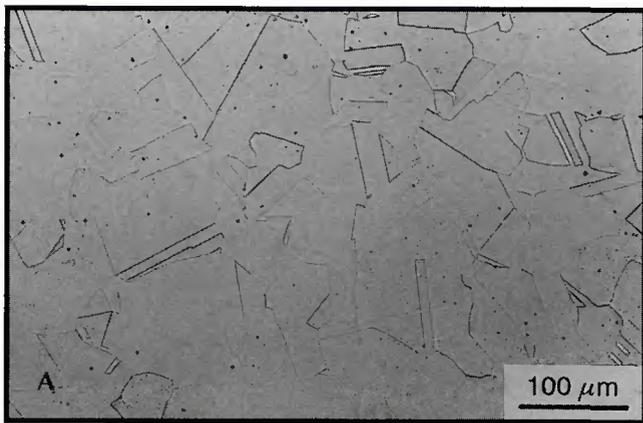
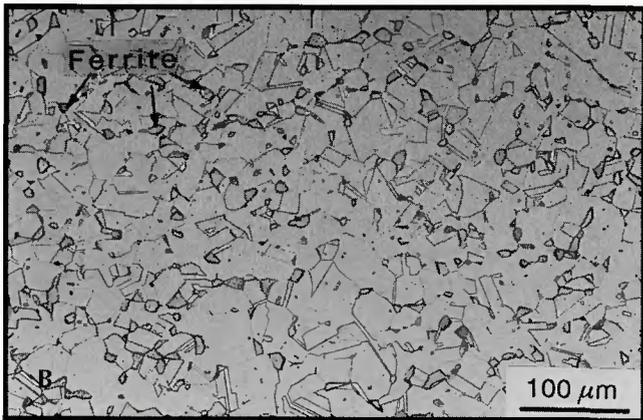
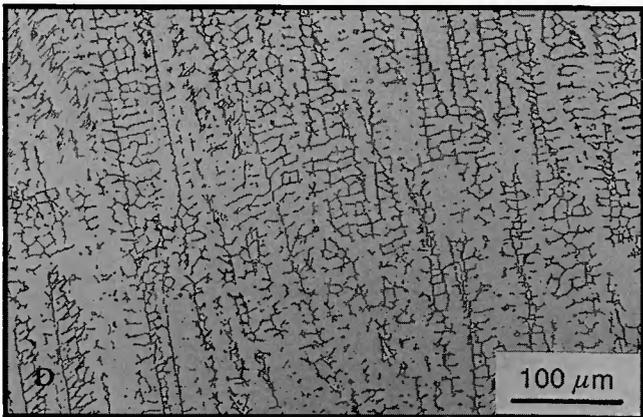
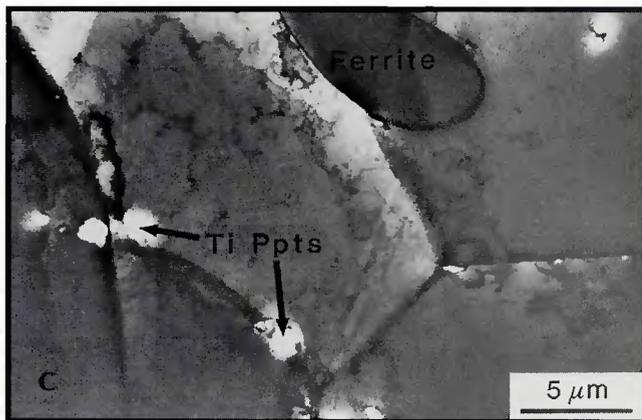
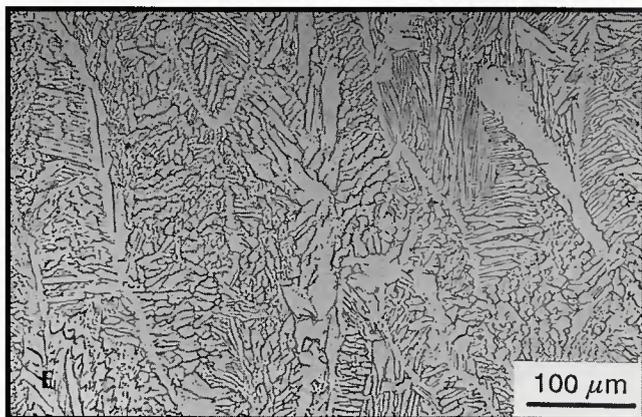
Fig. 3 — Micrographs of various initial microstructures. A — Optical micrograph of homogenized Type 308 steel with fully austenitic structure; B — optical micrograph of two-phase austenite plus ferrite microstructure of homogenized Type 308CRE steel; C — transmission electron micrograph of homogenized Type 308CRE showing distribution of titanium-rich precipitates; D — optical micrograph of as-welded two-phase austenite (light) plus ferrite (dark) microstructure of Type 308 steel; E — optical micrograph of as-welded two-phase austenite (light) plus ferrite (dark) microstructure of Type 308CRE steel.

The microstructures of the initial structures are shown in Fig. 3A–E. As noted earlier, the homogenized Type 308 steel contained a fully austenitic structure — Fig. 3A. Electron microscopy showed that the grain boundaries were free of precipitates, and electrolytic extraction results indicated that

no appreciable precipitate (0.07 wt-%) was present. In contrast to the homogenized Type 308 steel, the homogenized Type 308CRE steel (Fig. 3B) was duplex austenite plus approximately 10% ferrite in the form of large isolated grains of ferrite, typically located at austenite grain boundaries. Significant precipitation was detected in the homogenized Type 308CRE steel. Small titanium-rich precipitates were found to be uniformly distributed throughout the austenite matrix — Fig. 3C. These precipitates were identified by x-ray diffraction as carbides, nitrides and sulfides. In the homogenized condition, 0.38 wt-% precipitate was present, as measured by electrolytic extractions.

The as-welded structures of both alloys were basically similar, with both containing austenite and approximately 10% ferrite — Fig. 3D and E. The ferrite was present in a highly interconnected form. The ferrite morphology in the GTA welds was primarily vermicular for the Type 308 steel, while the Type 308CRE steel contained more of an acicular fer-

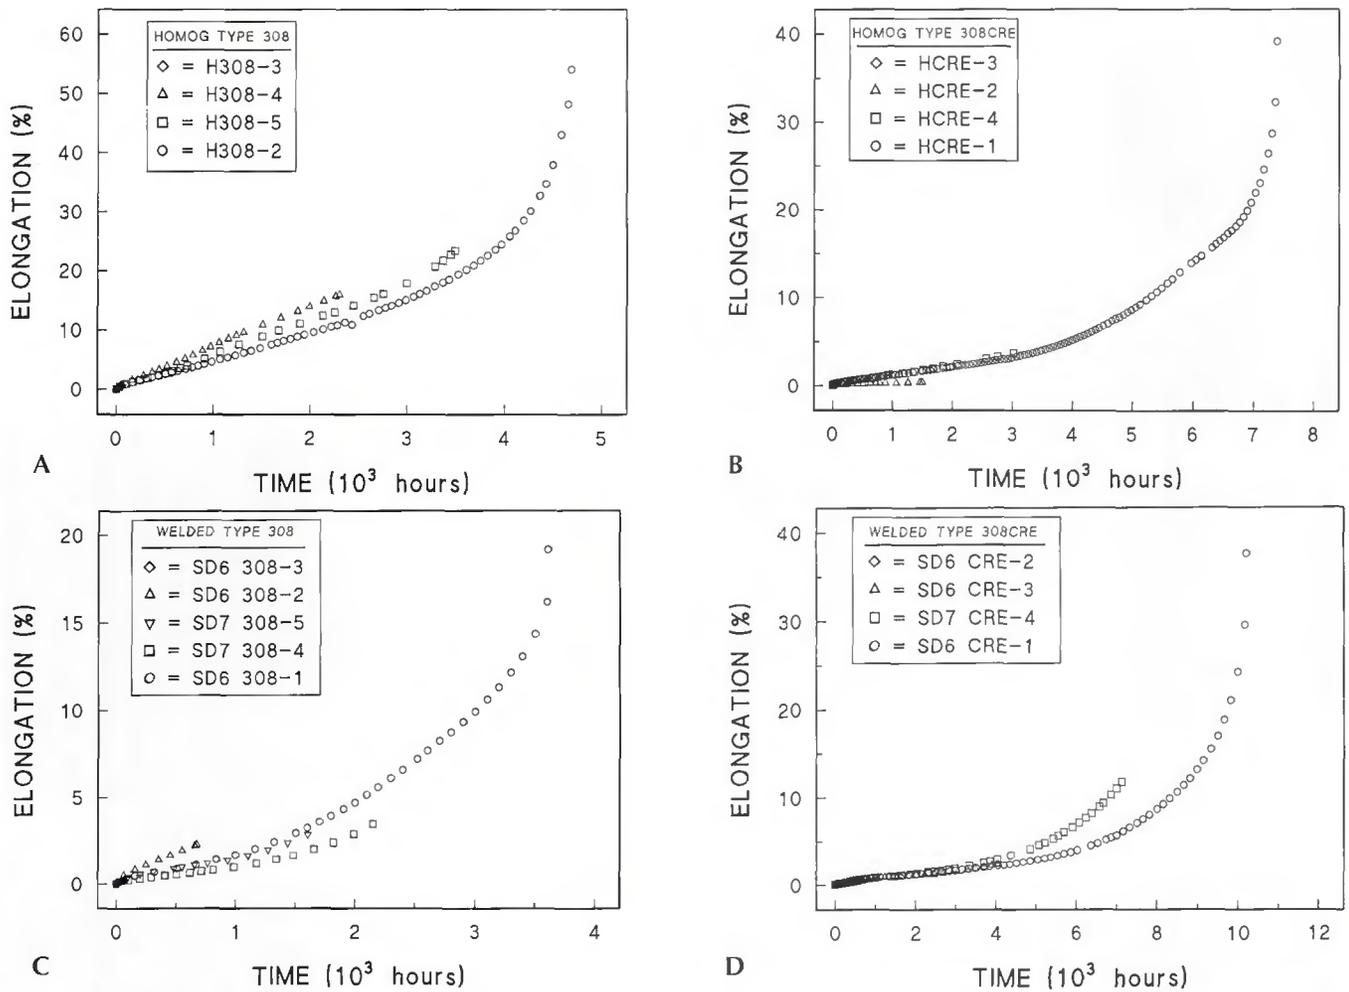
Fig. 4 — Creep curves for interrupted tests of: A — homogenized Type 308 steel; B — homogenized Type 308CRE steel; C — welded Type 308 steel; D — welded Type 308CRE steel.

Plots of elongation vs. test time for the interrupted creep tests for each material and each starting condition are shown in Fig. 4A–D. The specimen numbers, testing times, creep-rupture times, reduction in area, and elongations to rupture for specimens in each of the four initial conditions are given in Table 2. As shown in Fig. 4, for each of the starting conditions examined the interrupted

tests followed essentially the same elongation vs. time curve as the test that was continued to rupture. For comparison of the behavior of the different alloys and conditions, a composite figure of the tests carried out to failure for the four initial conditions that were tested is presented in Fig. 5. The improvement in creep properties due to the addition of CRE elements (titanium in this case) is evident. The homogenized, and as-welded Type 308CRE materials showed significantly greater rupture lives and reductions in area. The homogenized Type 308CRE alloy showed over a 50% increase in stress-rupture life compared to the homogenized Type 308 alloy and a significant increase in reduction in area while still maintaining a large rupture elongation. The welded Type 308CRE alloy showed the longest rupture life of all the conditions tested, with nearly a 200% increase in rupture life over the welded Type 308 steel, and nearly a

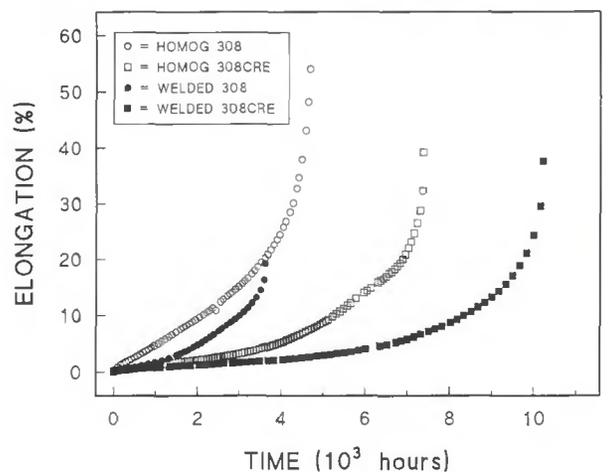
Fig. 5 — Composite of creep curves taken to failure for all four initial alloys and conditions. The creep-rupture times for the Type 308CRE steels are considerably longer than the corresponding times for the Type 308 steels.

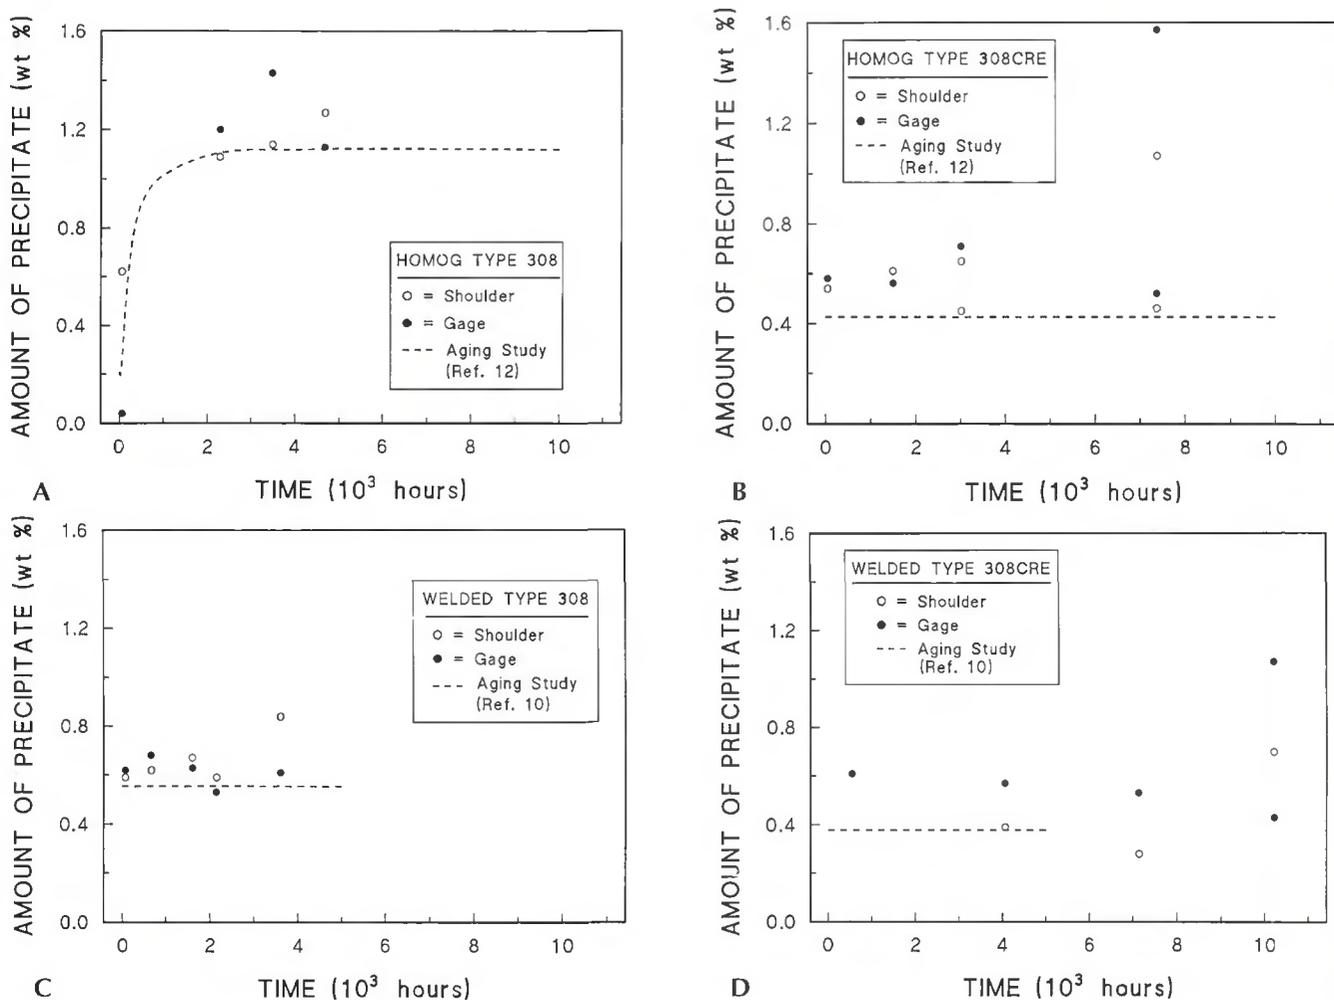
Fig. 6 — Plots of wt-% precipitate vs. test time at 650°C for: A — homogenized Type 308 steel; B — homogenized Type 308CRE steel; C — welded Type 308 steel; D — welded Type 308CRE steel. Open data points are for shoulder sections (no stress) while filled data points are for gage sections (stressed).

Electrolytic extractions were performed on both the stressed gauge sections and the unstressed shoulder sections of the creep specimens. Precipitate amount vs. the test time is plotted in Fig. 6A–D for each of the four conditions evaluated. Superimposed on the figures are dashed lines representing the extraction results from earlier aging studies on unstressed samples (Refs. 11, 13). It can be seen that in nearly all cases the new data agree well with the earlier results. Furthermore, by directly comparing the results from shoulder (unstressed) and gauge (stressed) sections, it is clear that the stress has little or no role in determining the amount of precipitate that forms upon exposure to elevated-temperatures.

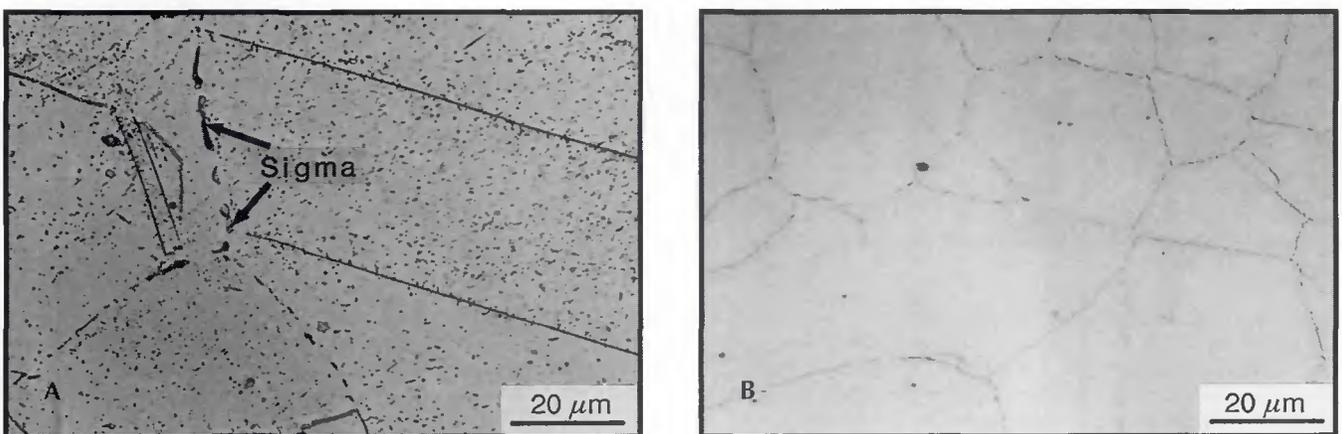
Fig. 7 — Optical micrographs of homogenized Type 308 steel. A — Extensive carbide formation along grain boundaries and within grains as well as some sigma formation in gauge section of homogenized Type 308 steel, Sample H308-5, tested for 3494 h; B — only carbide precipitation, primarily along grain boundaries, found in shoulder section of homogenized Type 308 steel, Sample H308-2, tested for 4688 h.

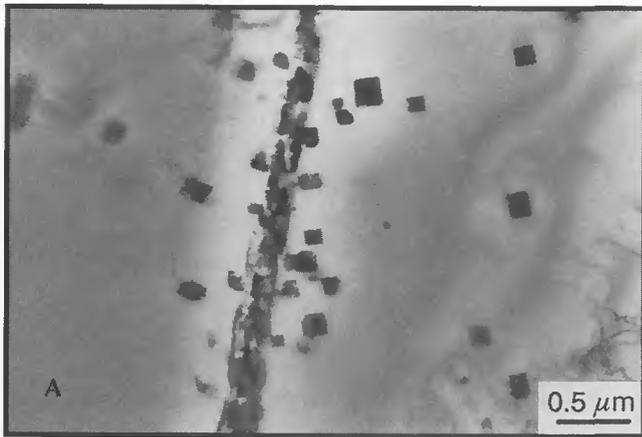
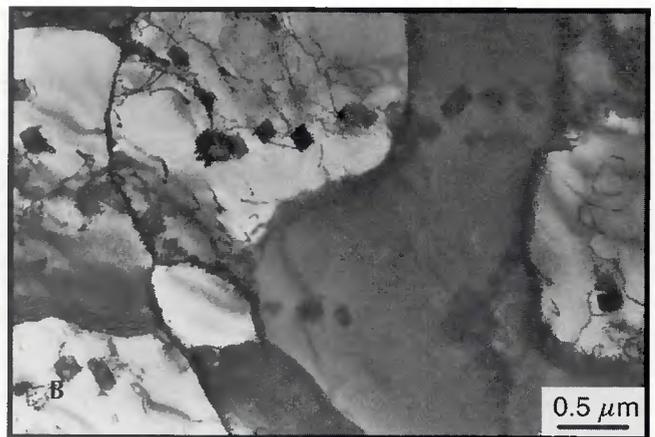
Fig. 8 — Transmission electron micrographs of homogenized Type 308 steel. A — Gauge section from Sample H3308-4, tested for 2300 h, showing carbide precipitation at grain boundaries and within the grains; B — gauge section from Sample H3308-5, tested for 3494 h and showing substructure development as well as carbide precipitation.

TEM examination revealed the extensive carbide formation at austenite grain boundaries as well as within the grains in homogenized and creep-tested Type 308 steel, as shown in Fig. 8A. With longer test times, a well-defined substructure was also found to have formed, as shown in Fig. 8B. The first signs of sigma phase formation were found by TEM in the gauge section of Sample H308-5, tested for 3494 h.

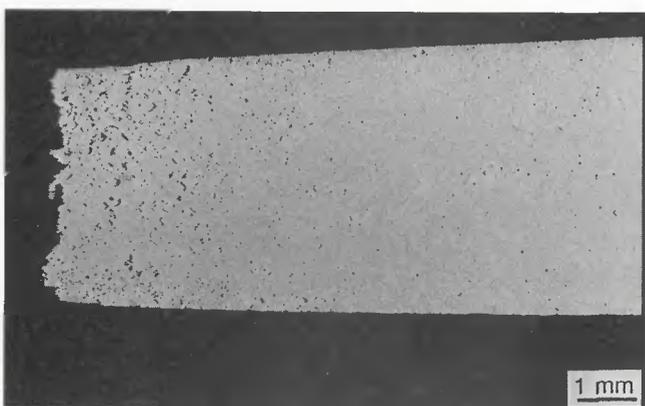
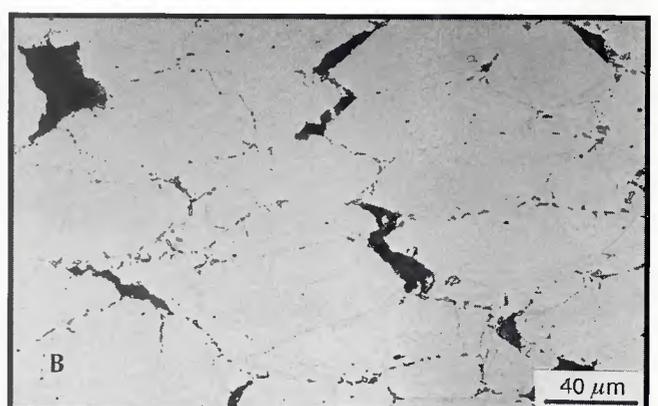
Fig. 9 — Optical micrographs near the creep-rupture fracture surface in homogenized Type 308 steel, Sample H308-2, tested for 4688 h. A — Low, and B — high magnifications showing extensive cracking. However, the exact path of the cracks cannot be determined by optical microscopy.

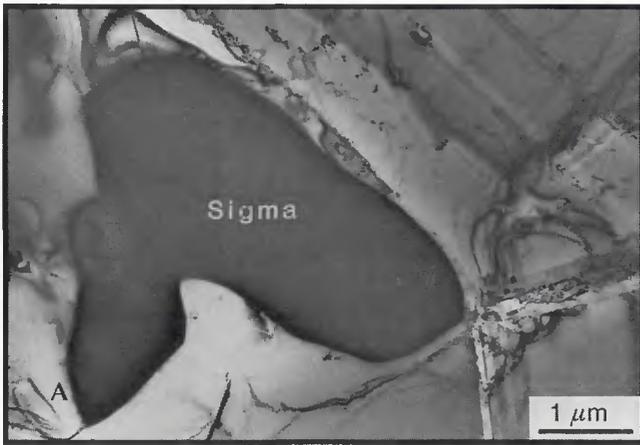
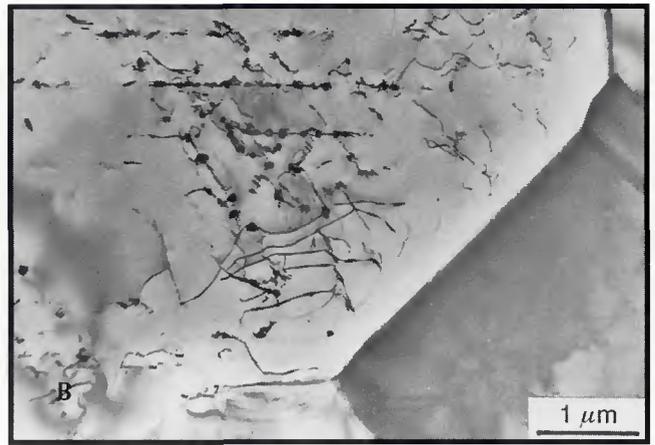
Fig. 12 — Transmission electron micrographs of homogenized Type 308CRE steel. A — Gauge section from Sample HCRE-2, tested for 1498 h, and showing sigma phase formed from ferrite; B — shoulder section from Sample HCRE-1, tested for 7382 h and showing fine precipitation along dislocations.

dislocations in the austenite grains — Fig. 12B. The majority of these precipitates were cubic TiC or TiN with a cube-on-cube orientation relation to the austenite matrix. However, some precipitates were found to contain phosphorus as well as titanium. Positive identification of these phosphorus-containing precipitates was not made.

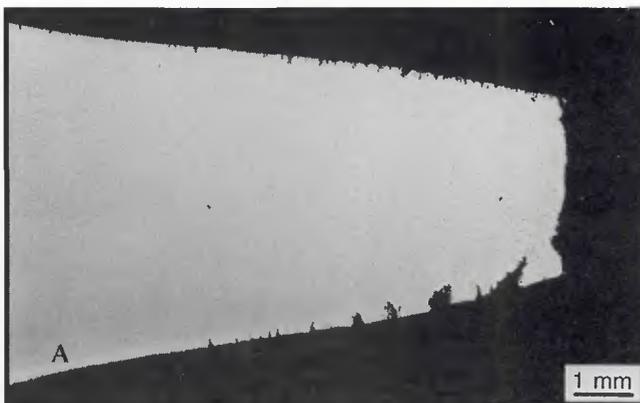
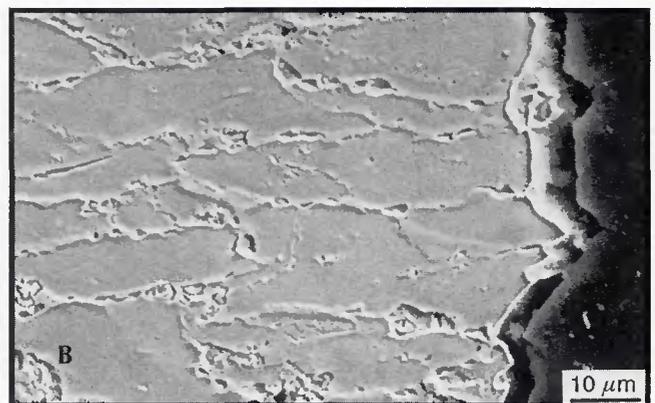
Fig. 13 — Microstructure near the fracture surface in homogenized Type 308CRE steel, Sample H3CRE-1, tested for 7382 h. Cracking is noticeably absent. A — Optical micrograph; B — scanning electron micrograph.

An optical micrograph of the homogenized Type 308CRE sample tested to rupture is shown in Fig. 13A. The abundant crack formation that was found in the homogenized Type 308 steel is absent in the Type 308CRE material. The significant improvement in reduction in area compared to the homogenized Type 308 steel (Table 2) is also evident (compare Figs. 13A and 9A). A scanning electron micrograph of the homogenized and creep-tested Type 308CRE alloy is shown in Fig. 13B. Although extensive sigma phase formation along the boundaries is evident, no sign of significant intergranular cracking, as found in the unmodified homogenized Type 308 steel, was observed.

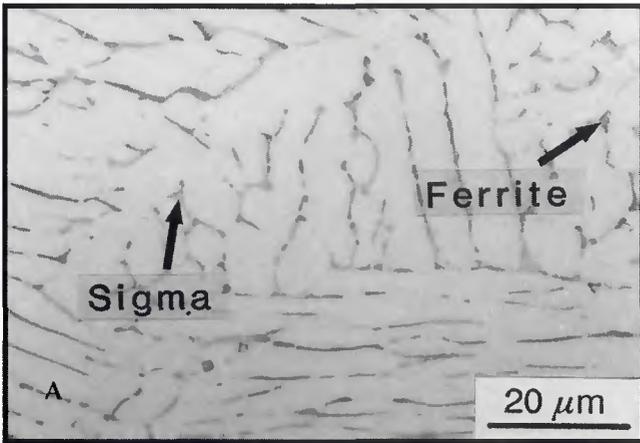
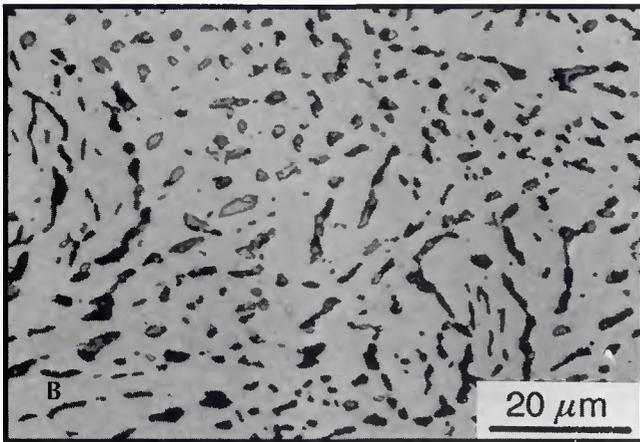
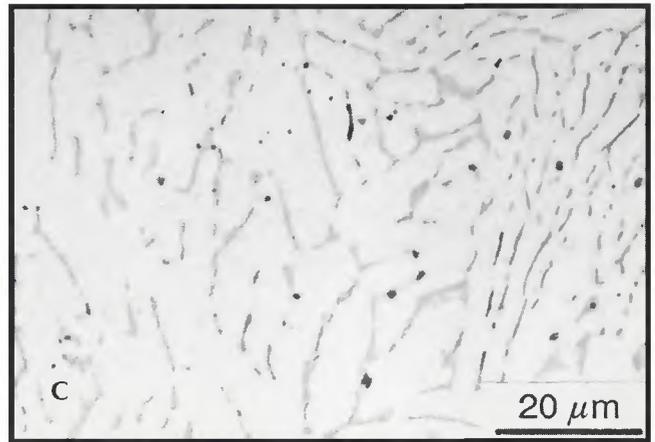
Fig. 17 — Optical micrographs of welded Type 308CRE steel. A — Later stages of ferrite (dark phase) to sigma (lighter phase) transformation in gauge section of welded Type 308CRE, Sample SD6 CRE-2, tested for 550 h; B — breakup of sigma phase structure after longer term testing. Gauge section of welded Type 308CRE, Sample SD6 CRE-1, tested for 10223 h; C — microstructure of same sample as B but taken from the shoulder section and showing much more continuous sigma phase morphology.

dramatic after longer creep testing times, as shown in Fig. 17B. Figure 17B also demonstrates the difficulty in distinguishing the ferrite and sigma phases when only one of these phases is present in the microstructure. Although the second phase appears to be dark, and therefore may be an indication of ferrite, electron microscopy confirmed that the second phase by optical microscopy was sigma. It is possible that the distinction between ferrite and sigma phase is more difficult in the welded Type 308CRE material because the second phase is finer than in the Type 308 weld. As was the case for the welded Type 308 and the homogenized Type 308CRE, there was little difference in the microstructures of the gauge and shoulder sections. The only noticeable difference was that the breakdown of the continuous second phase network was less significant in the shoulder section, as shown in Fig. 17C.

The final condition that was examined was the welded Type 308CRE, and the microstructures are presented in Fig. 17. As seen in Fig. 17A, nearly all of the ferrite had transformed to sigma phase after 550 h. As was observed in the welded Type 308 alloy, there was a tendency for the continuous ferrite to break up into smaller islands of sigma phase upon transformation. No appreciable precipitation during creep-testing was observed. The breakdown of the continuous second phase network was quite

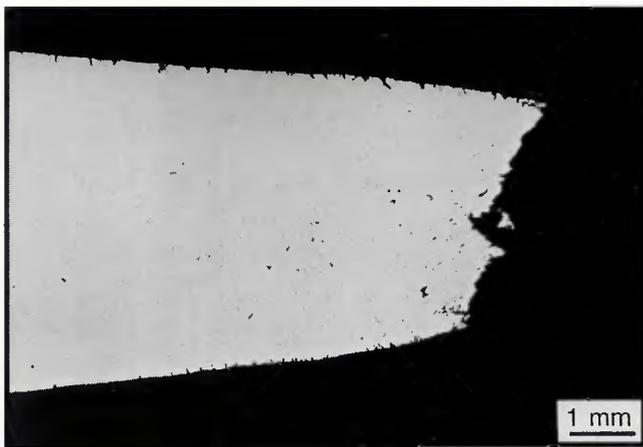
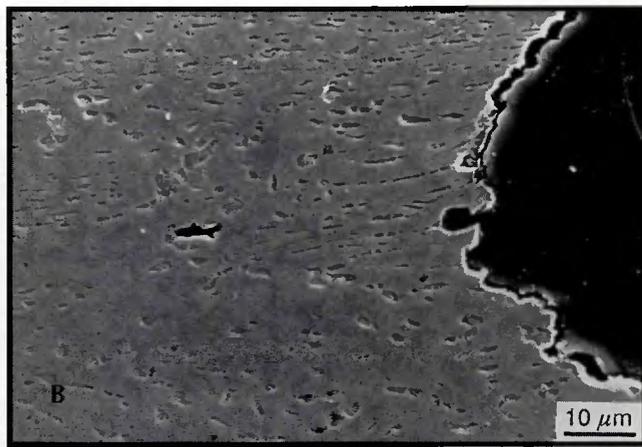
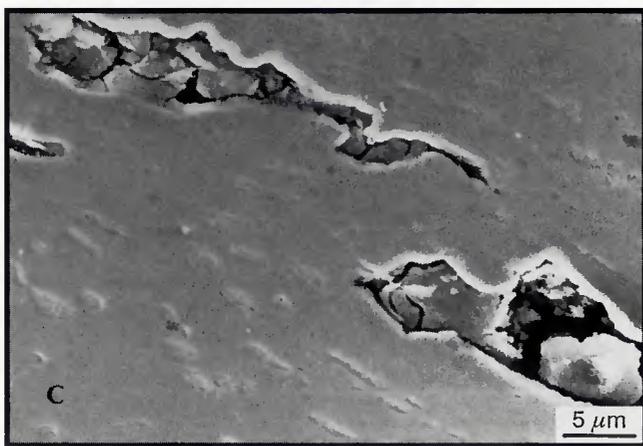
Fig. 19 — Microstructures near the fracture surface in welded Type 308CRE, Sample SD6 CRE-1, tested for 10223 h. A — Optical; B — scanning electron micrographs showing very limited cracking, and C — higher magnification scanning electron micrograph showing fine cracks are present but they are typically confined to within the sigma phase.

An optical micrograph of the area near the fracture for the Type 308CRE weld is presented in Fig. 19A. As observed for the homogenized Type 308CRE material, little crack formation was observed, and the improved reduction in area (Table 2), compared to the Type 308 weld, is evident. A scanning electron micrograph of the welded and creep-tested Type 308CRE structure is shown in Fig. 19B. Very limited cracking was found, although extensive sigma phase was detected. Without the presence of a well-defined carbide network, fine crack formation is found within the

When carbide networks are absent, cracks were found within the sigma phase — Fig. 19C. This is not surprising,
