WELDING RESEARCH

Corrosion Behavior of Stainless Steel and High-Alloy Weldments in Aggressive Oxidizing Environments

Nickel alloy filler metals compensate for the lower corrosion resistance of matching composition stainless steel welds in aggressive environments

BY A. H. TUTHILL AND R. E. AVERY

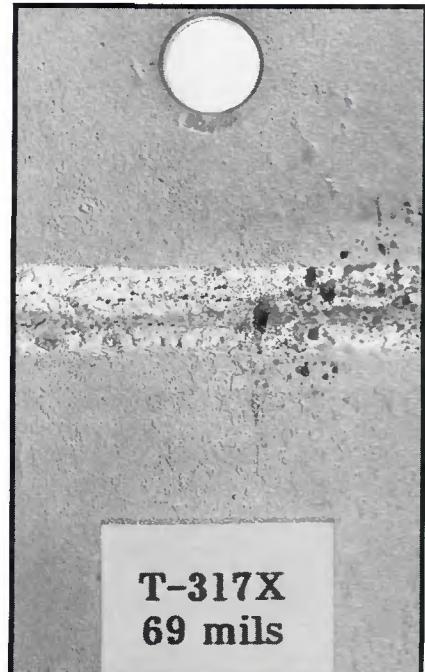
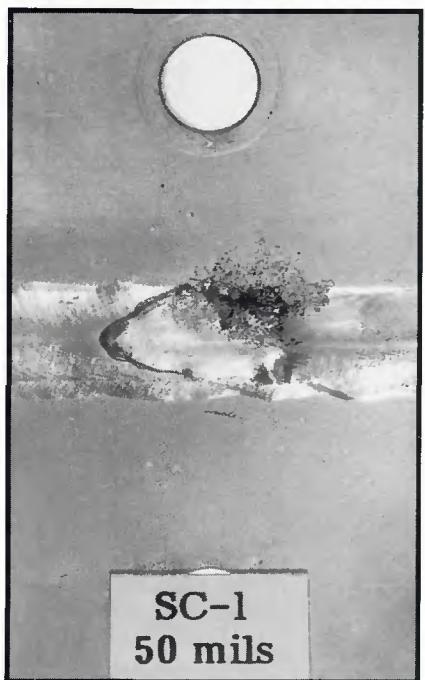
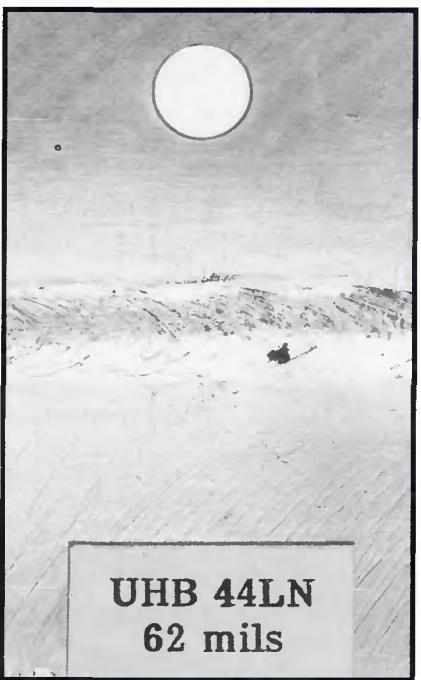
**Fig. 2 — Weld metal corrosion in matching composition welds.**

The general nature of pitting attack that occurred in the matching composition weld metal is shown in Fig. 2. Corrosion of the weld metal, when it occurred, was by pitting. Figure 3 shows the depth of weld metal pitting on 317X welded with a matching composition filler metal in an exposure where there was no corrosion of the base metal.

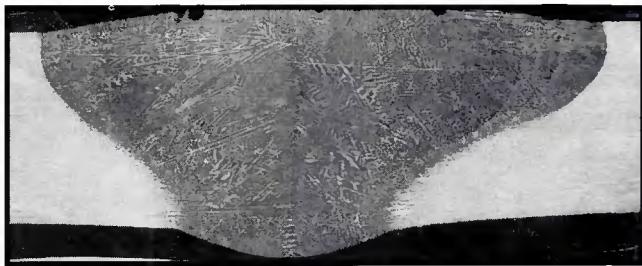
Fig. 3 — Type 317X matching-composition weld metal. Weld attacked but not the base metal.

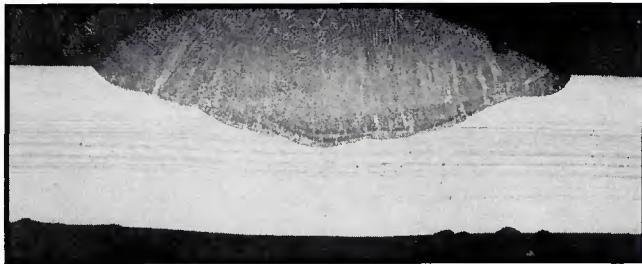
Fig. 5 — Type 317L. Pitting in the HAZ on the side opposite the weld bead.

There are several instances where there was pitting in the heat-affected zone but not in the base metal or weld metal. Figures 5 and 6 show pitting of the HAZ on the side opposite the bead of a plate weld on 317L and 254 SLX specimens. In Fig. 7 there is knife-line-like pitting of the HAZ just adjacent to the weld on an E-Brite specimen. No special studies of this type of HAZ corrosion were undertaken in this program.

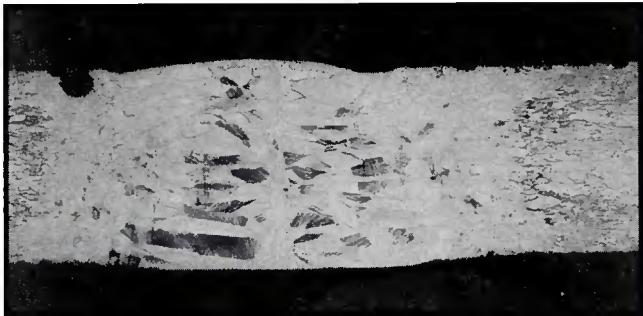
Fig. 7 — E-Brite. Knife line attack adjacent to the weld.

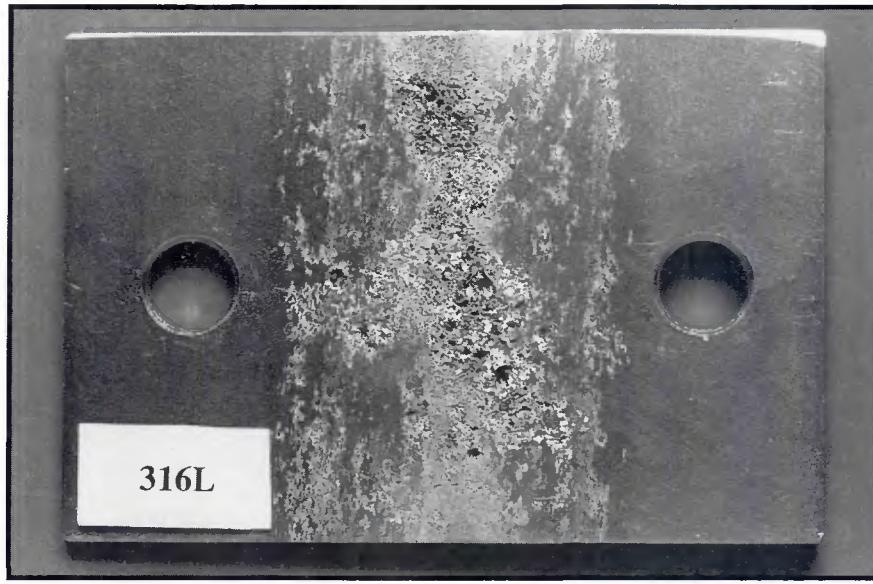
Fig. 11 — Pitting corrosion associated with postweld cleaning by stainless steel wire brush on the back of a 316L coupon after exposure in chlorine dioxide-stage washer.

Wire brushing with stainless steel wire brushes is also a common method of cleanup after welding. Garner reported corrosion initiated on several stainless steel specimens in the area where the specimen had been power wire brushed with a clean stainless wire brush (Ref. 6) — Fig. 11. He suggested that the attack may be due to inadequate heat-tint removal, the use of low-alloy stainless steel brushes such as Types 410 or 304, or due to redeposition of abraded metal and oxides. Pickling would be expected to remove any such metal transferred by stainless steel wire brushing or remove other foreign surface deposits.
