COPE CRACKING IN STRUCTURAL STEEL AFTER GALVANIZING

There have been isolated reports of cracks in the flame cut radius of copes of galvanized steel

By Thomas J. Langill, Ph. D.
and Tom Schlafly

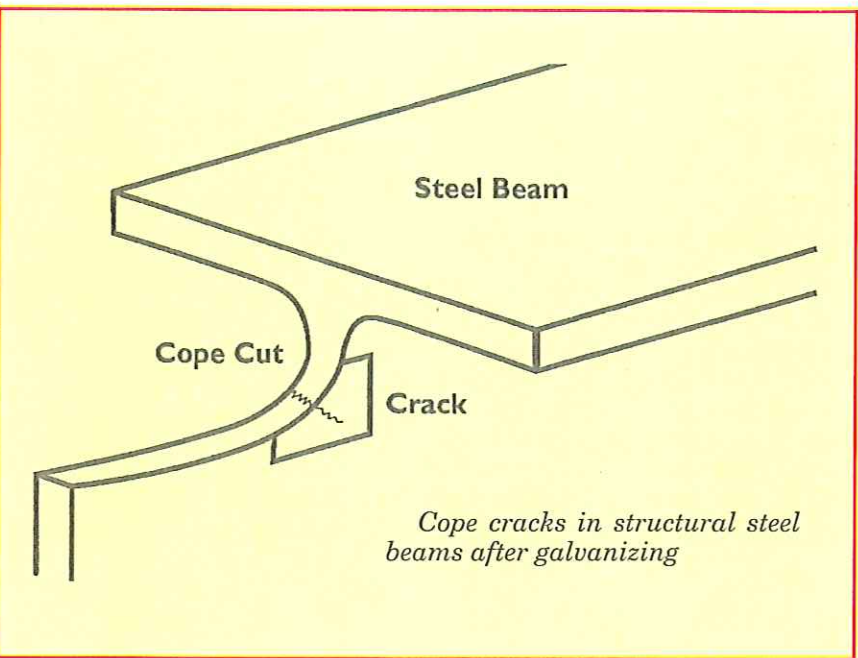
monly found in the flame cut radius of copes and extend radially away from the copes at 45 degrees. They are visible on both sides of the web indicating they extend through the material. The cracks have appeared in A36, A572 and probably in A588. Cracks have been found in some material from a given heat and not in other material from the same heat. There have been reports of cracking in material

- The flame cutting causes high tensile residual stresses (at or near yield point) along the flame cut surface of the cope. The galvanizing temperature can create stresses at a lower level, but throughout the member as evidenced by warping in some sections.

- The reaction of steel to the presence of liquid metal can cause an effect called liquid metal embrittlement. Galvanizer's pickling baths and handling techniques can vary to some degree.

- ASTM A143-74 Standard Practice for Safeguarding Against Embrittlement of Hot-Dip Galvanized Structural Steel Products and Procedure for Detecting Embrittlement (ASTM VOL 1.06) states that the duration of pickling can effect embrittlement. The standard further states that heating to 300 deg F. between pickling and galvanizing in most cases results in expulsion of the hydrogen absorbed during pickling. Variation in galvanizer practices such as bath temperature, quenching, bath additions and pickling time have not been found to have a measurable effect on probability of crack occurrence accord-
