SUPPLEMENT TO THE WELDING JOURNAL, DECEMBER 1971

Cracking in Welded Steam Pipe

Cracking tends to occur in a new grade of austenitic stainless (Fe-Ni-Cr-Mn-No-V-N-B) when the carbon content exceeds 0.030% and when noncircular inclusions are present

BY J. A. ISASI, R. C. BATES, AND J. HEUSCHKEL

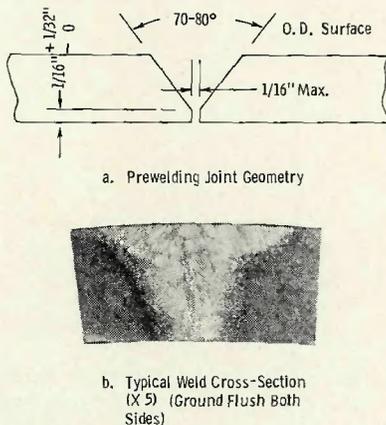
The two half-plates from which each elbow was made were cold formed in a closed die. The matching edges, taken from the same parent plate, were prepared by plasma-arc torch cutting, grinding, machining, or a combination thereof, to produce the joint geometry shown in Fig. 1. Any torch cutting was followed by grinding or machining to remove scale and oxides, and to provide a good fit.

Fig. 1—Welded joint details

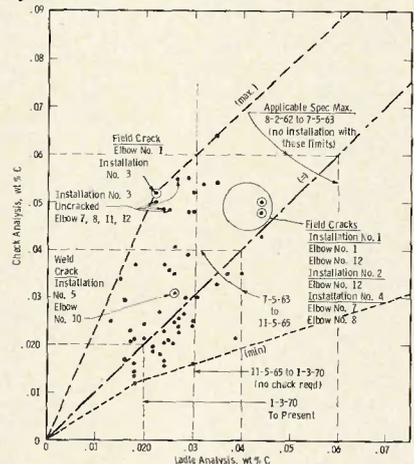
The most significant deviation between originally reported ladle analysis and the newly determined check analysis was found in carbon contents, Fig. 3. The heats which resulted in field cracking were highest in carbon content and the check analyses were higher than the previously reported ladle analyses.

Fig. 3—Relation between reported carbon ladle analyses and elbow plate stock check analyses

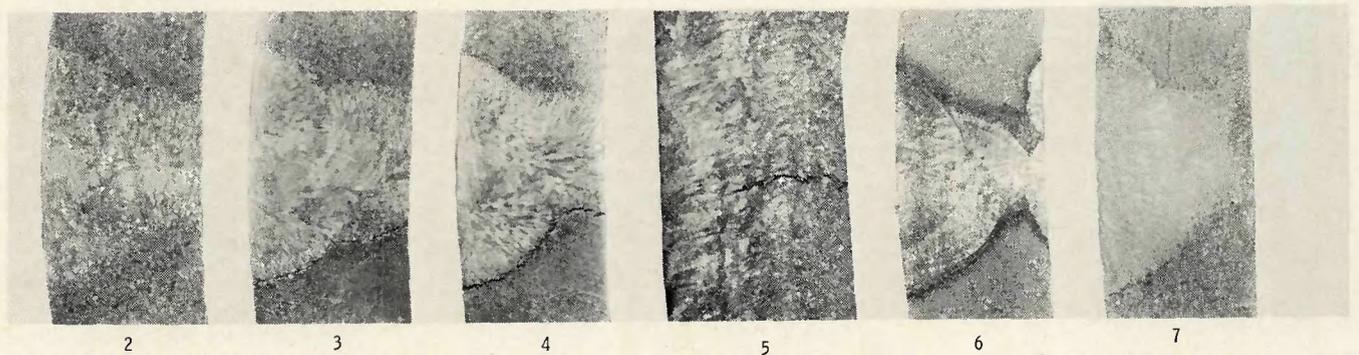
Fig. 8—Macrosections through cracked intrados welds in installation no. 4. Mag: 5X

Fig. 9—Macrosections of intrados welds in elbow no. 8, installation no. 4. Mag: 5X

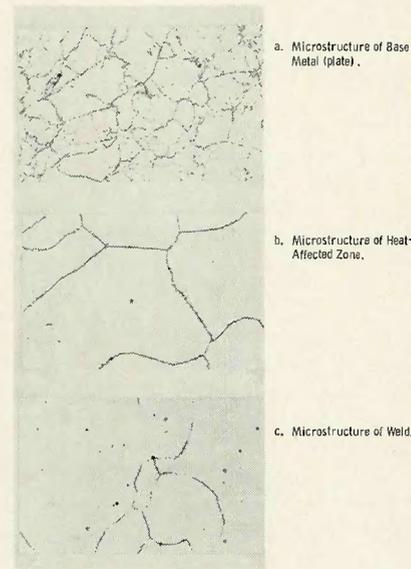
To provide some background information concerning the original microstructure of the elbows of concern in this investigation, unused plate samples from Heat No. 806286 were examined, Fig. 10a. Also, samples taken from a creep specimen made from either plate material or from a trimmed end of elbows (transweld creep specimens) were examined. Figures 10b and 11 give the typical microstructure for these two types of specimens.

Fig. 11—Typical microstructure of three areas in transweld creep-rupture specimen (weld at center of gauge length) after 7843 hr at 1025F and 50 ksi. Specimen machined from trim end of 14-in. elbow made from heat no. 806286. Mag: 1000X

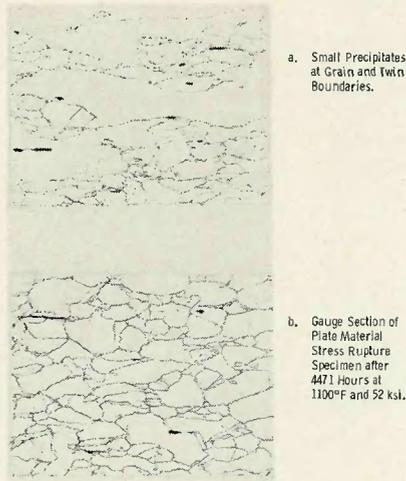
Fig. 10—Microstructure of original plate in as-heat-treated condition and after stress-rupture tests made from heat no. 806286. Mag: 1000X

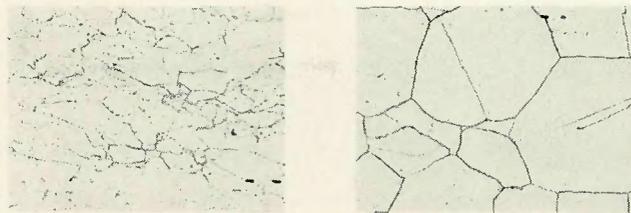
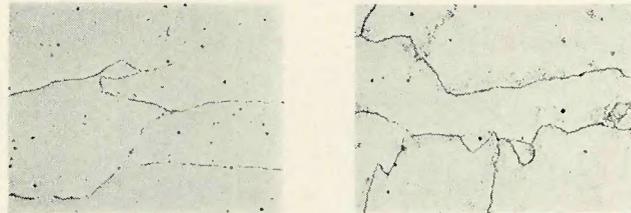
The microstructures of all investigated components except Elbow No. 2, Installation No. 3, were found to contain large amounts of precipitates as illustrated in Figs. 15 and 16. The relative distribution of particles in these components was determined to be about the same. In the base metal, the particles were located primarily at the grain boundaries, twin boundaries, and prior boundaries, with small amounts situated randomly within the grains. In the HAZ and weld regions, the particles were found mainly at the grain boundaries; although small amounts of fine intragranular precipitates were present in the weld which appear to be associated with the dendritic structure. In general, the size of the particles in the HAZ and weld areas were much larger than in the base metal and form essentially a continuous network at the boundaries.

Fig. 15—Typical microstructure of three areas in elbow no. 12, installation no. 2. Elbow made from heat no. 806286. Mag: 1000X

a. Microstructure of Base Metal Close to Intrados Weld.

b. Microstructure of Heat-Affected Zone Region.

c. Microstructure of Weld Near the Outside Surface of the Pipe (OD).

d. Microstructure of Weld Near the Inside Surface of the Pipe (ID).

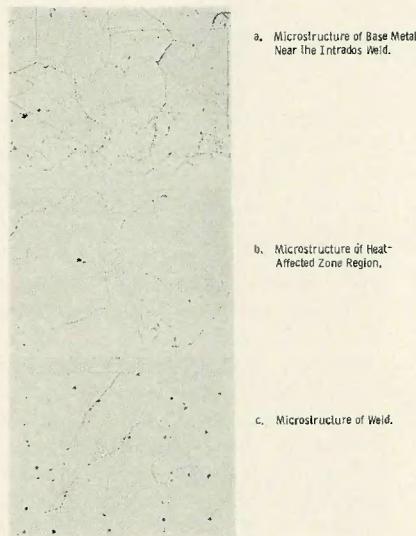
Fig. 16—Typical microstructures of three areas in elbow no. 1, installation no. 3. Elbow made from heat 2813. Mag: 1000X

a. Microstructure of Base Metal Near the Intrados Weld.

b. Microstructure of Heat-Affected Zone Region.

For most of the components under investigation, two different regions could be clearly observed in some of the metallographic sections of the weld areas. This is illustrated for Elbow No. 1, Installation No. 3, in Fig. 16c and d. The microstructure of the weld region (0.028% C) close to the O.D. surface of the pipe was found to be almost free of particles, as shown in Fig. 15c. The second region corresponding to the area of the root pass of the weld (i.e., close to the I. D. surface of the pipe) was found to contain large particles at the grain boundaries and fine particles in the grains close to the boundaries, as shown in Fig. 16d. The reason for the differences in the two regions is that

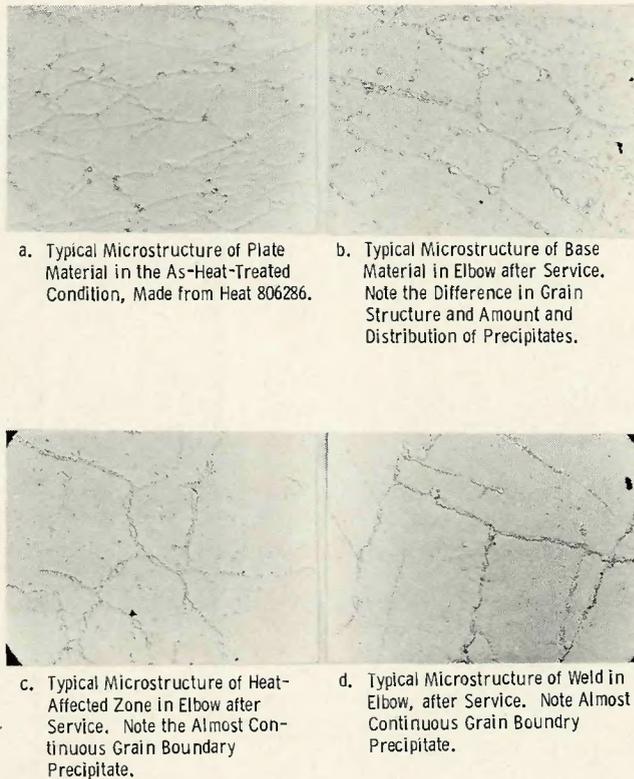
Figure 18 shows electron micrographs at 5000X from plastic replicas illustrating the amount and morphology of the grain boundary particles in the original plate material from Heat No. 806286 and in a typical elbow made from that heat after service. These electron micrographs clearly illustrate the effect of service conditions on the microstructure of the material, i.e., precipitation of particles during service. Carbon extraction replicas from the base material of all four elbows investigated were obtained and used to identify the grain boundary particles by electron diffraction and electron microprobe analyses of single large particles or groups of particles. The particles were identified to be mostly $M_{23}C_6$ type carbide (where M is mainly Cr) plus possibly some Cr-Mo-N and Cr-N particles. Strong indication of nitrogen substitution for carbon in $M_{23}C_6$ type carbide was also detected. The presence of a large number of $M_{23}C_6$ type particles at

Fig. 18—Electron micrograph from plastic replicas showing relative amounts, size, and distribution of precipitates in plate material before service and in plate material, HAZ, and weld after service (elbow no. 1, installation no. 1). Mag: 5000X

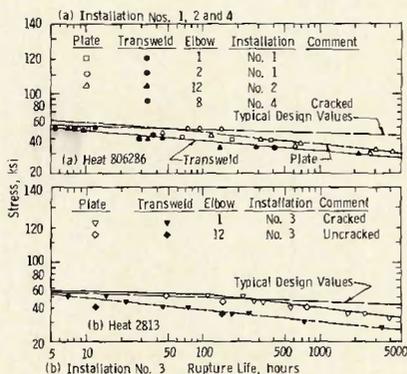
Fig. 21—Stress-rupture data of service-exposed material (temp 1150F) (left)

Fig. 22—Stress-rupture data of service-exposed material (temp 1150F) (below)

Stress-rupture data from service exposed material are shown in Figs. 21 and 22, together with the typical design, stress-rupture curve at 1150F. In general, for all heats investigated, the original acceptance data are in good agreement with the design data. Therefore, the design data (dashed lines in Figs. 21 and 22) are used in this investigation as typical. Typical values of stress-rupture ductility are presented in Table 4.

Figure 21a shows the data for all tested elbows made from Heat No. 806286. The slope of the curve through the points for the plate material is about the same as that of the curve through the points for the transweld material, indicating that the rate of decrease of rupture strength is about the same for both cases. The same observation is true for Fig. 21b, which shows the data for Heat No. 2813. For the case of Heat No. 806286, there is a difference of about five times in the rupture life between transweld and plate values, and for the case of Heat No. 2813, the difference is about one order of magnitude. For both cases, the transweld values were lower.

Figure 22 shows the data for the circumferential weld on the straight pipe of Installation No. 3 and the data for the service exposed elbow made from Heat 2696 (low carbon heat, 0.031%C). The data for the straight pipe indicate properties which are significantly lower than typical, while the data for Elbow No. 10, Installation No. 5, are about typical.

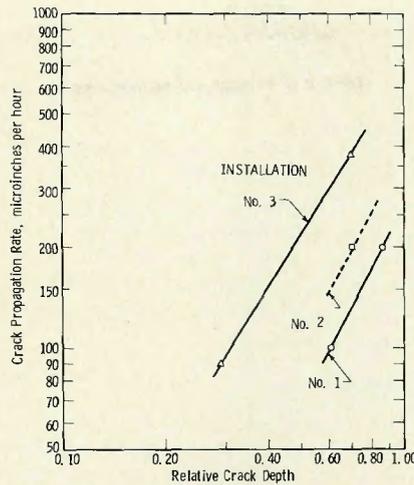
In Fig. 25, the logarithms of the crack growth rates of the various cracks are plotted as a function of relative crack depth (crack depth divided by nominal wall thickness). In this figure, a straight line is drawn through the two points for the two Installation No. 3 cracks and another through the Installation No. 1 cracks (one each in Elbow Nos. 8 and 11). In both instances, the slope of the lines is close to 2.0. A dashed line of a slope of 2.0 is shown through the point for the crack in Installation No. 2. Figure 25 shows that, for comparable crack lengths, the crack propagation rate is highest for the Installation No. 3 elbow and lowest for the Installation No. 1 elbows.

Fig. 25—Relationship of crack propagation rate with relative crack depth (ratio of crack depth to wall thickness) for stress-rupture cracks for various elbows

Rough estimates of the time necessary for propagation of the stress-rupture cracks from about 5% of the wall thickness to about 80% of the wall thickness was made for the elbows in each station as 7000 hours, 5000 hours, and 2500 hours for Installation Nos. 1, 2, and 3, respectively. These estimates were based on linear extrapolations of the lines in Fig. 25 relating crack propagation rates and crack depths.
