Austenitic Stainless Steel-Ferritic Steel Weld Joint Failures

BY R. L. KLUEH AND J. F. KING

ABSTRACT. The cause of failures of dissimilar-alloy (austenitic or ferritic) joints in superheater and reheater tubes of fossil-fired steam plants was investigated. In the failures of interest, cracks form and propagate in the ferritic steel (usually 2½ Cr-1 Mo steel) about 5 to 15 µm from the fusion line. The complex microstructure developed at the interface between weld metal and 2½ Cr-1 Mo steel during welding and elevated-temperature service was examined in (1) the as-welded and as-welded-and-tempered conditions and (2) failed and unfailed joints having more than 100,000 h of service in a fossil-fired boiler.

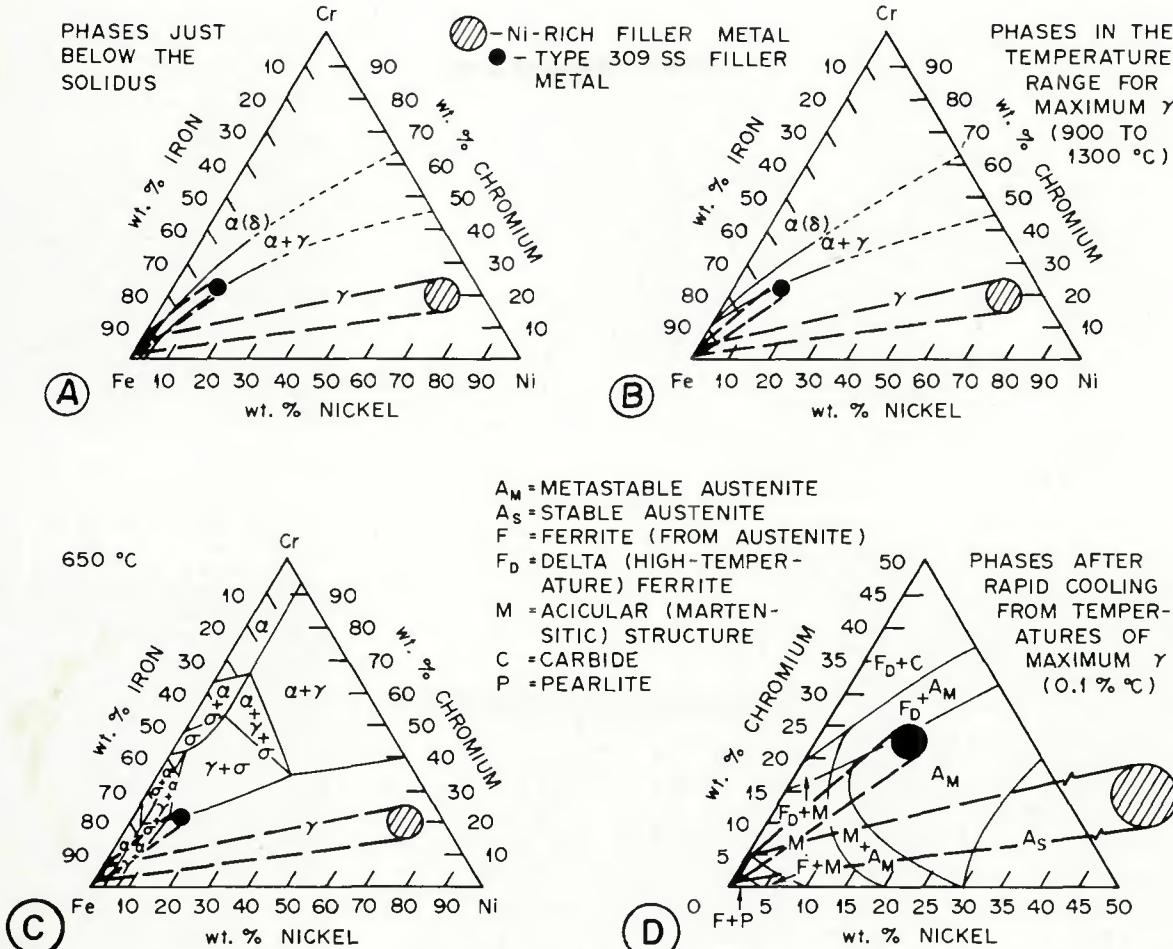
The microstructure of the dissimilar alloy weld is determined by phases developed during welding. Various phases are indicated in Fig. 1 which consists of Fe-Ni-Cr diagrams taken from the *Metals Handbook* (Ref. 16) on which regions representing Type 309 stainless steel and nickel-rich filler metals have been superimposed.

Fig. 1—Sections of ternary Fe-Ni-Cr phase diagram. Regions are shown to represent the compositions of $2\frac{1}{4}$ Cr-1 Mo steel, Type 309 stainless steel filler metal, and the typical nickel-base filler metal. Published by permission of American Society for Metals, E. C. Bain and R. H. Aborn, "Cr-Fe-Ni Phase Diagrams," pp. 1260-61 in **Metals Handbook**, Cleveland, 1948.

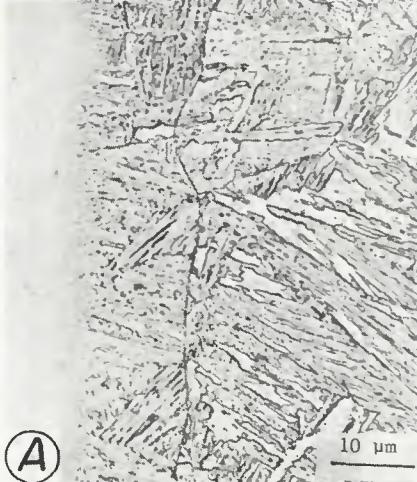
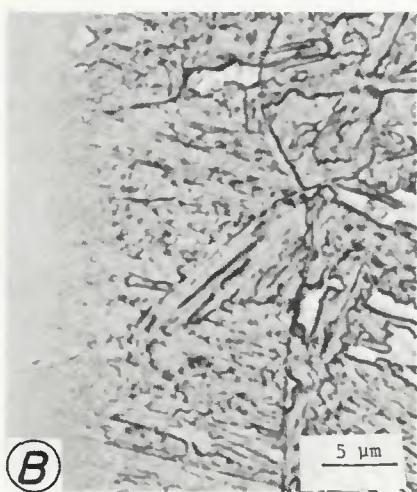
To determine what phases form during welding, we made several bead-on-plate welds on annealed $2\frac{1}{4}$ Cr-1 Mo steel plate. Figure 2 shows the interface microstructure of Type 309 stainless steel weld metal on the $2\frac{1}{4}$ Cr-1 Mo steel plate. Two observations are of interest:

on steam generator tubes, as we will demonstrate. On close examination of Fig. 2, another phase appears to be present in the grain boundaries—Fig. 2 B.

Fig. 2—Microstructure of region near fusion line of bead-on-plate weld of Type 309 stainless steel on annealed 2½ Cr-1 Mo steel. Etched lightly with 2% nital

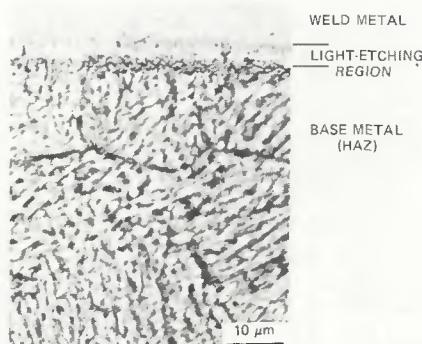
The microstructures of Fig. 2 were brought out with the typical etchant for $2\frac{1}{4}$ Cr-1 Mo steel (2% nital). When the $2\frac{1}{4}$ Cr-1 Mo steel was over-etched, another zone became visible between the weld metal and the $2\frac{1}{4}$ Cr-1 Mo steel (Fig. 3) and would appear to be the "light-etching phase" observed by Eaton and Glossop (Ref. 10) and Jones (Ref. 13).

As a result of the heavy etching, we found it difficult to resolve, simultaneously, the light-etching region and the $2\frac{1}{4}$ Cr-1 Mo steel microstructure. By focusing on the light-etching region, a substructure can be delineated—Fig. 3. Furthermore, at the edge of this region (away from the weld metal), a narrow dark area occurs that is somewhat different from the region on either side of it. This region could be one that contained two phases [$\gamma + \alpha(\delta)$] during welding—Fig. 1.

Fig. 3—Microstructure of region near fusion line of bead-on-plate weld of Type 309 stainless steel on annealed 2½ Cr-1 Mo steel. Etched heavily with 2% nital to bring out light-etching zone

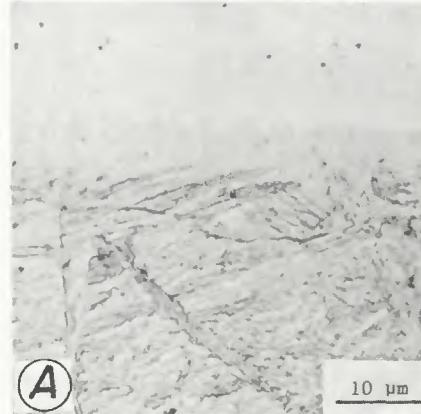
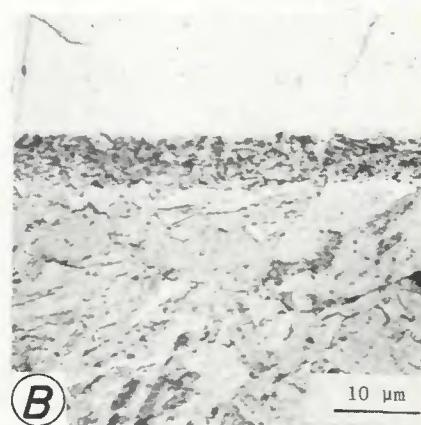
Similar microstructures occur when nickel-base filler metals are used instead of Type 309 stainless steel filler metal. Figure 5A shows the interface for an ERNiCr-3 filler metal. After a piece of this weld was aged for 500 h at 566°C (1051°F), the dark-etching region again

became evident—Fig. 5B. We made similar observations on bead-on-plate welds for ENiCrFe-3 and ENiCrFe-2 on 2½ Cr-1 Mo steel plate.

Fig. 5—Microstructure of region near fusion line of bead-on-plate weld of ERNiCr-3 filler metal on annealed 2½ Cr-1 Mo steel plate: A—as-welded; B—aged 500 h at 566°C (1051°F)

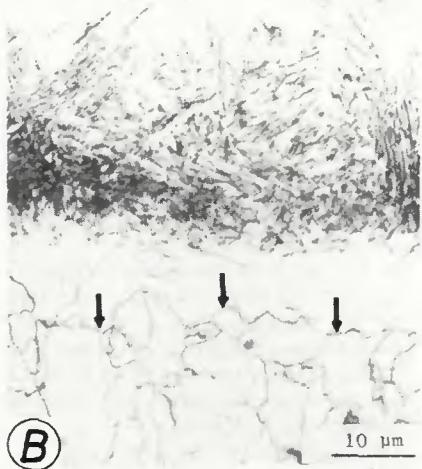
treatment at 704°C (1299°F), the dark-etching "lamellar phase" of Eaton and Glossop (Ref. 10) was observed—Fig. 4. All indications are that this is a precipitate that formed in the light-etching region of Fig. 3. Although difficult to resolve, at high magnification a small precipitate again appears to be present in the grain boundaries parallel to the fusion line (arrows in Fig. 4B). The microstructure between these grain boundaries and the dark-etching phase is noticeably different from that of the $2\frac{1}{4}$ Cr-1 Mo steel well away from the fusion line. Extremely few precipitate particles are in the matrix between the grain boundaries and the lamellar precipitate. The dark-etching phase also appears when a Type 309 stainless steel bead-on-plate weld is aged for 500 h at 566°C (1051°F) (without a postweld heat treatment; this aging treatment is similar to a service exposure).

Fig. 4—Microstructure of region near fusion line of bead-on-plate weld of Type 309 stainless steel filler metal on 2½ Cr-1 Mo steel plate annealed 5 h at 704°C (1299°F) after welding. Etched with 2% nital. Arrows indicate precipitates in grain boundaries

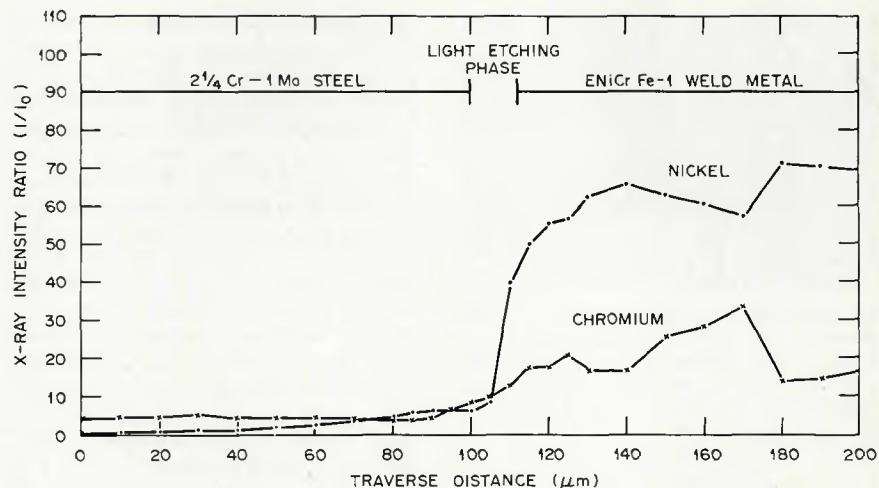
With the microprobe, nickel and chromium profiles were determined from the weld metal through the light-etching phase into the 2 1/4 Cr-1 Mo steel. The light-etching phase definitely delineated the region of nickel and chromium diffusion—Fig. 9. Qualitative microhardness observations showed that the light-etching region is harder than the neighboring regions.

Fig. 9—Nickel and chromium profile across fusion line region of specimen in Fig. 11. Shown is the light-etching zone to be associated with diffusion from the weld metal

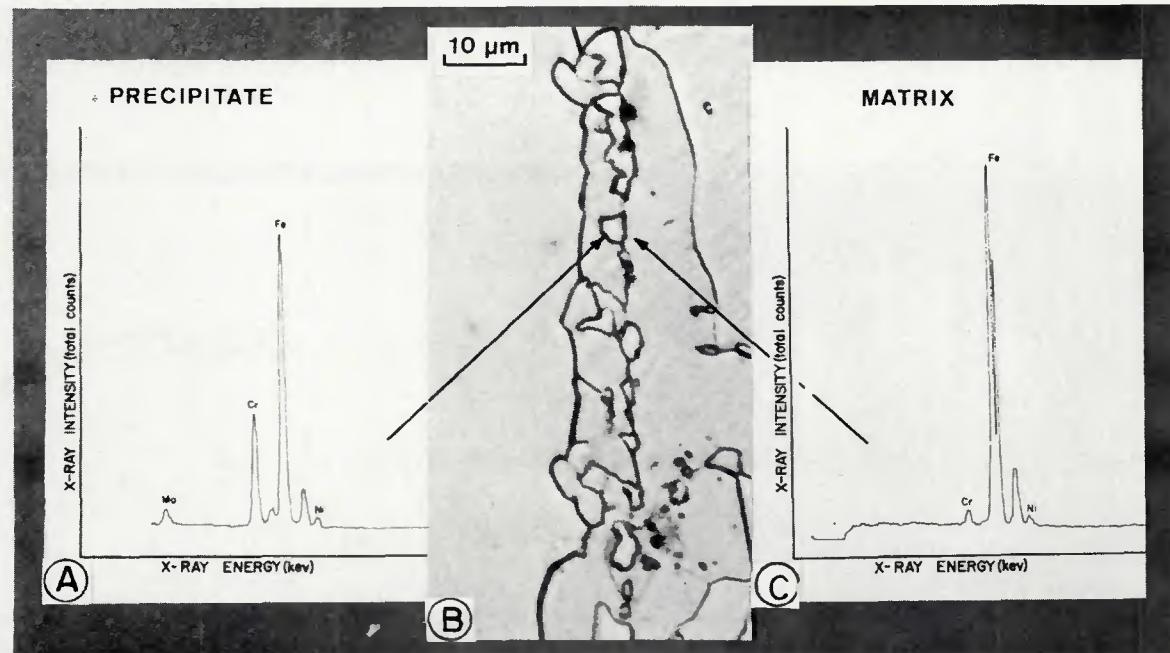
about 560°C (1040°F) but which was not heat treated before examination. We compared the x-ray intensities for three precipitates with the intensities of the nearby matrix. As shown in Fig. 10 for one of these precipitates, the chromium concentration was considerably higher than it was in the adjacent matrix. A slight increase also occurred in the molybdenum concentration. The other two precipitate particles showed similar results. These microprobe results are in agreement with the proposed mechanism.

Fig. 10—X-ray intensities for precipitate and 2 1/4 Cr-1 Mo steel matrix for the transition joint in service for more than 100,000 h at 560°C (1040°F)
