Failure of Welded Floor Truss Connections from the Exterior Wall during Collapse of the World Trade Center Towers

Failure of connections, as a result of overloading, occurred within the heat-affected zone of the base metals

BY S.W. BANOVIC AND T. A. SIEWERT

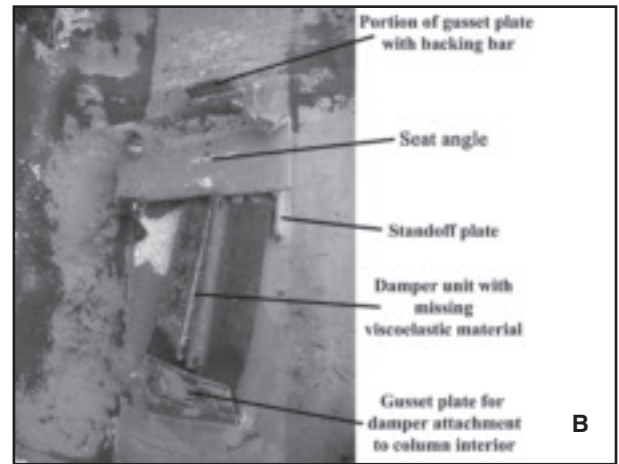
Fig. 3—A — Schematic showing attachment of the floor truss to the exterior wall; B — undated construction photograph showing the various features of the structural subsystems and their connections.
