Inspecting Upgraded Hydroelectric Generators

Extending the life and increasing the output of older hydroelectric power plants require expanded inspection programs

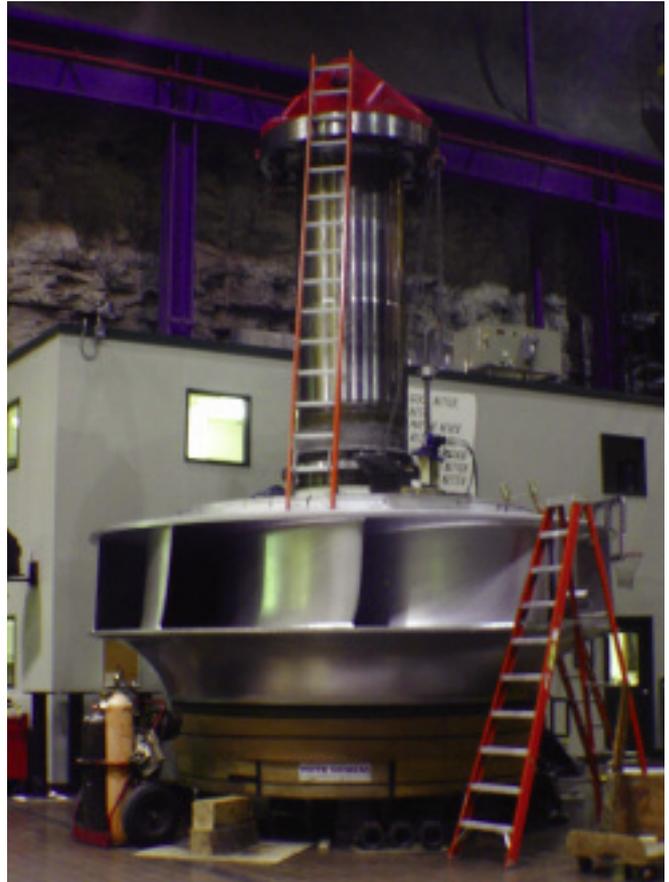
A typical turbine runner and shaft on a 350-megawatt system. Turbine upgrades can require extensive modification of the water path through the spiral case and past the stay vanes.

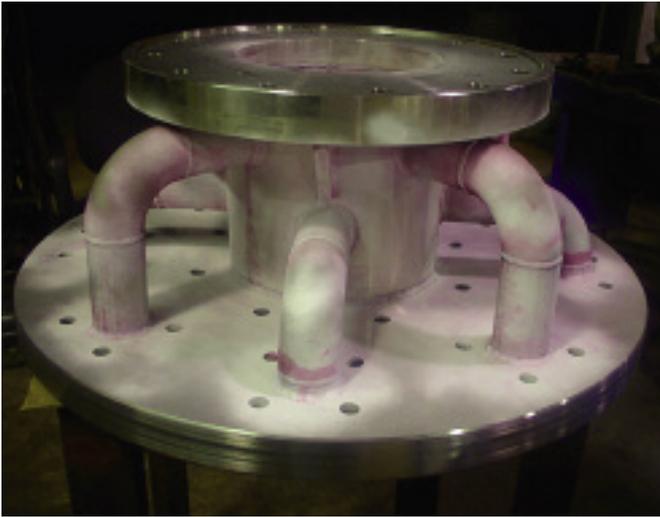
Fig. 1 — A completed penetrant test on a high-pressure rotor water distributor assembly. These are used on the very rare water-cooled hydroelectric generator rotors.

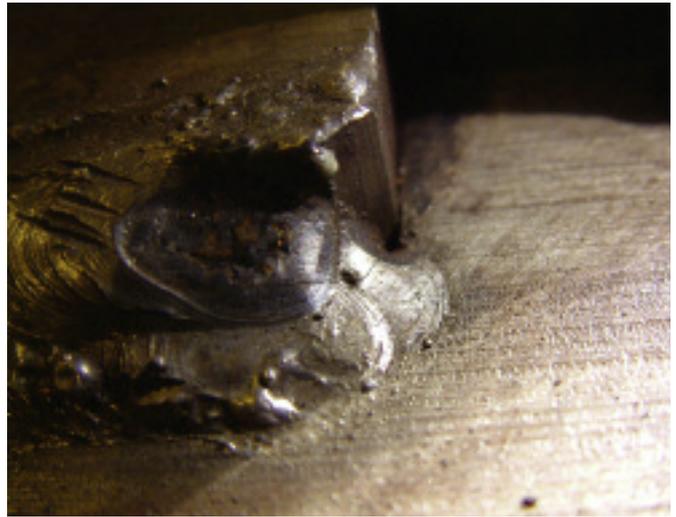
Fig. 2 — Newer repair weld pass over vintage weld passes that contained large cracks that were not ground out. The result was propagation of the old weld cracks into the new repair weld.

There are three areas of concern on the rim assembly: the rim-to-spider attachment key welds (Fig. 2), the brake ring, and the tack welds on the rim-clamping studs. Other areas include welded fan blade assemblies and other welded/bolted attachments and supports. The rim-clamping studs are prevented from backing off by large tack welds between the nut/washer and washer/rim top or bottom plate. These single-pass welds are several inches long and require only 100% visual inspection. The rim-to-spider tack welds can have several passes and are highly stressed both centrifugally and thermally. At rest, the welds are usually under transfer compression so if cracks develop in operation, many times they are squeezed shut. Often, these cracks can barely be seen visually, if they are not totally invisible. In fact, there are times when even PT cannot present these cracks strongly. Fluorescent penetrant testing might add a slight level of additional sensitivity here but usually isn't warranted, and due to access limitations, ultrasonic testing (UT) is not usually possible.

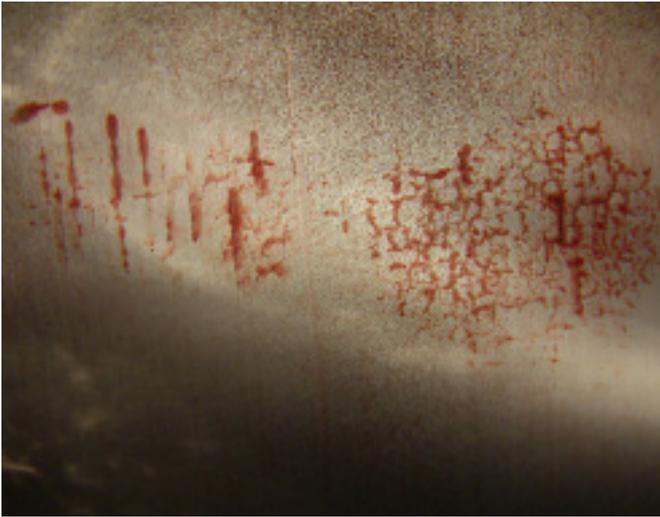
Fig. 3 — Penetrant test brings out small stress cracks and heat checking on the rotor brake ring surface.

The brake ring (a large, flat, donut-shaped ring at the bottom of the rim) presents several inspection opportunities — Fig. 3. First, the attachment points (weld-locked bolts) to the spider require a visual inspection. Then the surface of the brake ring gets 100% visual and PT inspections looking for heat checking and cracks. There are numerous other small nonmetallic components attached including electrical insulating components that also require visual investigation as part of a comprehensive

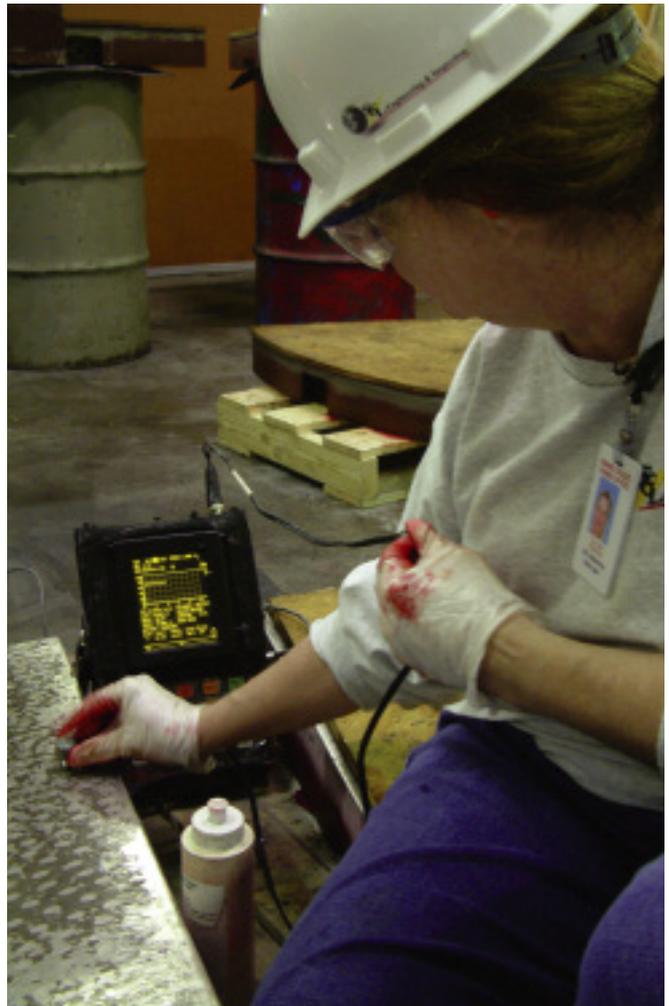
Fig. 4 — A UT technician checks a generator thrust bearing for unbonding.

Bearings. Generator and turbine bearings — both guide and thrust bearings — are high wear, high maintenance items. They have always been prime candidates for inspection (visual, PT, and UT) during any outage whether the outage was for simple maintenance checks or for a major upgrade. Older, obviously worn bearings or bearings that visually show the early stages of failure are usually re-babbitted after only a visual inspection before going out for rework. However, since most upgrades, including major ones, do not change the rotational speed or weight load on the bearings, if the bearings are good there is usually no need to upgrade them. An inspection to determine their continued serviceability may include a general visual inspection, followed by a 100% PT inspection of the edges at the steel/babbitt interface, and a UT thickness inspection of the entire surface to look for unbonded areas — Fig. 4.
