Brazed Nickel/Columbium Dissimilar Metal Pipe Joints for 720 C Service

Best results are obtained with a BNi-4 (Ni-3.5Si-2B) filler metal using a tongue-in-groove joint configuration with a columbium alloy tongue when investigating application of brazing to dissimilar metal pipe joints for a Brayton cycle space power system

BY G. K. WATSON AND T. J. MOORE

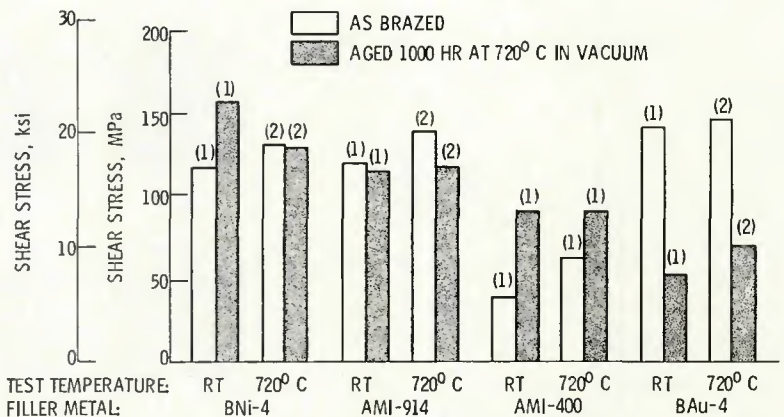
Fig. 5—Braze metal shear stress at fracture for double lap tensile-shear specimens for Hastelloy X/C-103 brazements tested at room temperature and at 720 C; the number of tests run is shown in parentheses above corresponding bar

Tests were run at room temperature and 720 C (1328 F) in both the as-brazed condition and after aging. The room temperature tests were conducted in air, and the 720 C (1328 F) tests were conducted in vacuum at a pressure of 1.3×10^{-4} N/m² (1×10^{-6} torr) or less. The crosshead speed was 1.3 mm (0.05 in.) per minute for all tests. The results of these tests for the more promising braze joints are summarized in Fig. 5 and are described further in the following paragraphs.

Both the BNI-4 and AMI-914 joints had good strengths at room temperature and at 720 C (1328 F). In general,

aging had little apparent effect on the strengths of joints brazed using these two filler metals. The AMI-400 joints failed at stresses notably lower than those obtained on the BNi-4 and AMI-914 joints. Also, some brittleness was noted in the AMI-400 joints in that two of the joints broke in handling. The strengths of the BAu-4 joints in the as-brazed condition were slightly greater than those of the other joints, but aging resulted in embrittlement and lower strengths.

Even greater embrittling and weakening effects were observed for the remaining filler metals. The as-brazed Palniro 7 joints, which were similar in strength to BNi-4 and AMI-914 joints, were severely embrittled during aging and broke in handling prior to testing. Extreme brittleness was characteristic for the Palniro 1 and the BNi-5 joints, even in the as-brazed condition. Five of the six Palniro 1 joints and all six of the BNi-5 joints were broken prior to testing.

The AMI-637 joints were as strong as BNi-4 and AMI-914 joints in the as-brazed condition at room temperature. At 720 C (1328 F), the AMI-637 joints were only about one-fourth as strong as BNi-4 and AMI-914 joints in both the as-brazed and the aged conditions.

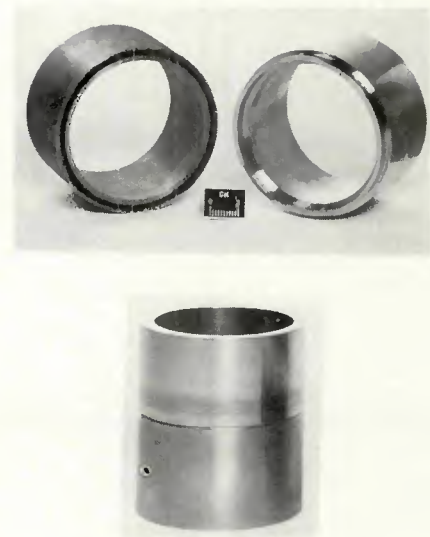
Fig. 9—Dissimilar metal pipe brazement and component parts for Hastelloy X tongue in Cb-1Zr groove

joint was typically twice the volume calculated to fill the joint. All brazing was accomplished in vacuum using procedures similar to those described previously. A typical brazed joint and its component parts are shown in Fig. 9.

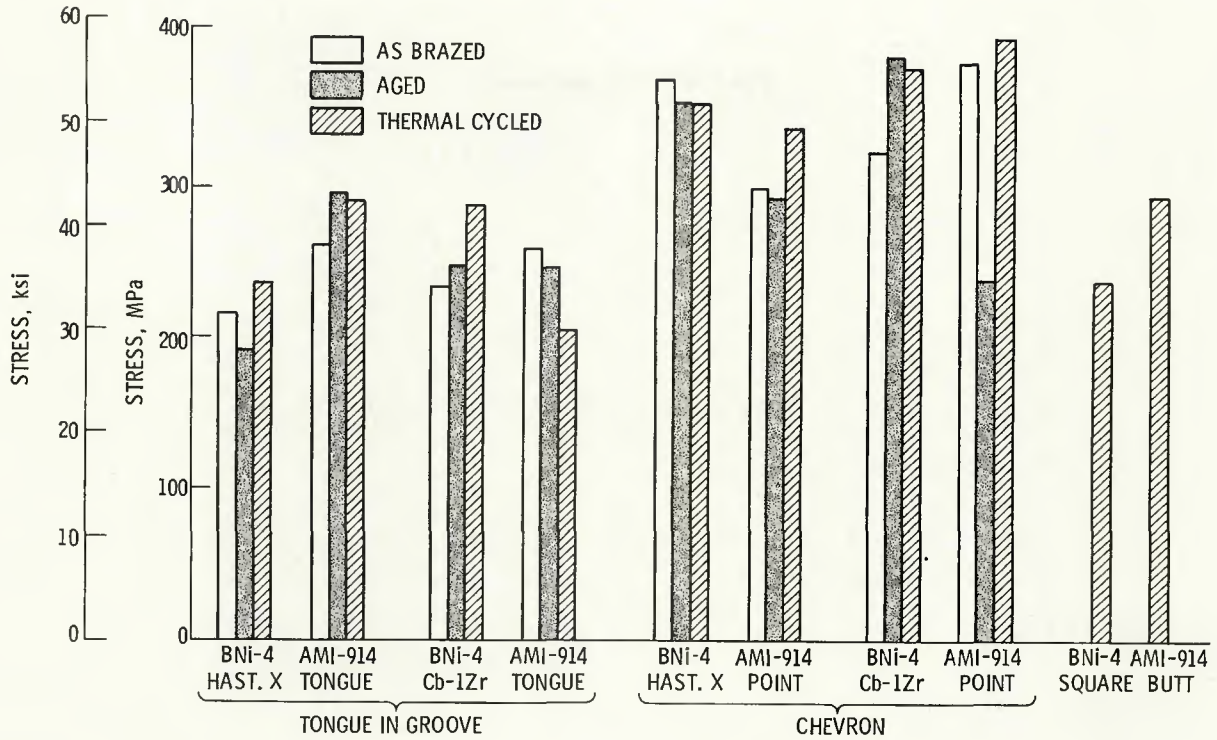
Fig. 11—Room temperature tensile test results for specimens taken normal to the brazed pipe joints; results are average of duplicate tests

Test results are summarized in Fig. 11. The tensile strength variations observed are believed to be caused by small flaws in the brazes. For example, examination of the fracture surfaces showed that the low strength of the aged chevron joint with the Cb-1Zr point and brazed with the AMI-914

alloy could be attributed to local areas devoid of filler metal.

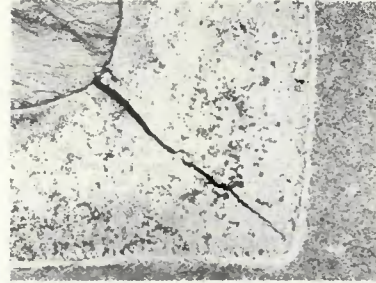
(a) Portion of large void in AMI-914 braze, aged condition.

(b) Corner crack in thermal cycled AMI-914 braze joint.

(c) Local cracks at BNi-4/base metal interfaces in thermal cycled condition.
