An Investigation of Ductility Dip Cracking in Nickel-Based Weld Metals — Part II

Fracture behavior and fracture surface morphology are related to microstructure, composition, and temperature

BY M. G. COLLINS, A. J. RAMIREZ, AND J. C. LIPPOLD

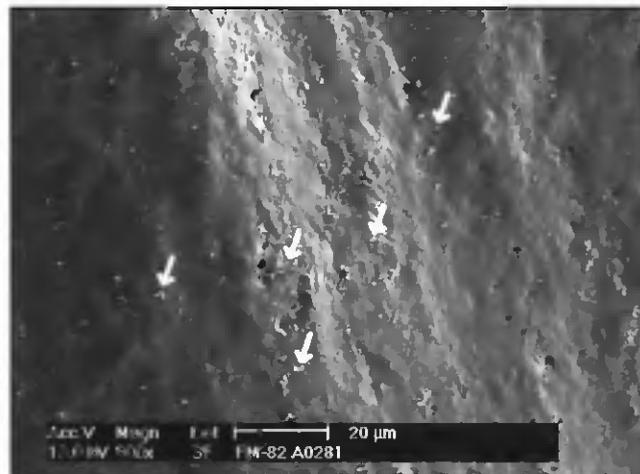
while the remaining regions, as illustrated in Figs. 8 and 9, possess macroscopically (400–600×) flat surface features. At 950°C (Fig. 8), these deep voids actually appear as surface porosity. This feature disappears, however, when the testing is conducted at 1000°C. Overall, the macroscopic flatness of the fracture surface appears to increase with temperature.

Fig. 8 — Filler Metal 82 fractograph at 950°C and 2% strain (hydrogen additions; 600×). Fracture surface subjected to longer cleaning times, revealing secondary particles.

Despite the fact that all STF tests are run in a protective argon atmosphere, some surface oxidation occurs, which tends to obscure some of the finer details of the fracture surface. The use of a mild inhibited acid solution to remove this oxidation proved very effective in revealing these fine details. When subjected to longer cleaning times, small secondary particles were revealed on the fracture surface. Figures 8 and 9 illustrate the DDC fracture surface of Filler Metal 82 with hydrogen additions at 950°C and 2% strain. Figure 8 is a low-magnification fractograph of the DDC fracture surface revealing large intergranular MC-carbides (between 1–2 µm) throughout (some of these carbides are indicated by arrows), while Fig. 9 provides a higher magnification fractograph

of a region of the fracture surface taken from Fig. 8. In Fig. 9, two different distributions of secondary particles are observed. The large particles in Fig. 9 are the same MC-carbides shown in Fig. 8, while the small precipitates, not visible at low magnifications (Fig. 8), appear to be MC-carbides as well. Although Figs. 8 and 9 were taken from the same sample and region, all the cleaned DDC test samples selected from the medium-temperature region (850–1000°C) of the DTR revealed a similar pattern of secondary particles along the fracture surface. Although not always detected by the microscopy methods employed in this study, based on detailed transmission electron microscope (TEM) work performed by subsequent continuing research, precipitation was found to be prevalent along the grain boundaries throughout the entire DTR but at different sizes and quantities (Ref. 6).
